Real Estate Inspection Report

Sample Report

**604 S. Any Street
Los Angeles, CA 90689**

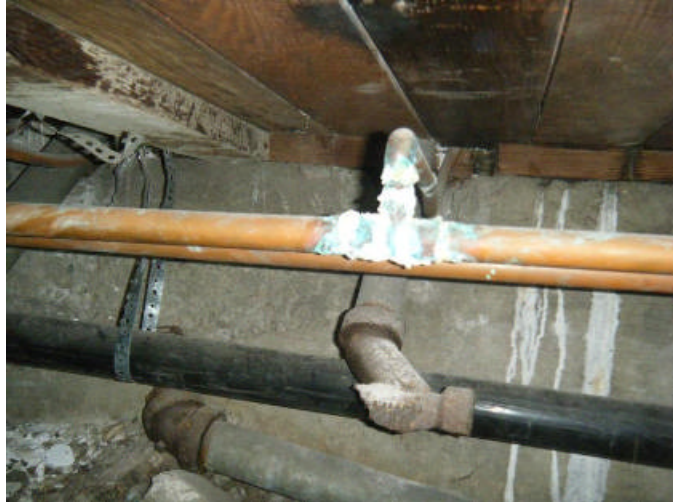
Needs Attention: Excessive corrosion was observed on some of the copper water supply piping under the kitchen or laundry area. This may require repair.

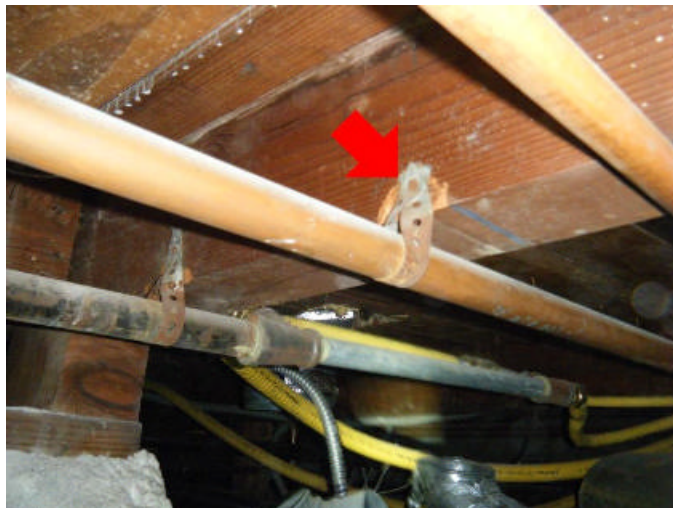
There is copper to galvanized steel contact occurring where the straps that secure the copper piping to the framing are made of galvanized steel. This may corrode both metals and is not an approved building practice. The straps should be changed to an approved material.

There are also areas where the water supply pipes were not well secured and should have additional strapping to the building.

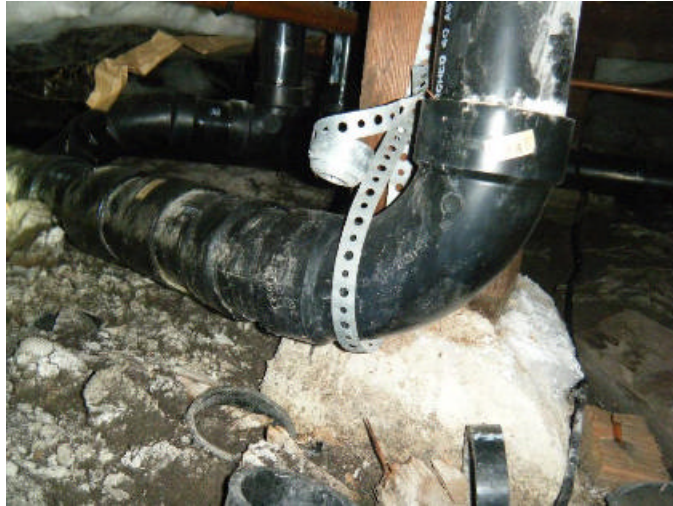
The attachment of the waste line piping to the framing of the building is substandard. Improper strapping materials were used in areas and minimal straps were observed on the newer piping.

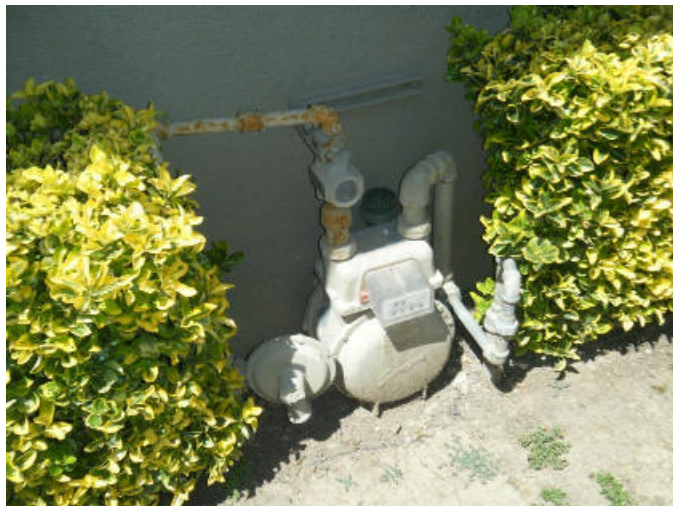
The safety shut off valve appears to be placed on the "Gas Company" side of the meter. This is only permitted if it was done by the Gas Company. It is advised to consult with a "retrofitter" specialist for additional details.

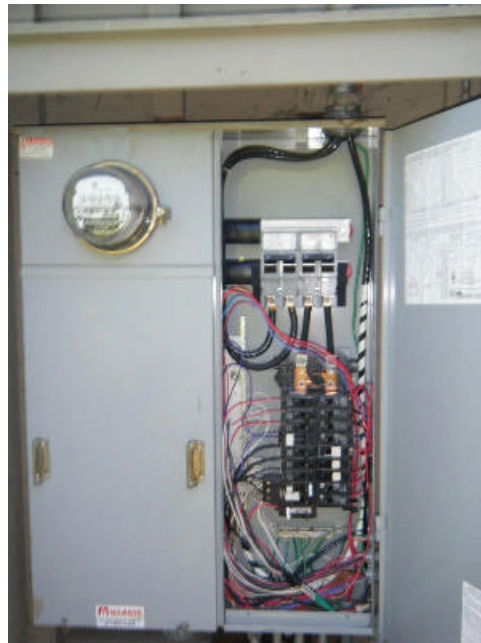
MAIN PANEL CONDITION: **Needs Attention: There is more than one wire connected to a single circuit breaker. This is an improper installation and should be corrected per the current standards. One of these was noted.**

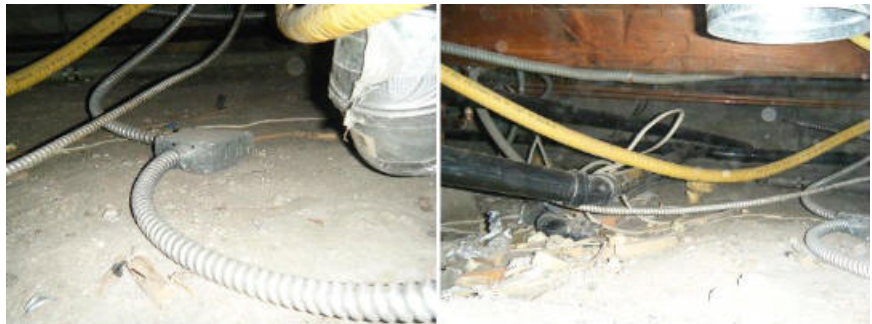
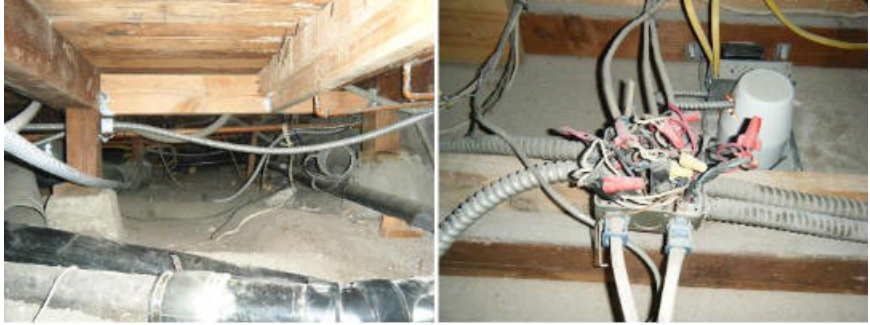
Not Acceptable: The wiring observed in the attic space and especially the crawl space/sub area is poorly installed. There several areas under the house where flexible and romex conduits as well as metal or plastic junction boxes are laying on the ground. In the areas of damp soil, some of these conduits are rusting and in poor condition. In the attic space, there are many open junction boxes stuffed with many wires that may not be able to fit a proper cover. These observable areas indicate that the at least portions of the wiring has been done by a less than qualified individual requiring us to recommend that the entire wiring and electrical system be examined by a licensed and reputable electrical contractor.

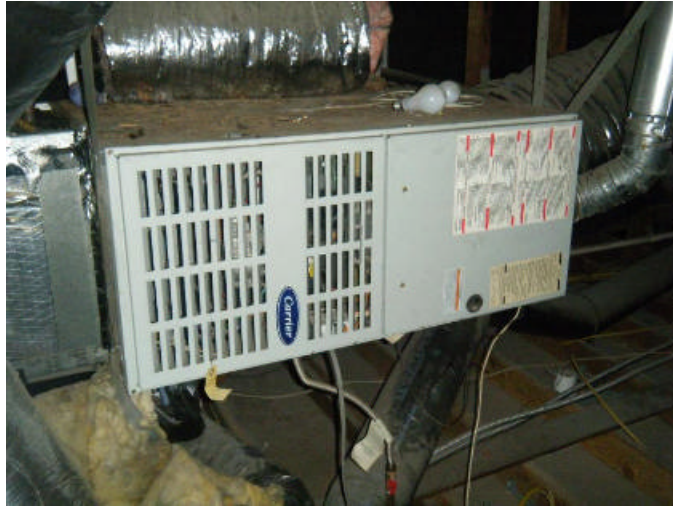
Needs Attention: There is no working platform installed to work on the furnace, this is a standard requirement for safe conditions around the furnace.

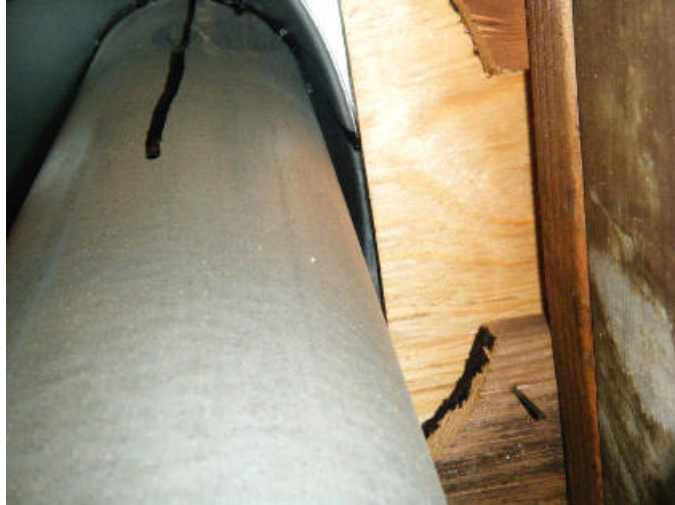
Not Acceptable: The furnace combustion vent does not have sufficient clearance from a combustible material. (wood roof framing or sheathing). This is being identified as a condition that could be a potential fire hazard. The combustion venting system needs to be evaluated by a qualified professional to establish proper clearance requirements and make corrections/repairs.

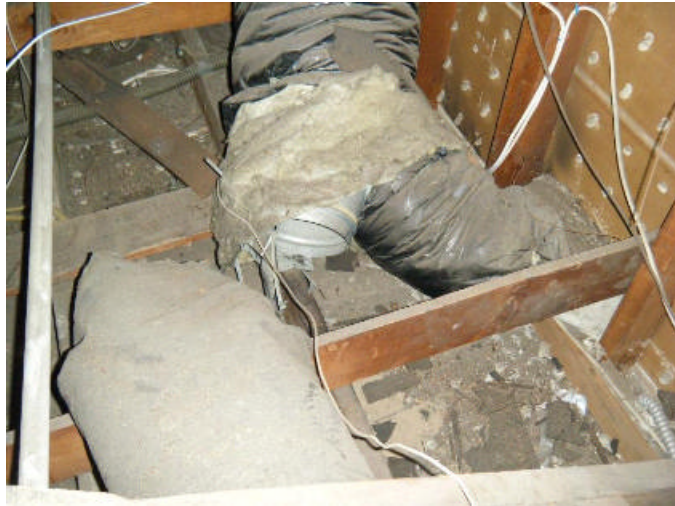
Not Acceptable: There is a disconnected duct that services the register at the right side of the living room near the bedroom hallway.

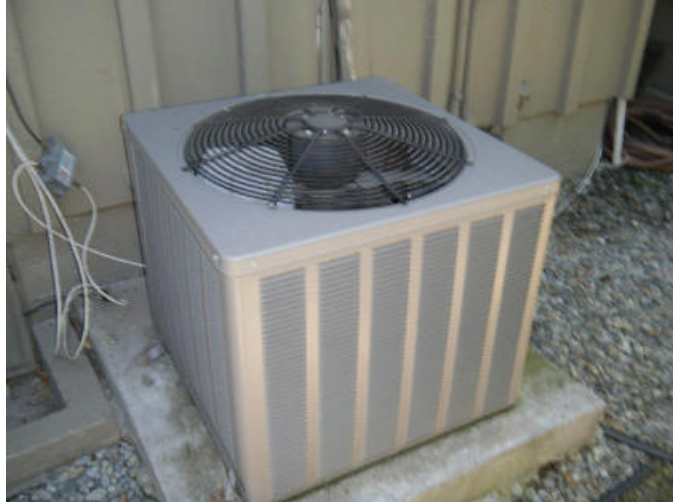
Needs Attention: The air coming out of the unit is somewhat cool and has less than the expected temperature difference between the return air and the cooled air. Only about 8 degrees difference was observed. This is not cooled enough to be considered functioning properly. A 15 - 20 degrees differential is what is looked for during this inspection. This should be evaluated and serviced by a licensed heating and air contractor to determine the reason this is occurring and its remedy.

Not Acceptable: The primary, secondary and backup pan under the coil all have drainlines that connect together. This is an improper installation and is advised for repair.

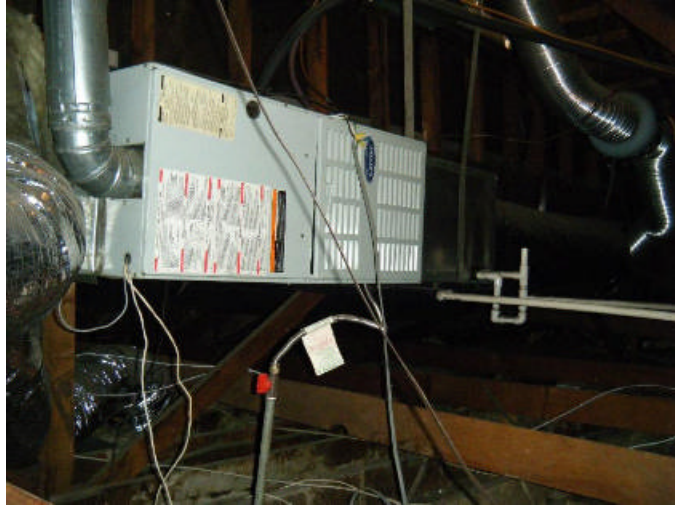
Needs Attention: There is no working platform installed to work on the furnace, this is a standard requirement for safe conditions around the furnace.

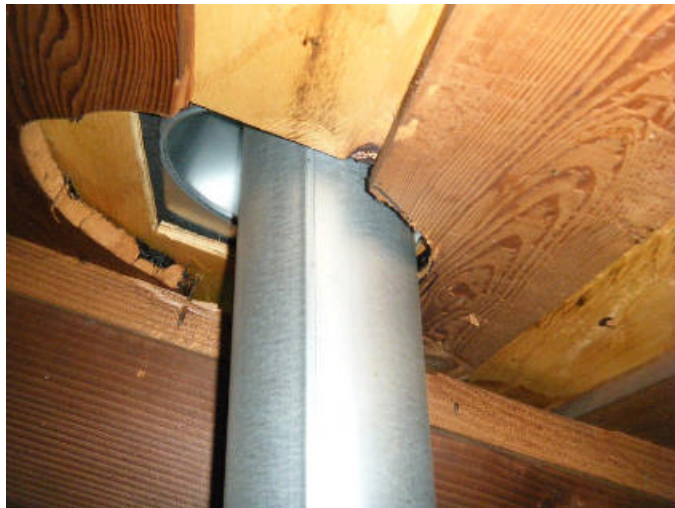
Not Acceptable: The furnace combustion vent does not have sufficient clearance from a combustible material. (wood roof framing or sheeting). This is being identified as a condition that could be a potential fire hazard. The combustion venting system needs to be evaluated by a qualified professional to establish proper clearance requirements and make corrections/repairs.

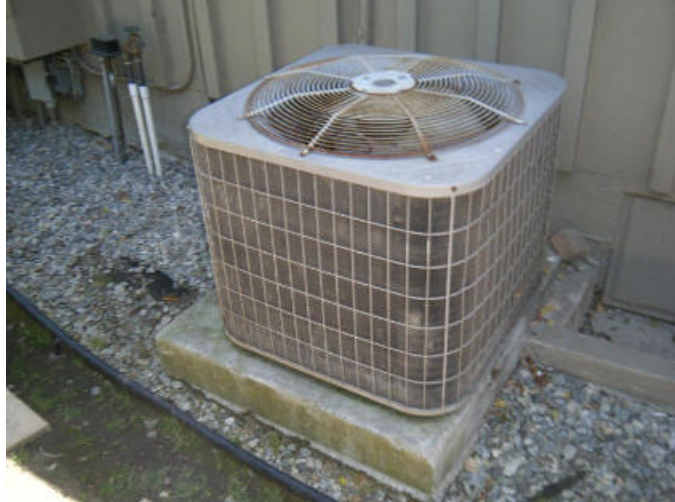
Needs Attention: The air coming out of the unit is somewhat cool and has less than the expected temperature difference between the return air and the cooled air. A range of 11 to 13 degrees was observed. This is not cooled enough to be considered functioning properly. A 15 - 20 degrees differential is what is looked for during this inspection. This should be evaluated and serviced by a licensed heating and air contractor to determine the reason this is occurring and its remedy.

Not Acceptable: The primary, secondary and backup pan under the coil all have drainlines that connect together. This is an improper installation and is advised for repair.

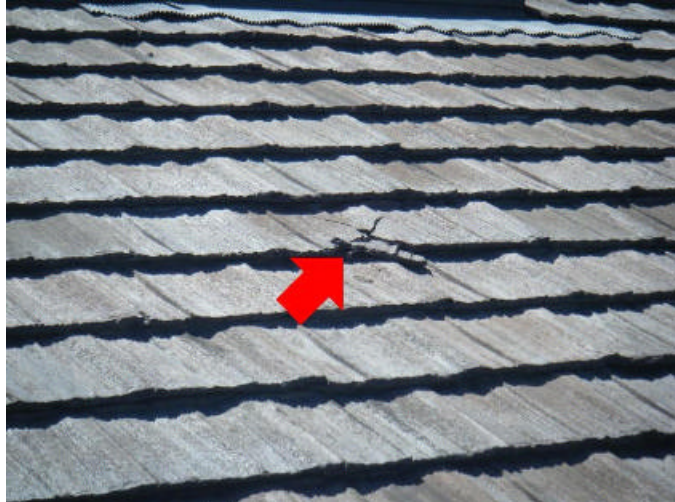
Needs Attention: At least one damaged tile was observed over the living room between the skylights. The function of the tile is to protect the underlayment which is the waterproof member of the roof system. This and any other damaged tile will need to be repaired by a qualified roofing contractor.

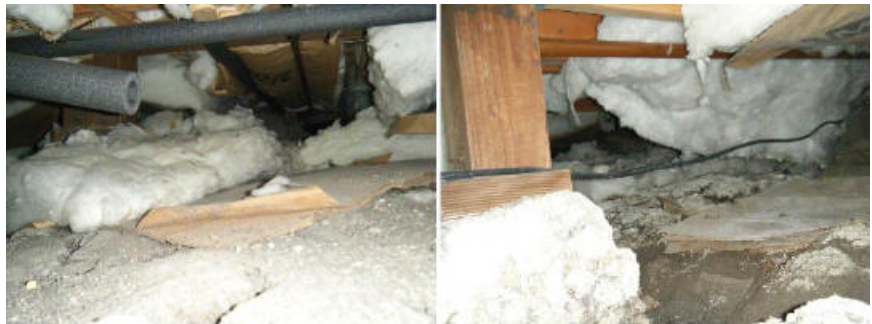
The insulation is not well attached under the building to the underside of the floor and is falling down in areas. This limits access and visibility of the foundation along the front right side.

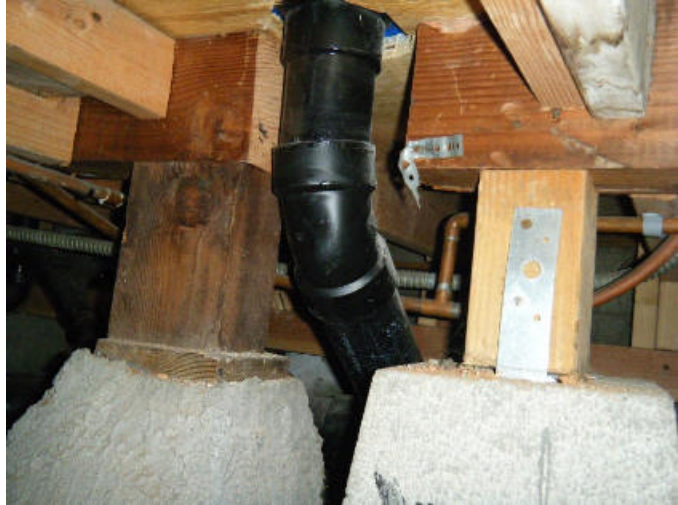
Needs Attention: One of main floor girders has been cut to provide room for a waste pipe. Additional support has been added by a second post and pier but this is non-standard and should be further evaluated.

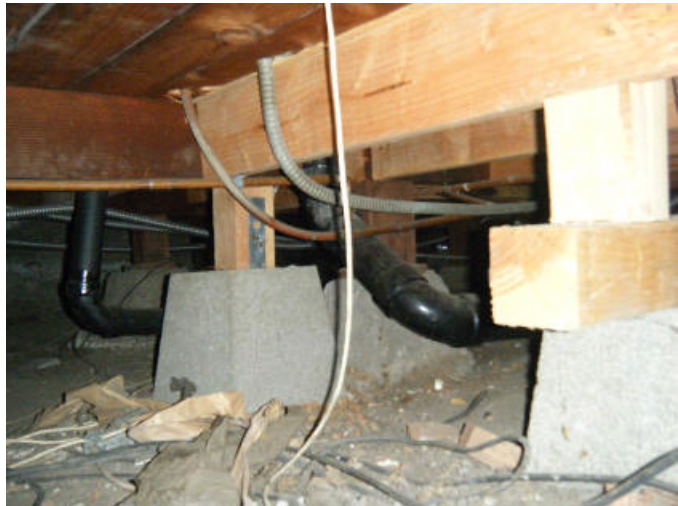
Needs Attention: There have been several posts and piers added under the maids area bathroom. These have been added in a manner that does not appear standard. Limited or no framing attachments were seen on most of the posts.

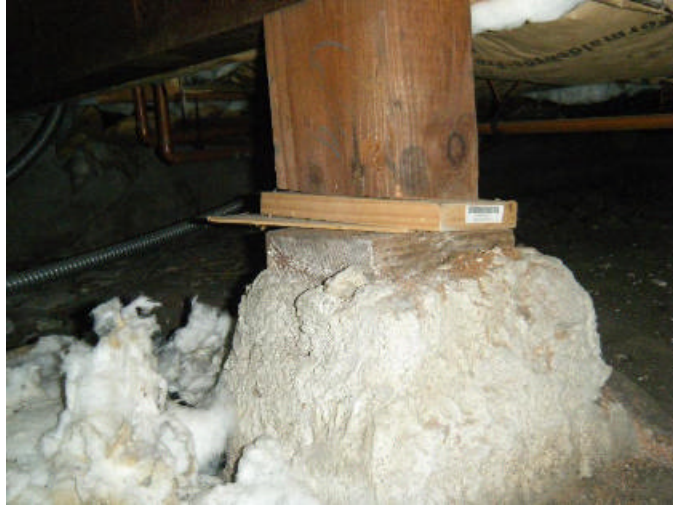
A number of pieces of wood such as shims are being used to raise some of the posts. These pieces are not attached and can slip during building settlement and movement. Due to the expansive nature of the soil under the house and the presence of moisture, it is expected that over time, they will work their way out.

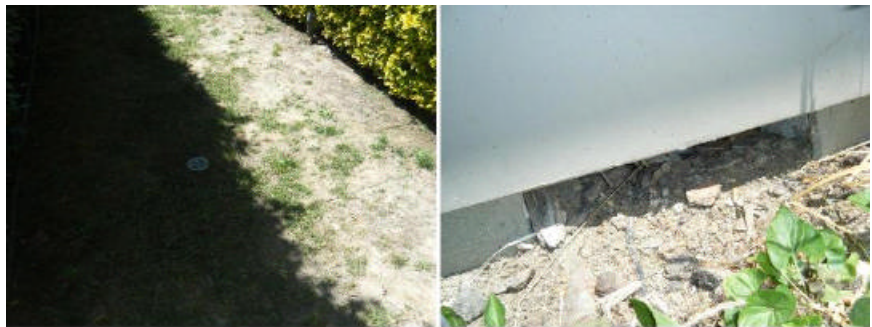
Needs Attention: The grading at the right side of the house slopes toward the structure and has a high point near the center where most of the area drains are. This can cause over-saturation of the soil at the structural footings which is the leading causes of foundation, deterioration, damage and settlement. Slope should fall away from the foundation at a minimum of 1/4 inch per foot and extend at least 10 feet away from the foundation.

Some of the exterior grade heights, such as at the front planter, patio area and along this right side are higher than the fresh air vents for the sub area. This condition increases the potential for moisture intrusion under the structure and due to the expansive nature of the soil discussed earlier in this report can increase the potential for building movement, settlement and potential foundation issues over time.

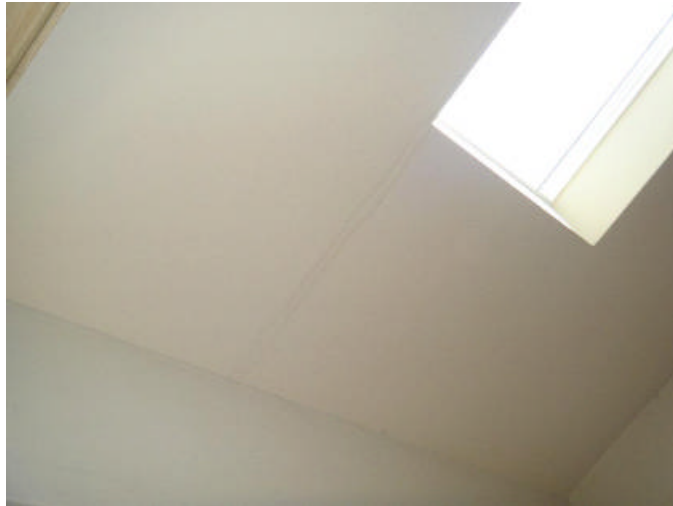
Needs Attention: There are moisture stains on the ceiling below the skylight closest to the right side of the living room. This could be a past leak of the skylight and it is advised to get the history of this staining.

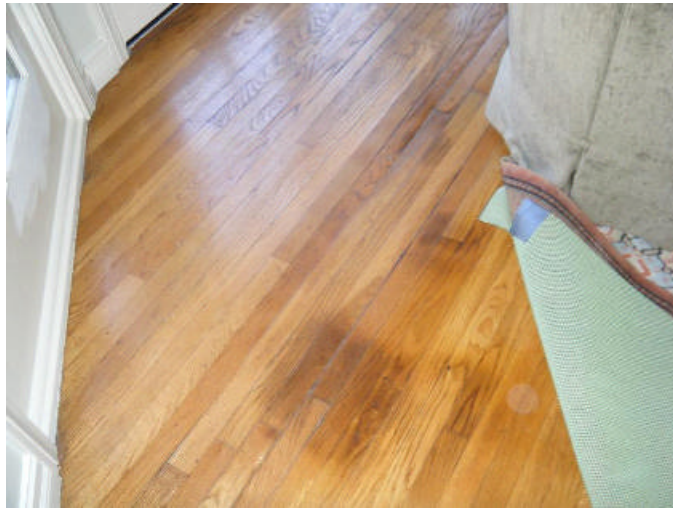
Needs Attention: There is staining and some deterioration to the hardwood flooring in various areas throughout the house. Some of this appears to be from pet urine, such as just inside the living room french doors. This kind of staining, while generally cosmetic by nature, cannot be removed.

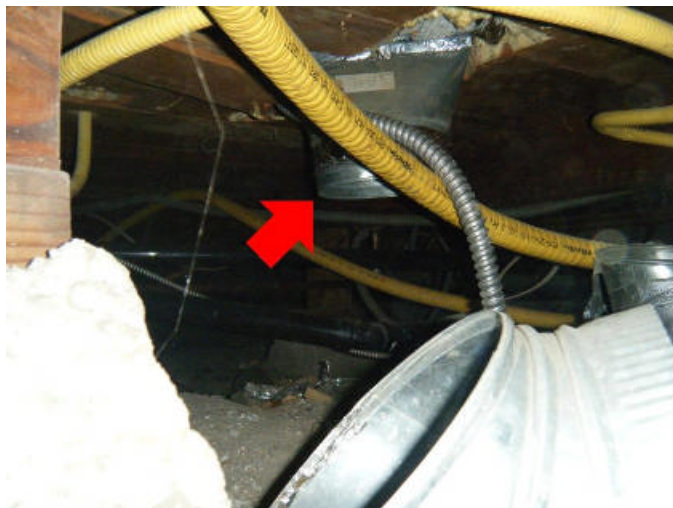
Not Acceptable: The downdraft vent behind the gas cooktop does not respond when tested with normal operation controls. When the sub area was entered, it was discovered that the vent to the exterior was never connected leaving the system to exhaust into the crawl space.
