Real Estate Inspection Report

Sample HOA Common Areas Report

Los Angeles, CA

Inspector - Bud Hayes
Confidential and Proprietary

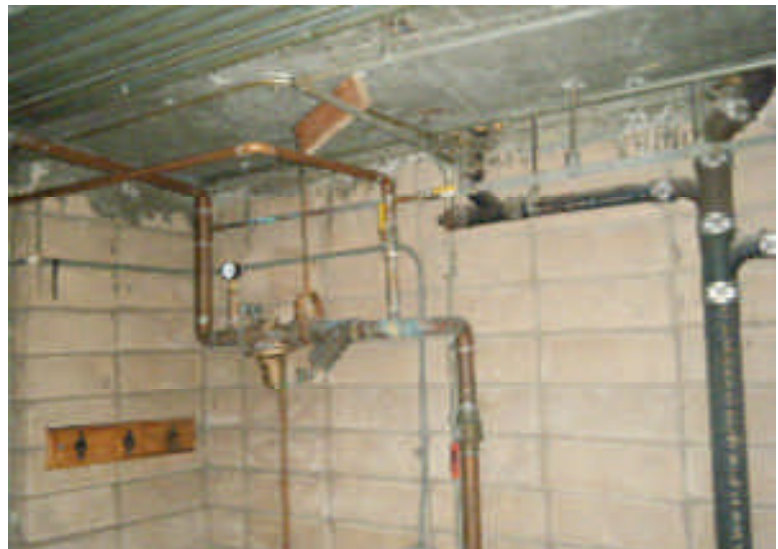
Left side water line and shut off

Copper piping is viewed coming out of the ground by the building and as the main line runs underground from the street to the building, this appears to be the main water line.. There are two main lines, one for each side at the front.

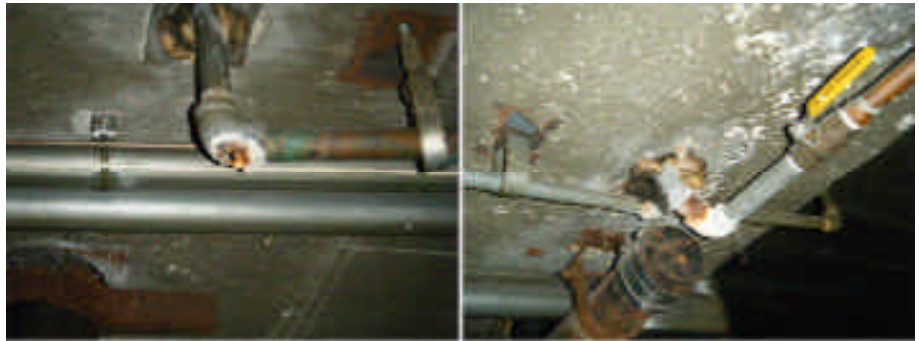
Not Acceptable, there are sections of water lines which are galvanized steel pipes and have excessive rust and some are dripping seen in the garage. These are the original pipes and are at the end of their life and will need to be replaced. These are rusting, corroded and are showing excessive deterioration in areas. here are some immediate repairs seen to be needed and copper repiping should be planned for in the near future.

Some of the pipes are copper to galvanized steel piping connections that appear to be without the proper fittings that keep these dissimilar metals apart. These metals react against each other without these fittings and the galvanized piping corrodes faster. Even proper fittings are just a temporary solution and will not correct or stop corrosion or handle the problems of pipes rusting out.

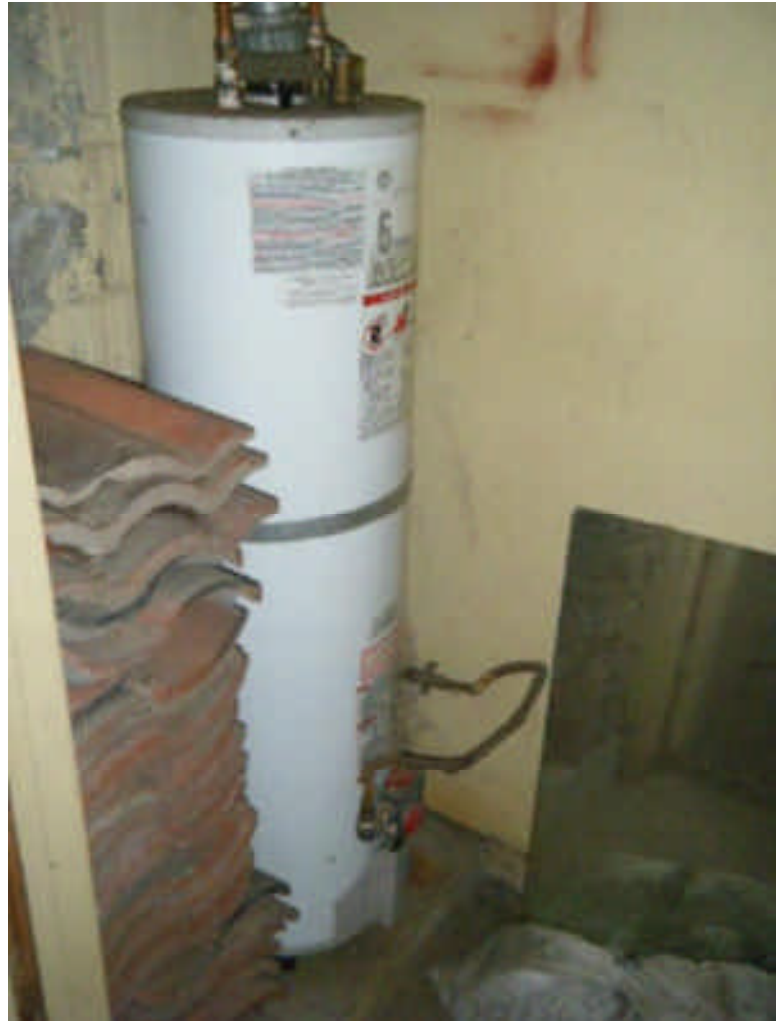
The water heater is located in the basement recreation area in the closet off of the sauna for the common area bathrooms.

- COMBUSTION AIR:** Needs Attention, the water heater does not have sufficient air to properly combust the natural gas it is burning and is missing a vent. It is supposed to have two vents. One vent needs to be high (seen open to the exterior) and one low (not present) and each vent is required to provide at least 50 square inches for air flow.
- WATER HEATER STRAPPING AND SUPPORT:** Needs Attention, the water heater only has one strap, it needs to have two straps to meet the state standards for water heater strapping.
- TEMPERATURE/PRESSURE RELIEF VALVE:** Serviceable.
- VENTING:** Serviceable, where visible.
- COMMENTS:** The adequacy or efficiency of the hot water heater cannot be determined in a limited time visual inspection. It is not known how hot the water will get or how long it will last and this is many times a matter of personal preference.

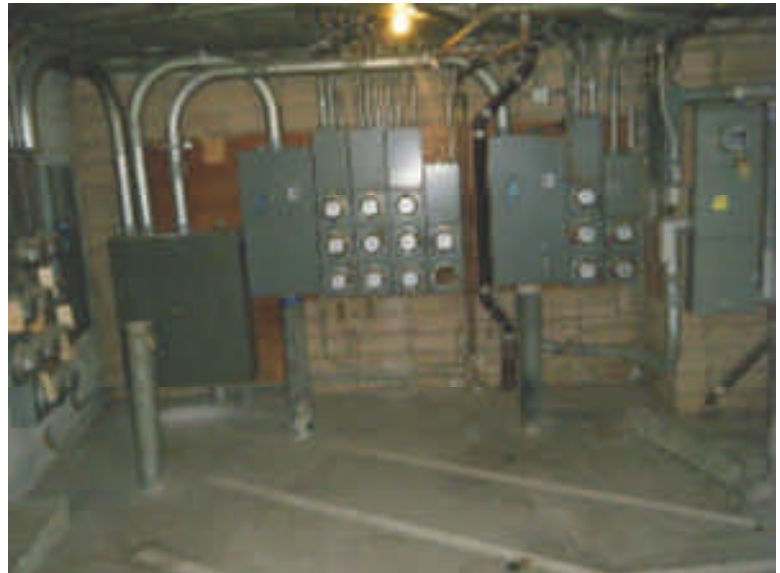
There are three 600 amp panels and meters for each unit typically 90 amps each and 175 amps for the house meter.

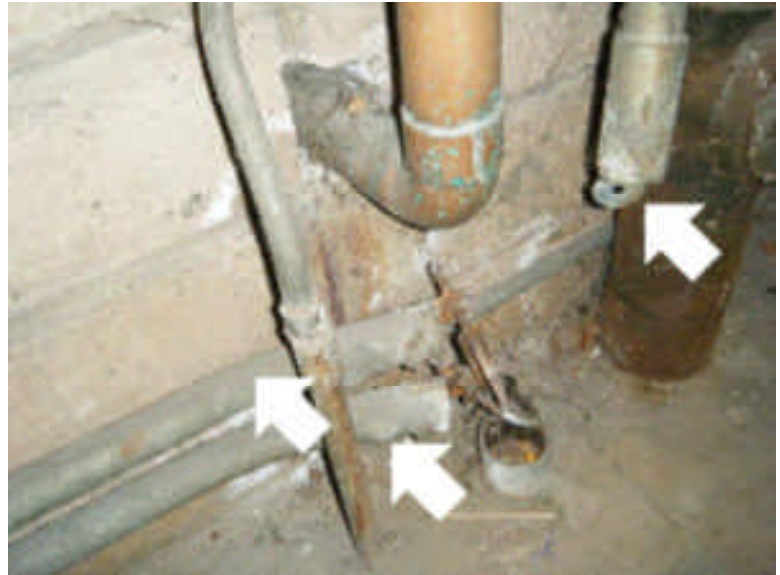
Not Acceptable, the grounding clamp was not connected to the cold water line or ground rod. This leaves the system without proper grounding which is a safety hazard.(It appears that the new copper line added did not have the ground clamps changed over and these are just dangling near the old abandoned steel pipe), This needs to be further examined and repaired as needed by an licensed electrician.

There was no driven ground rod observable at the main electrical panel. While not required in the past this is an important safety feature. It advised to have a secondary grounding system installed as a back up to the primary ground connection to the cold water pipe. This is a recommended upgrade but it is not a mandatory requirement unless alterations or modifications are made to the system.

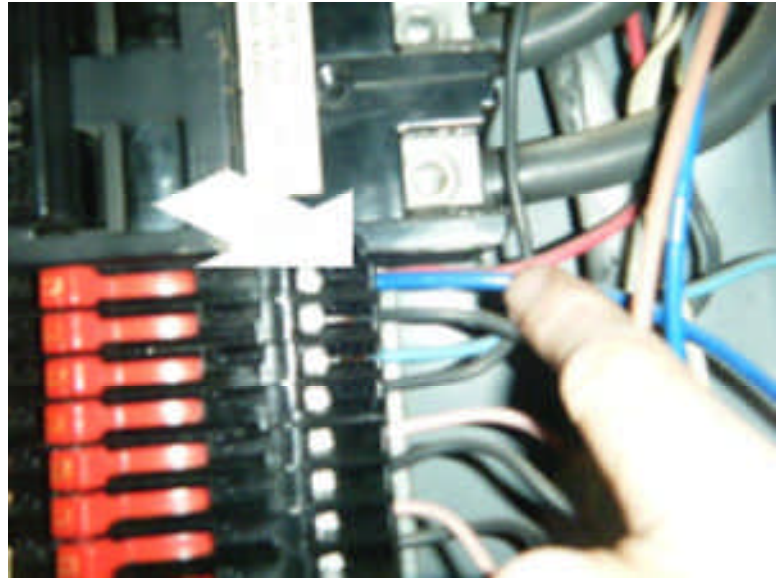
Needs Attention, at the garage sub panel, there is more than one wire connected to a single circuit breaker, where only one wire should be connected to each breaker. This can sometimes cause overloading of the wires or breakers. It also can cause the wires to have improper contact with the breaker and arc between the wire and the breaker. one of these was noted. This needs to be further examined and repaired as needed by a licensed electrician.

Note; this is a "Zinsco" brand of circuit breakers and panel which is known for the circuit breakers to wear out quicker than other brands. When they begin to trip off too easily it is time to have an electrician replace those breakers. Some electricians advise to have the panel checked annually to insure that the connections of the breakers to the panel; are kept secure and in good contact.

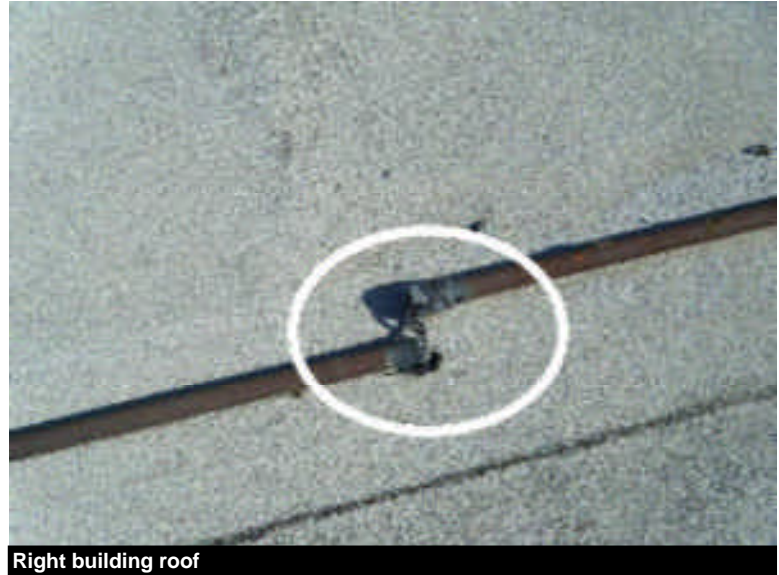
Not Acceptable, there are some loose and open joints on the conduits on the roof and some wires are exposed such as the one leading the fan system for the garage vent system. This needs to be further examined and repaired as needed by a licensed electrician.

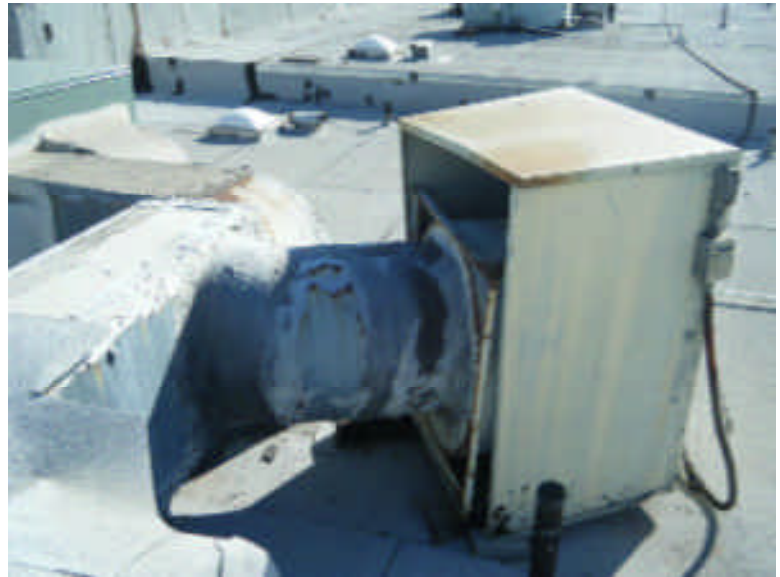
Needs Attention, the exhaust fan on the roof is not working. It is old and deteriorated and this appears to be at the end of its useful life and probably needs replacement instead of repairs.

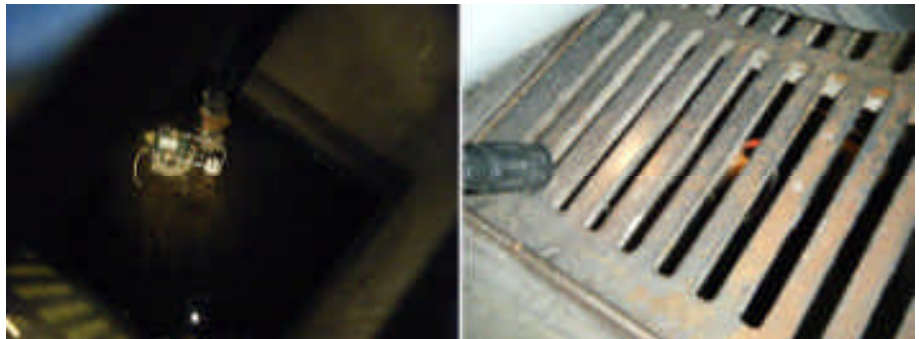
Not Acceptable, the sump pump system in the garage has a junction/relay box which below grade in the sump pump well which needs to be checked and insured this is a safe component or possibly relocated. This needs to be further examined and repaired as needed by an licensed electrician.

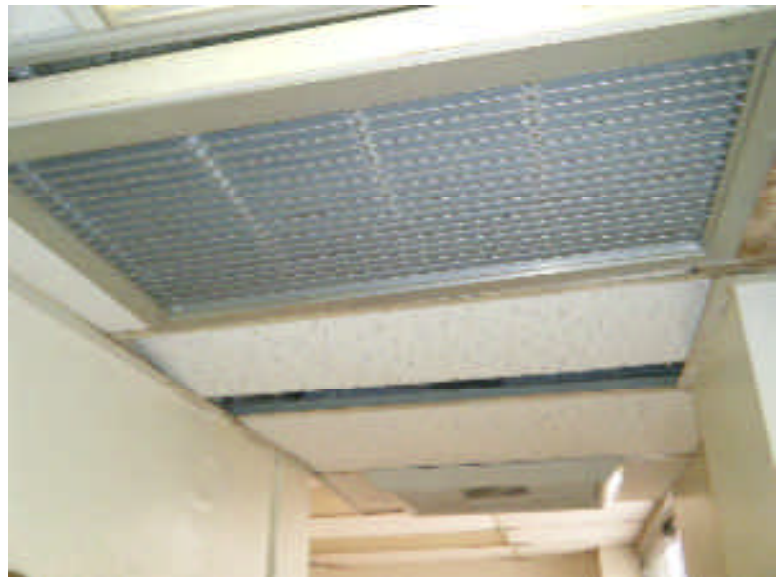
The heating unit is located inside the building above the ceiling.

CONDITION: **Not Acceptable, the unit is not working.**

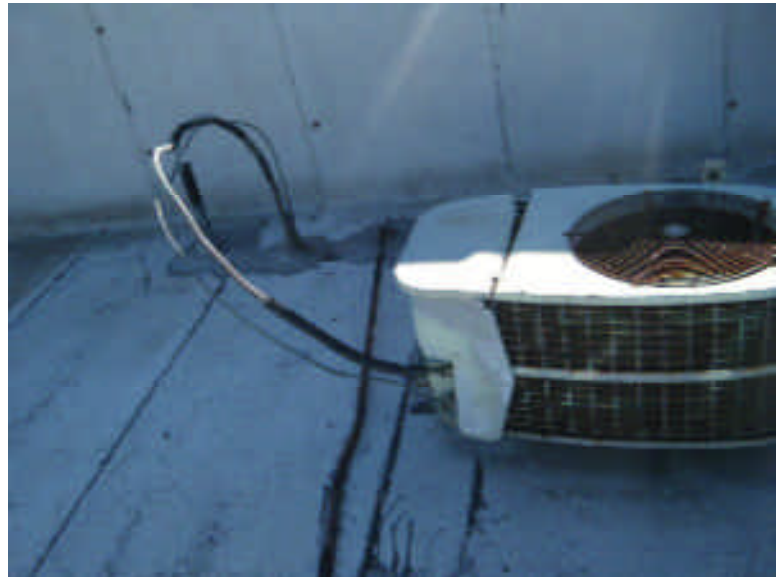
The condenser for the air conditioning is located on the roof.

Not Acceptable, the air conditioning system is older and past its expected service life. It is not working and appears deteriorated. this appears to be at the end of its useful life and probably needs replacement instead of repairs.

Not Acceptable, the air conditioner did not turn on and operate when tested with the normal controls.

The air conditioning system will need further evaluation to determine its true condition and any repairs or replacement carried out by a qualified air conditioning contractor. The air conditioning specialist may find addition items that need repair to the system and this is expected and why it is being turned over to them for further investigation.

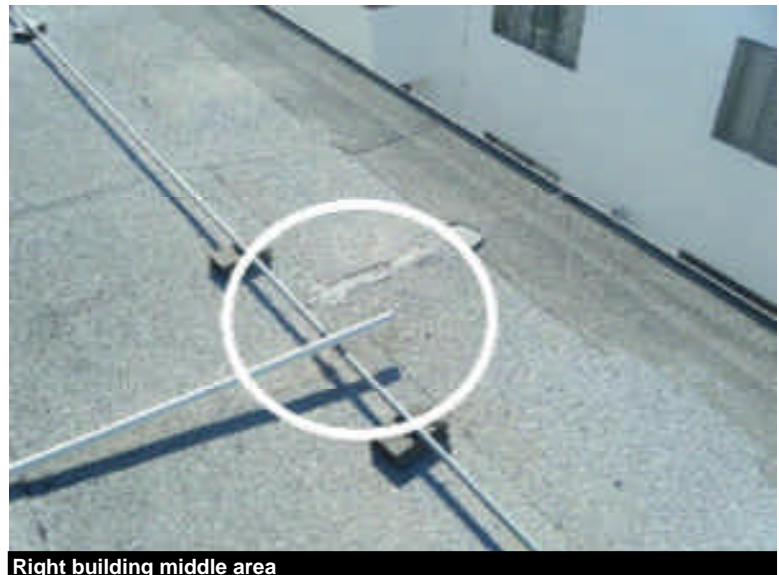
Needs Attention, some of the units have their drain lines emptying onto the roof instead of the gutter and drain system.

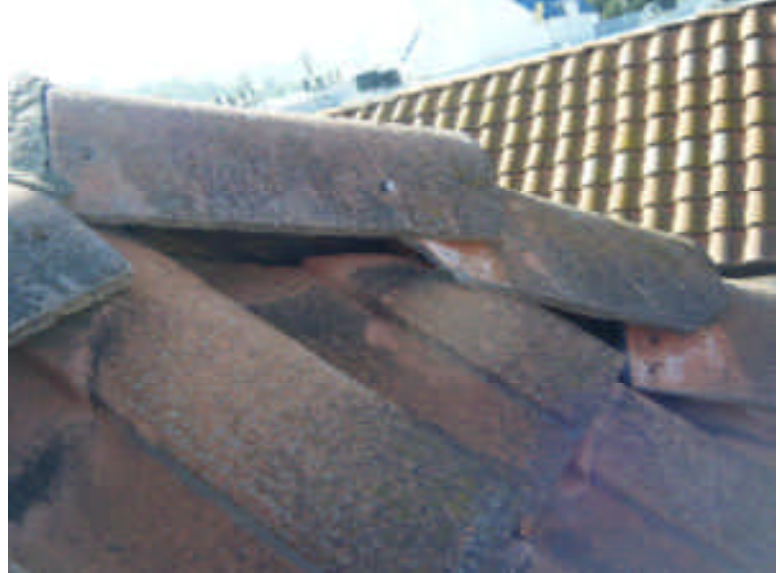
There is no mortar at the top ridge caps of the tile sections and some gaps are visible and does not appear to be a reliable water proof seal.

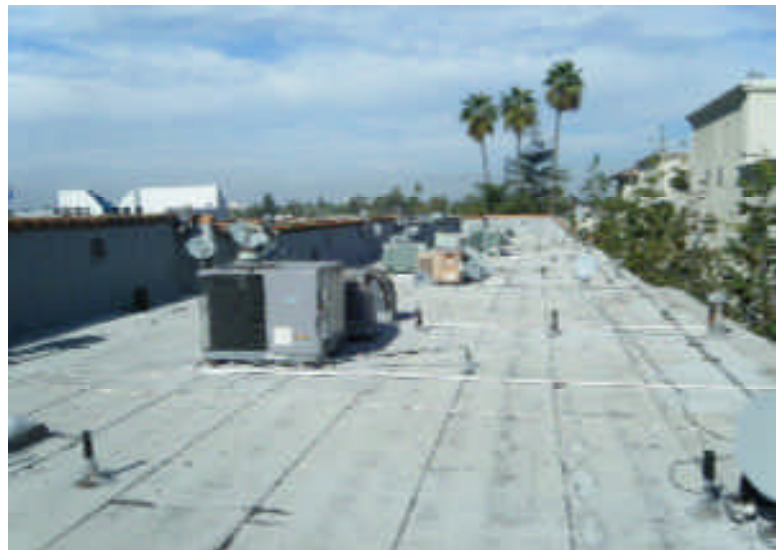
Left roof area

on the low sloped roof, the roofing material is worn, deteriorating and losing its granule surface. It is nearing the time to replace this roof. It is advised to have a roofing contractor further examine this and make any needed repairs. The left roof has many areas with worn granules and various patches and some new material added.

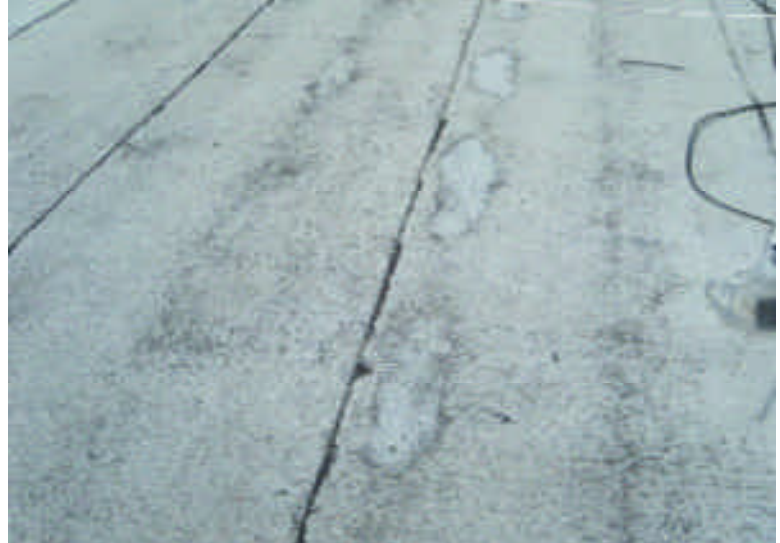
Close up view of worn area on left roof

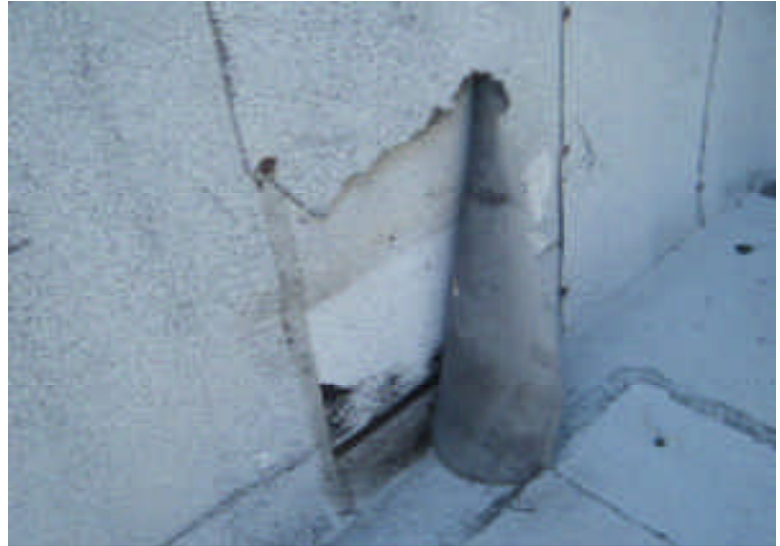
Left roof

Not Acceptable; There is a torn area of roofing material on the left roof inner parapet wall near the middle area.

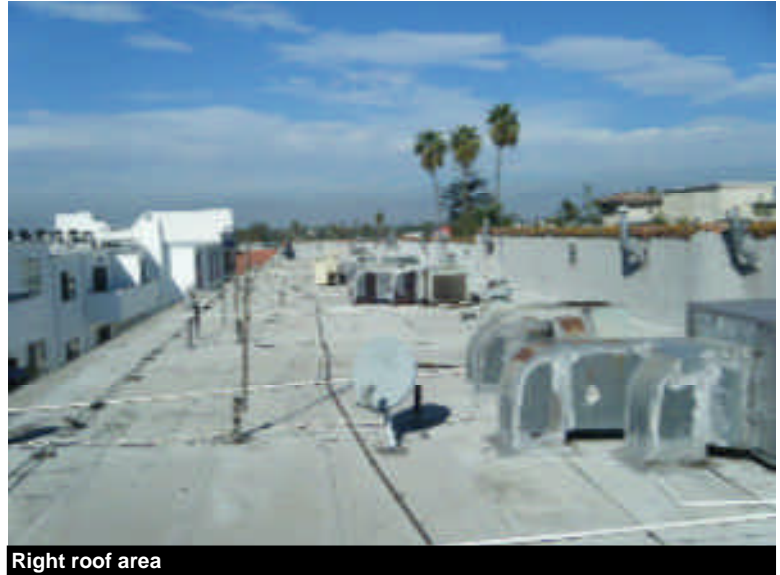
Right roof area

The right roof appears to be in better shape than the left roof, but wear is seen in some areas and some patching and more sections of newer material. Some servicing is still needed to prolong the life of the roof.

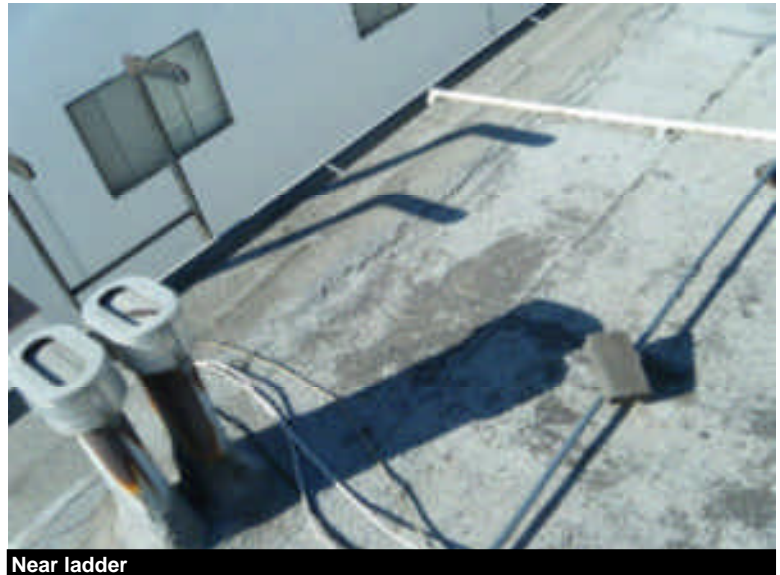
Near ladder

The roof is especially worn at the ladder area where heavy foot traffic occurs.

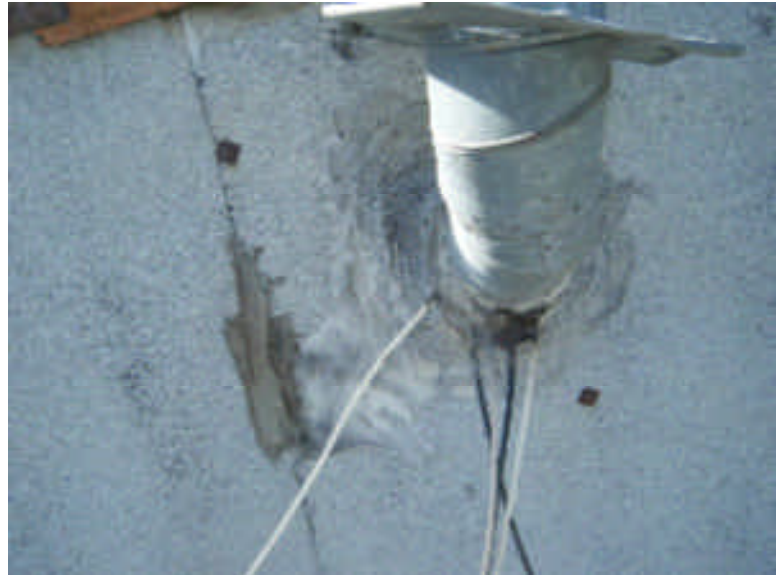
Needs Attention, there are low voltage wires penetrating near the vent pipe on the left roof near the middle which is sealed but appears non standard and hazardous next to the fireplace vent pipe.

There are many areas of deteriorated mastic and a leak is reported in unit #3 below their roof package furnace.

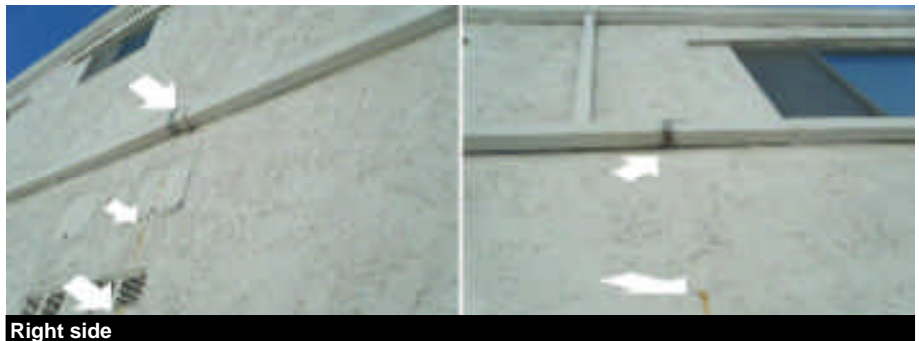
Right side

Needs Attention, the added horizontal downspout on the right side has rusty areas at some joints and stains down the wall indicating leaks and needs servicing.

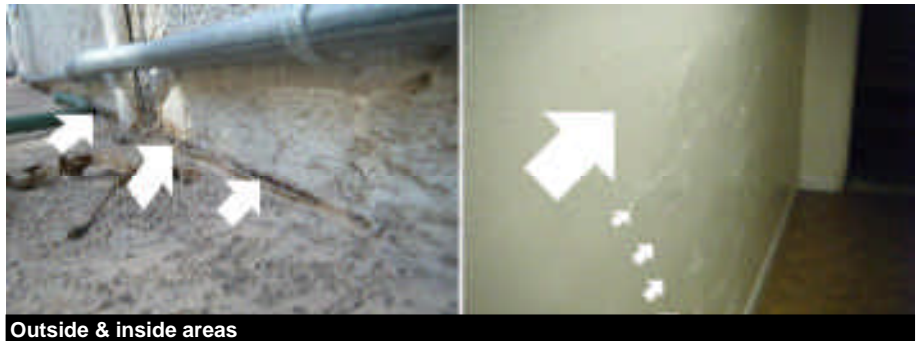
Outside & inside areas

There is moisture intrusion seen in the back rec room just below the grade of the patio near the spa which needs correction.

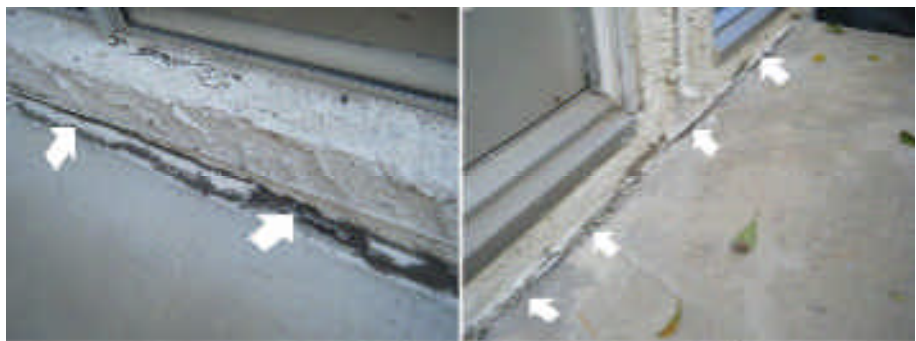
There are gaps at the sidewalk and porches at the joints at the

bottom of the stucco which need proper weather proofing.

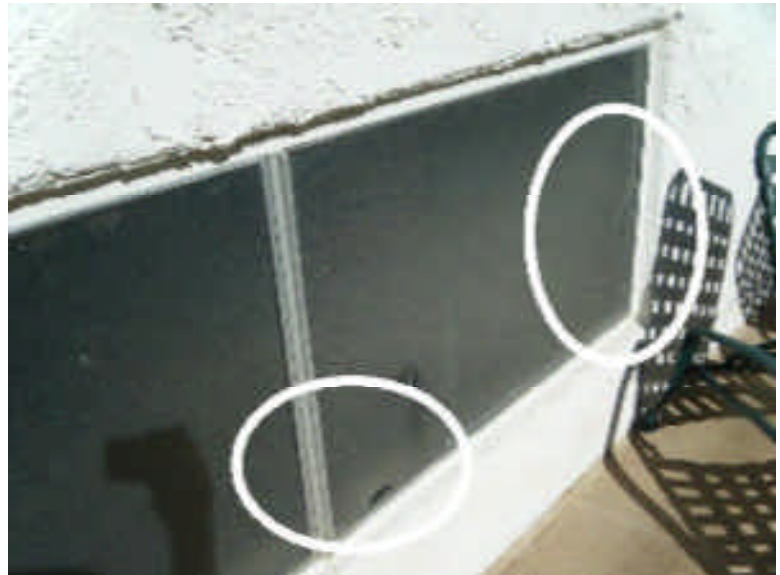
Not acceptable, there is a broken window in the back near the pool.

Note: these are older glass panes and are not safety glass and are close to the ground.

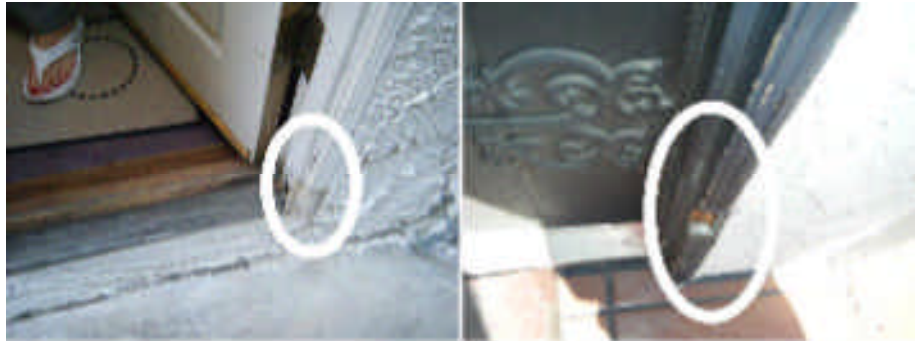
Not Acceptable, there are areas of damage to the exterior of the doors such as at unit #1 front door and Unit #22 back door and some deterioration on other exterior back doors. see the pest control report for more information.

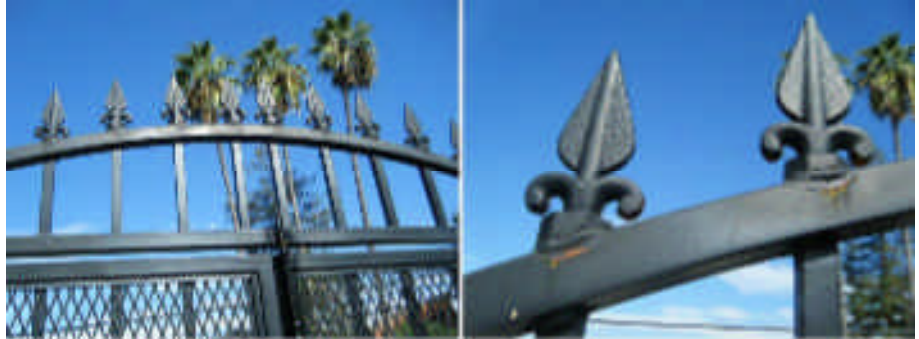
Not Acceptable, there is rust and corrosion showing on the new front gate area and appears this may not be properly painted.

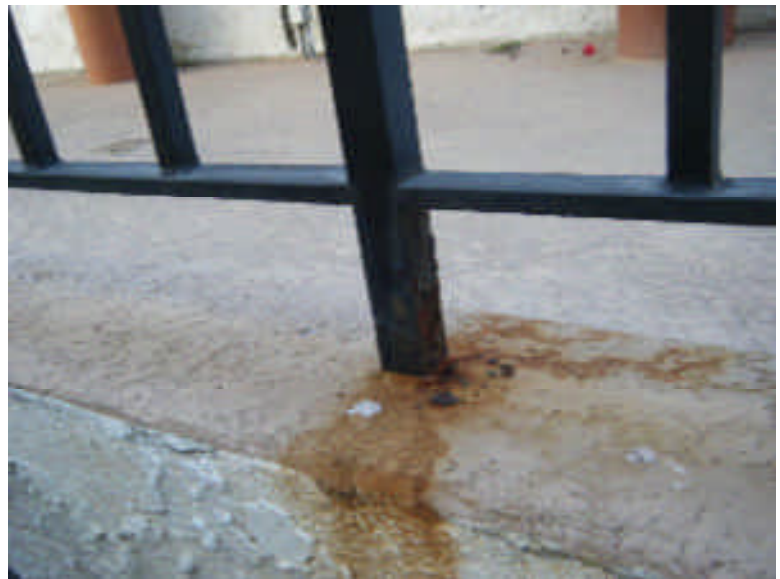
Needs Attention, the back railing around the lower patio near the spa and rec room area has areas of rusting and deterioration and needs repair and repainting.

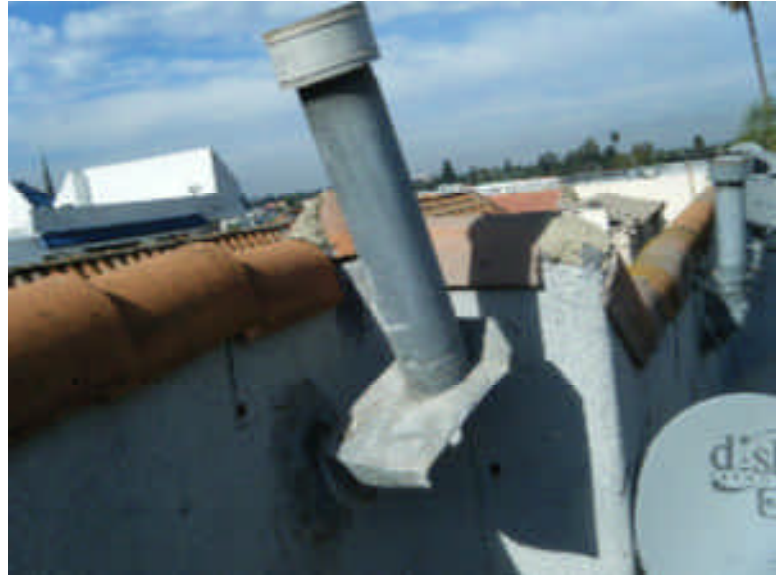
Needs Attention, one flue was seen loose and poorly secured secured on the left roof middle area.

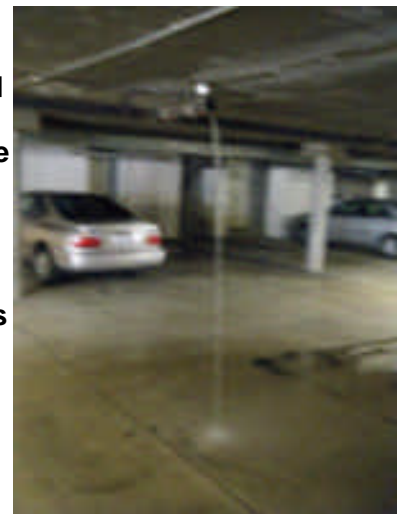
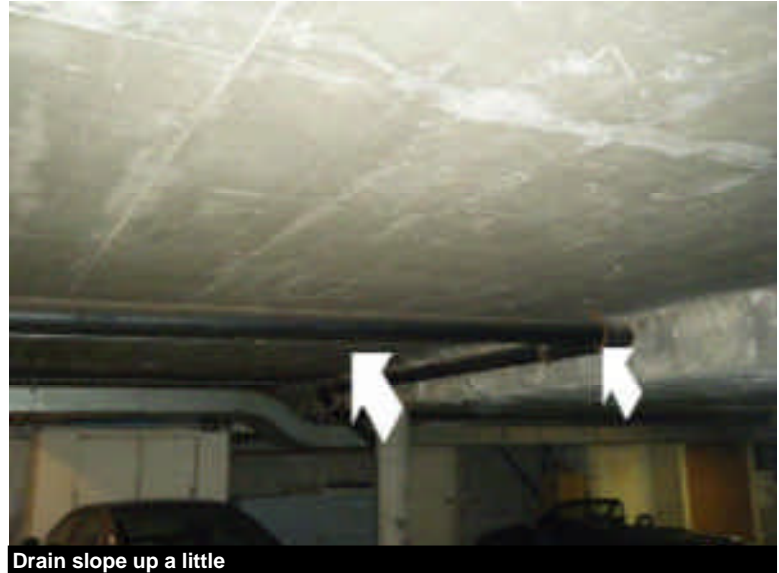
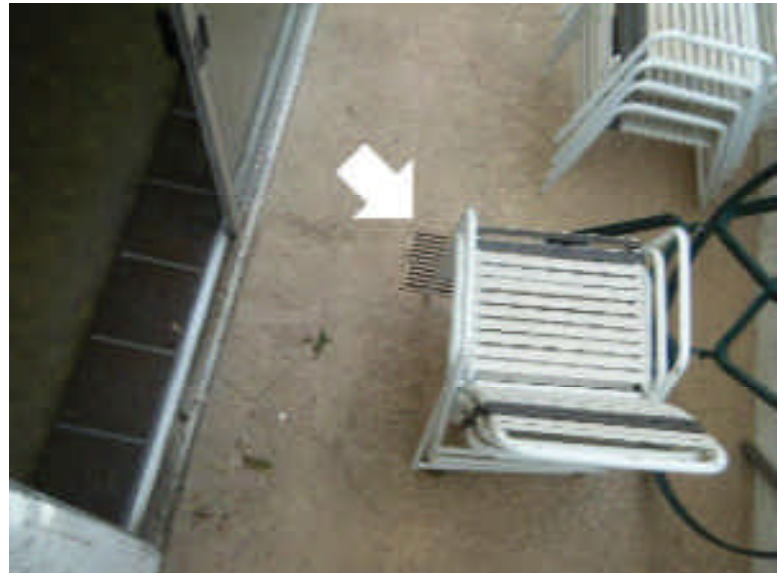
Not Acceptable, the courtyard area drains were found to have water standing in them. A cap was removed in the garage and an abundance of smelly stagnant water came out of the pipes. There is a drain line in the back area which slopes up and then down and does not appear to be allowing the water to drain. Some sediment is seen in the pipes and this system needs repairs and servicing.

The back lower patio near the rec room sliding door was reported that this has backed up in the past.

The area drains should be fully cleaned and serviced and slopes corrected so this is a reliable system. This needs to be further examined by an approved professional and repaired to insure this is safe and properly operating.

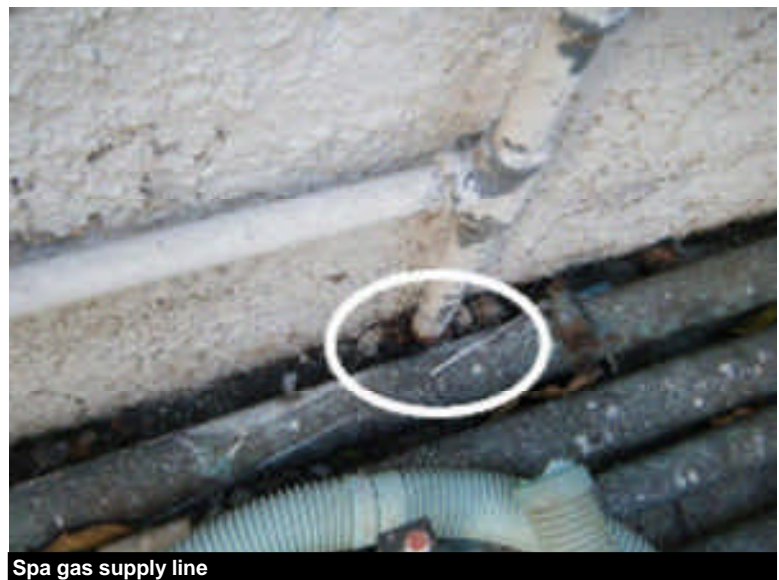
Spa gas supply line

Needs Attention; The gas line to the spa is also rusty at the ground and unreliable. The pool heater line was reported as leaking and a new gas line is scheduled for installation. It is advised to have the contractor modify this line to include a new supply pipe for the spa equipment

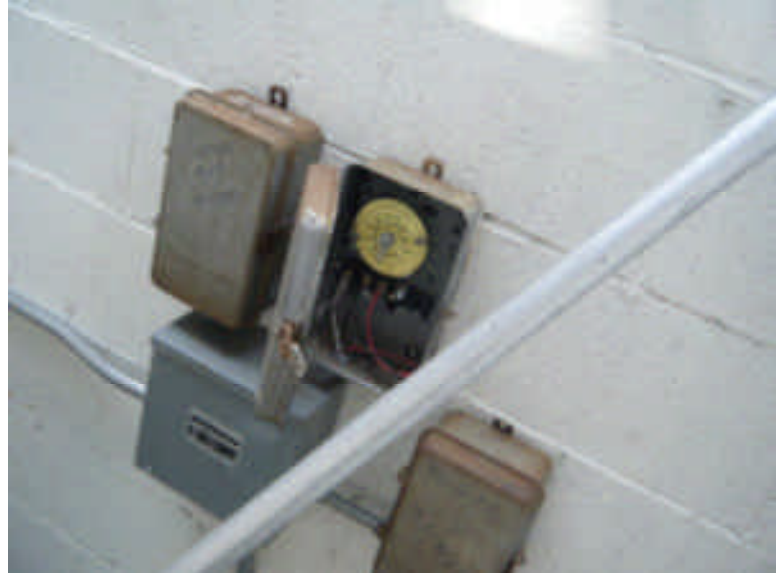
Not Acceptable, the timer box(s) has a missing plastic cover guard inside it. The electrical wires are exposed to contact in this condition and it is recommended that this be re-installed.

The equipment is not bonded with a bonding wire between all the pool equipment. This is a heavy copper wire that is a standard safety feature on pool equipment

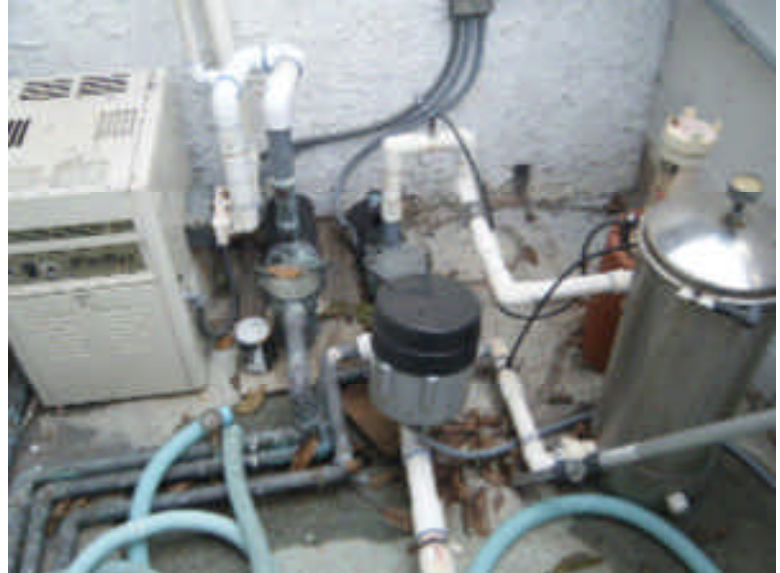
Needs Attention, some of the equipment is older and nearing the end of it expected useful life.

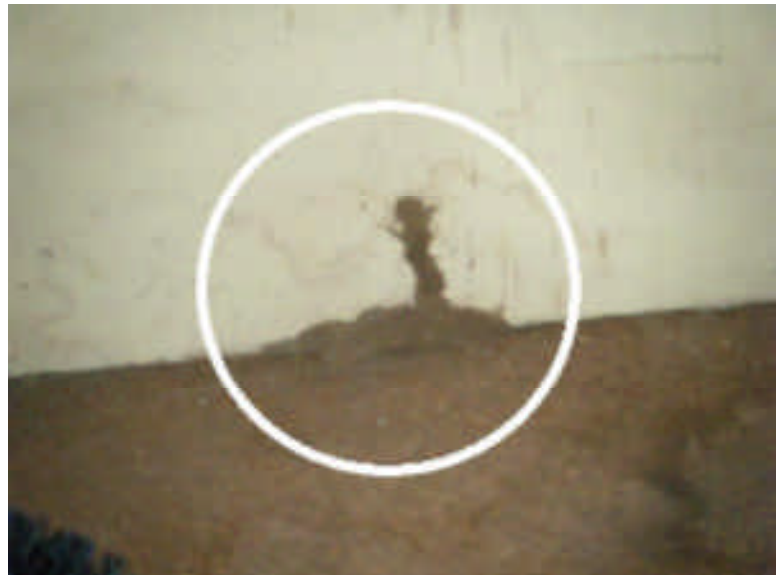
Not Acceptable, there is "damage" to the wall under the sink, see the pest control report for more information.

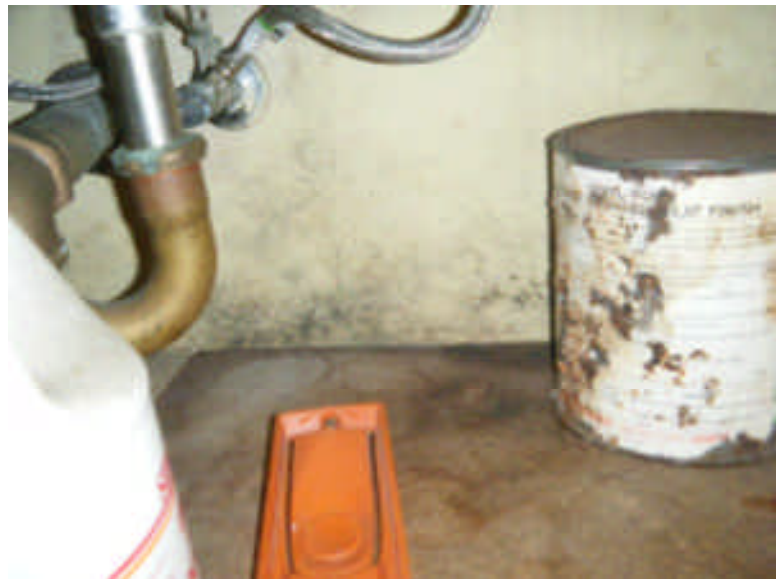
Needs Attention, the cabinet base below the sink has moisture damage and the cabinet base below the sink has mold like substances in it and it is advised to have a professional mold inspection evaluate the area and take any remedial actions necessary .

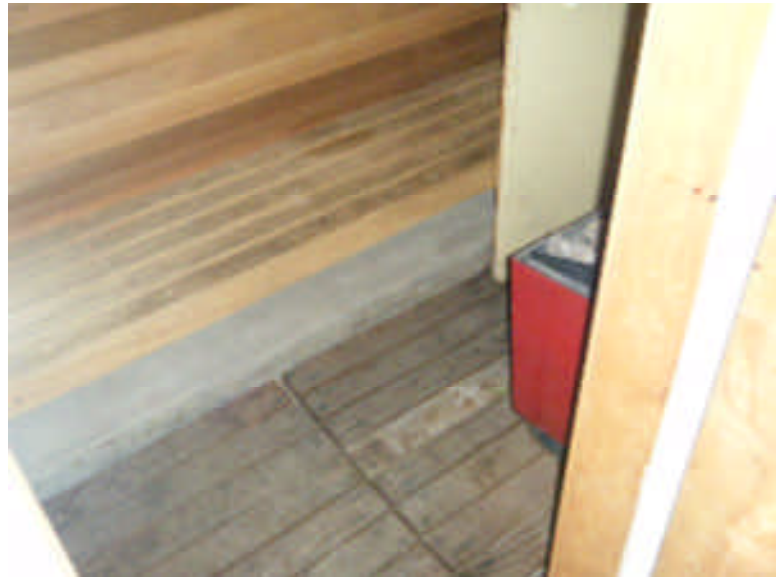
Sauna

Needs Attention, the floor boards are worn and deteriorated.

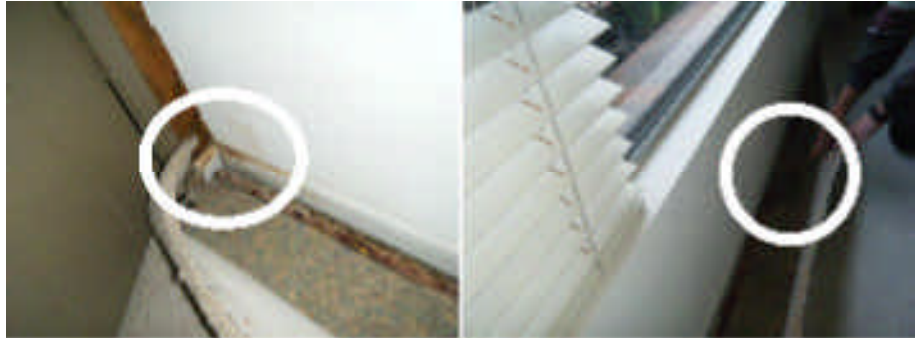
Not Acceptable. water stains and intrusion is found near the edge of the exterior planter and in the middle area.

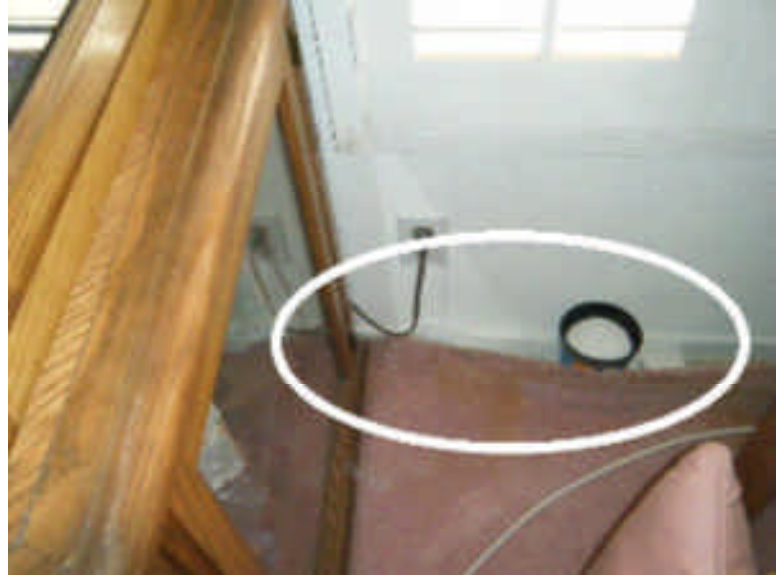
Not Acceptable. there are areas of moisture stains inside near the edge of the planter area.

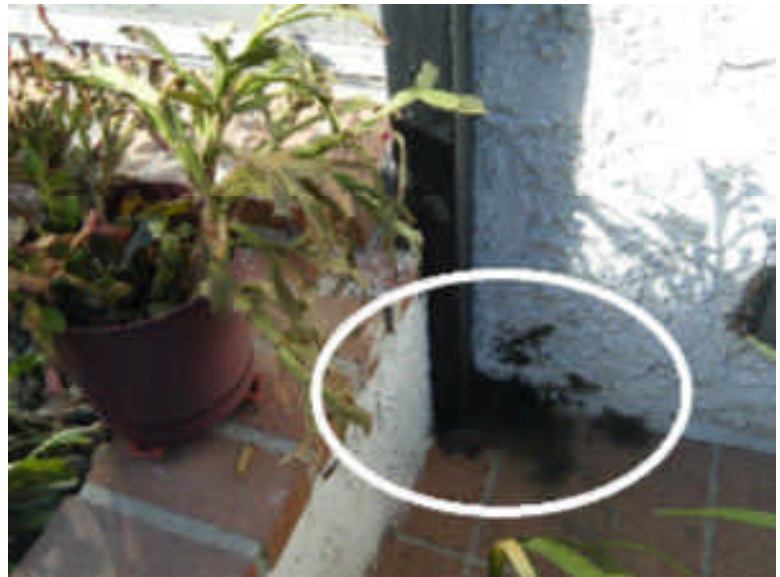
The tenant had put a vaseline on the joints in an attempt to seal this jointed area (the vaseline has aged and turned black)

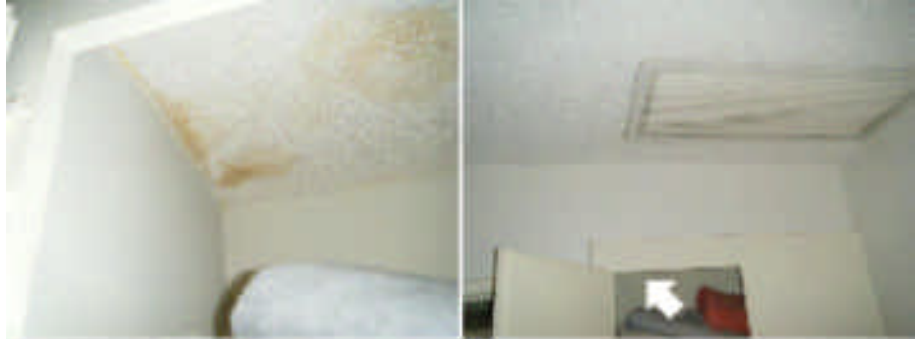
Not Acceptable; there are areas of moisture stains on the ceiling in the upstairs closet at the top of the stairs near the air return. This appears to be a leak from the heating duct penetrations through the roof.

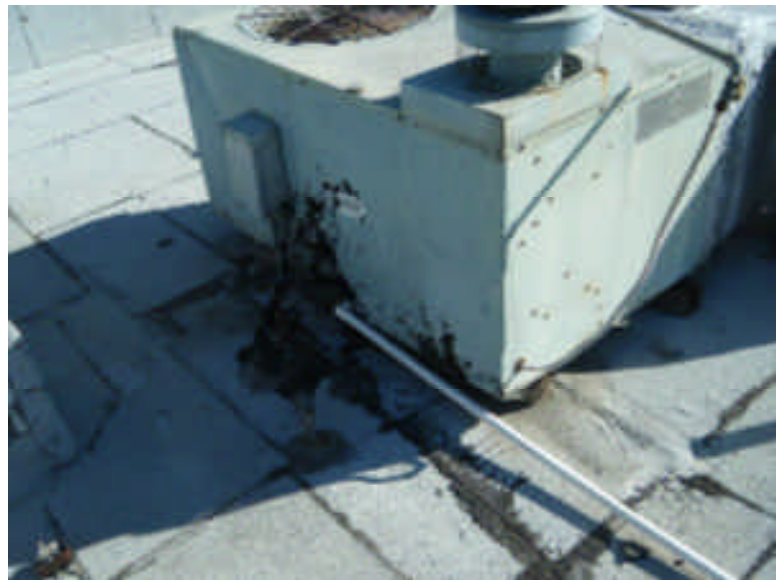
Heating unit on roof above this area needs servicing.

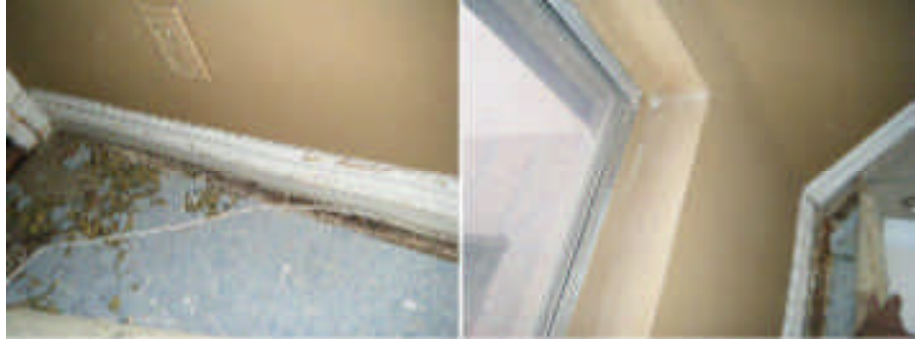
Not Acceptable. there are areas of moisture stains at the left and right sections near the edges of the planters.

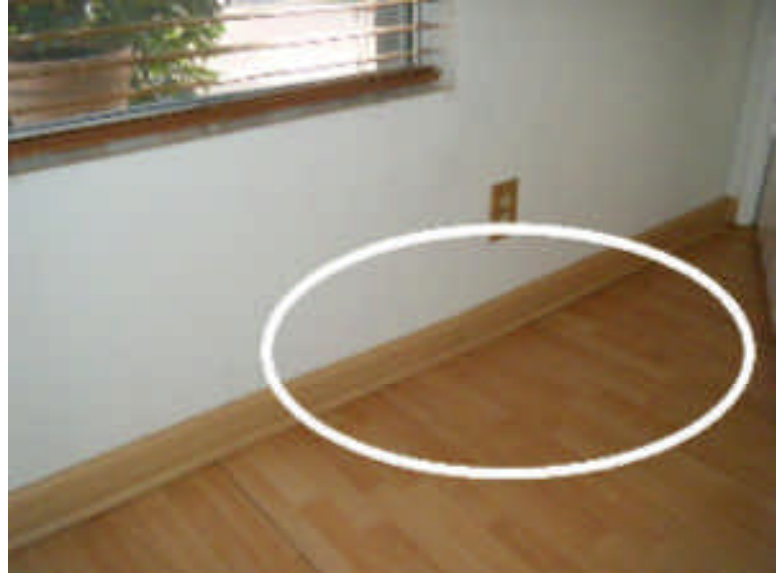
Not Acceptable, there are areas cupping and bowing pergo type flooring along the planter area especially near the front door.
