Real Estate Inspection Report

September 2009.

Sample Apartment Report

Huntington Park, CA 90255

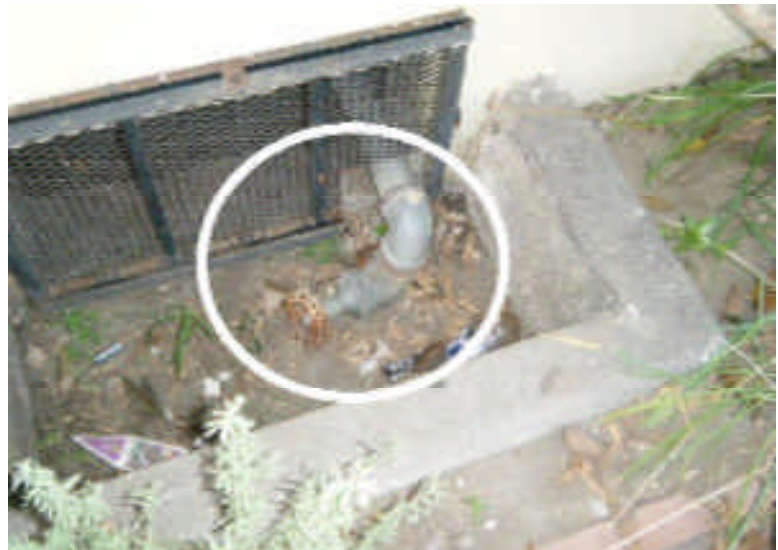
Crawl space access shut off

On the right side of the building in the back courtyard in the crawl space access opening one was located and another inside of garage #6. There seems to be other shut offs on the property also. Check with the owner for more details.

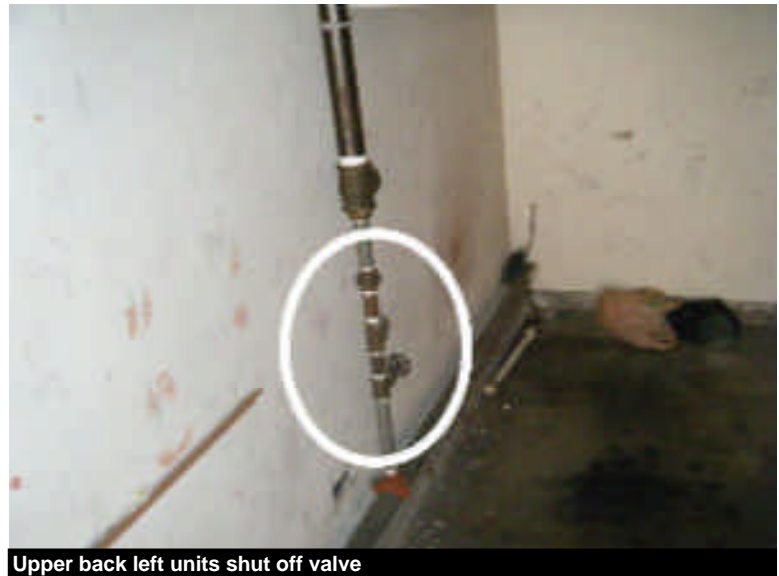
CONDITION: Needs Attention: The main water line is made of galvanized steel piping. It appears to be the older, original piping and due to the age it is near / at the end of its useful working life and may need to be replaced in the near future.

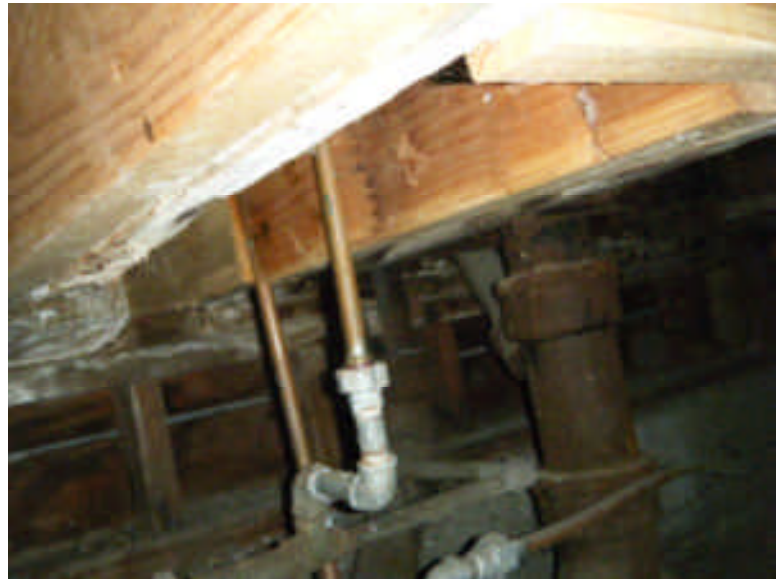
CONDITION: Needs Attention: The water lines are a combination of copper and galvanized steel piping. The original galvanized steel piping that is left in the system has rust and is showing deterioration. Some of the original pipes have been replaced with copper piping as they wore out, which is why there is copper in the system. The remaining galvanized steel pipes will need to be replaced in the future as they continue to wear out.

Note: there were no active leaks found today, but these are older and nearing the end of their expected useful life. Frequent repairs should be expected until the building is fully upgraded and repiped.

Some copper lines are seen under the front right section and at some water heaters as repairs were done.

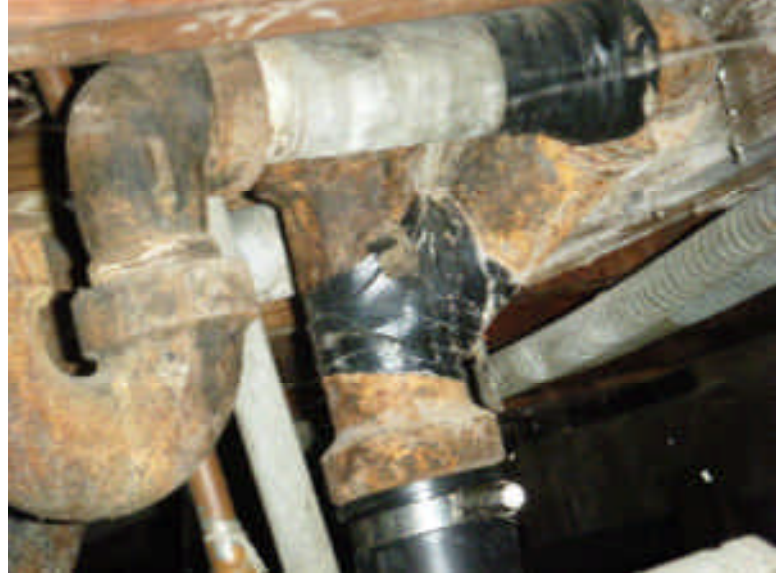
Not Acceptable: there are some oddly repaired waste lines using duct tape seen in the front left area. This is non standard and unreliable.

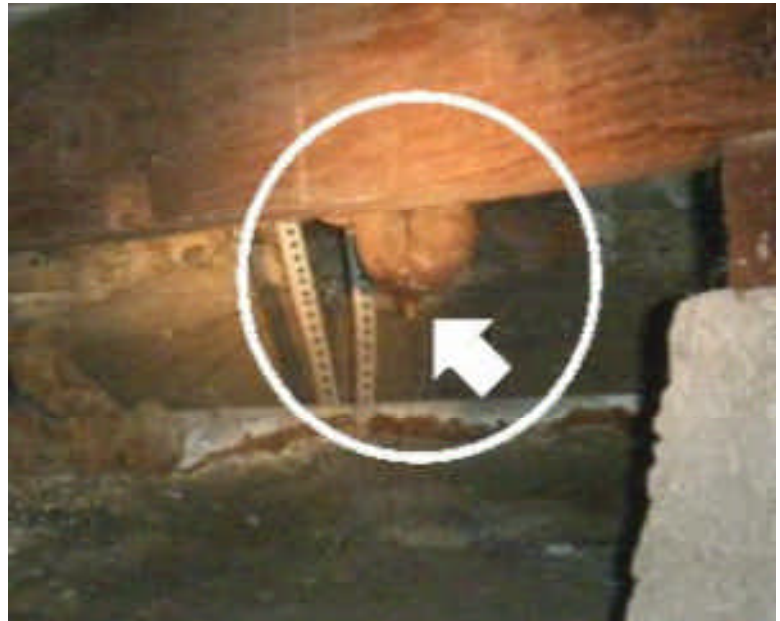
Not Acceptable, under the back building in the middle access area there is a dripping leaking large waste drain line. This appears to be the source of the excessive dampness under this area of the back building.

It is advised to have a licensed Plumber further examine this and make any needed repairs.

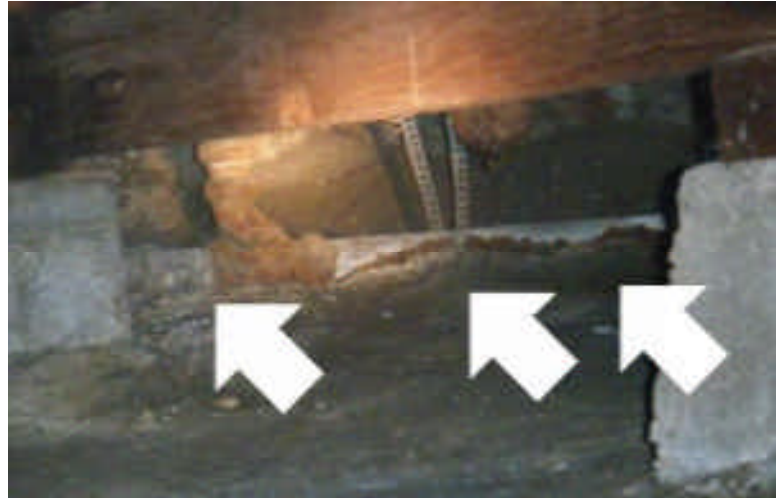
There are other waste lines in contact with this damp soil showing excessive rust on the exterior (it appears this waste line has been leaking, or some other leak also, for awhile)

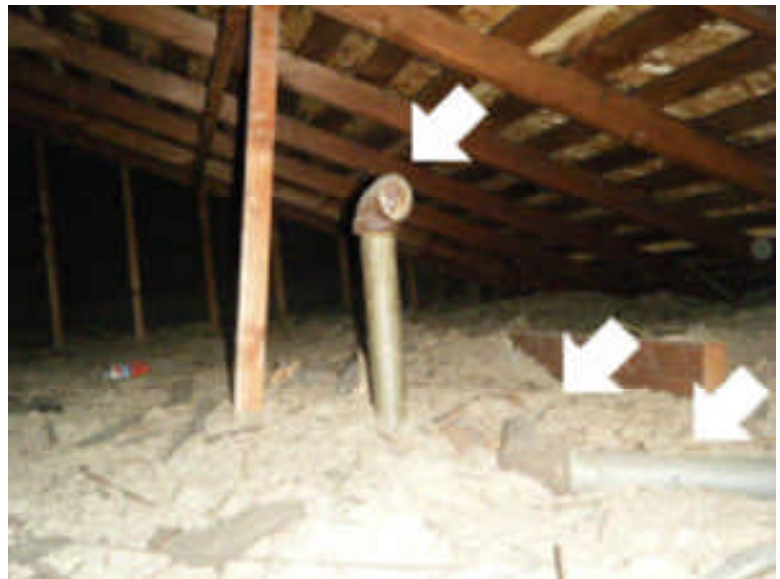
Not Acceptable , what appears to be a vent pipe was partially removed, parts laying in the attic and the vent pipe above the shower in the back upper left unit terminates in the attic instead of through the roof to the exterior. This allows sewer gases into the attic area. It is advised to have a licensed Plumber further examine this and make any needed repairs.

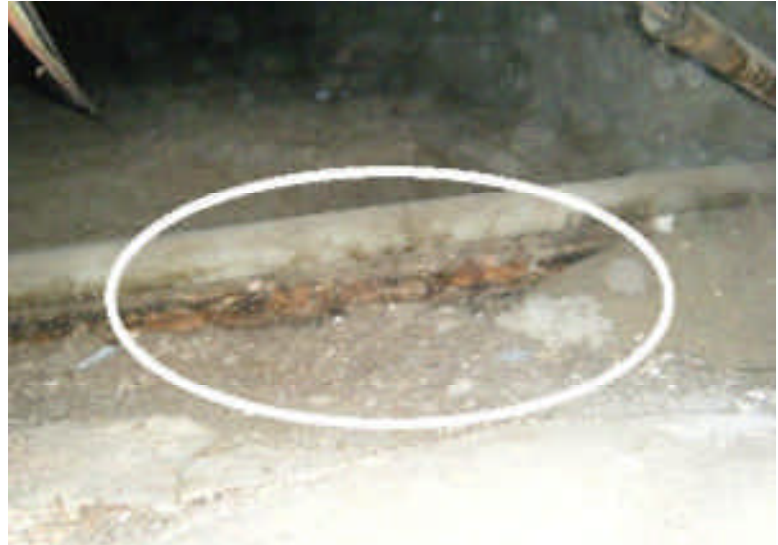
Left front middle area

Needs Attention, There are areas on the waste lines with rust blisters where the material is failing and may seep or leak at any time. These sections of pipe have failed and are ready for replacement at this time. The waste system should be fully evaluated by a plumbing specialist and repaired / replaced as needed.

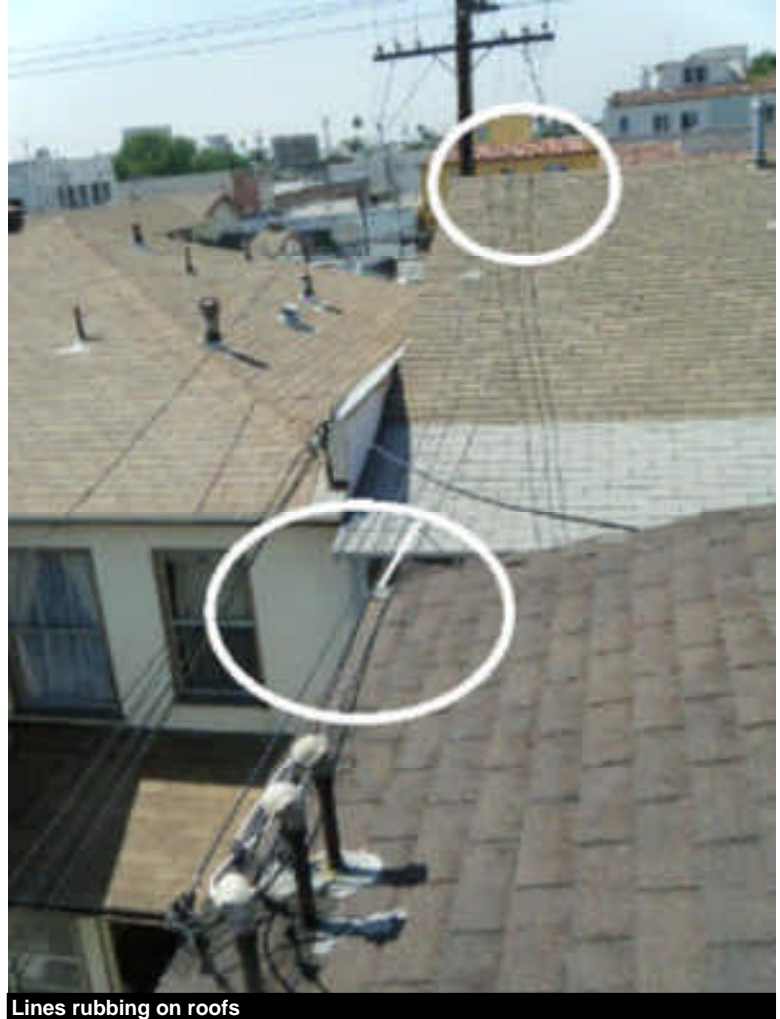
Not Acceptable: , the power lines are rubbing onto the roof areas in two locations and is a safety hazard.

They should be raised up so there is less chance of contacting them. It is advised to check with your local Power Company for the current requirements.

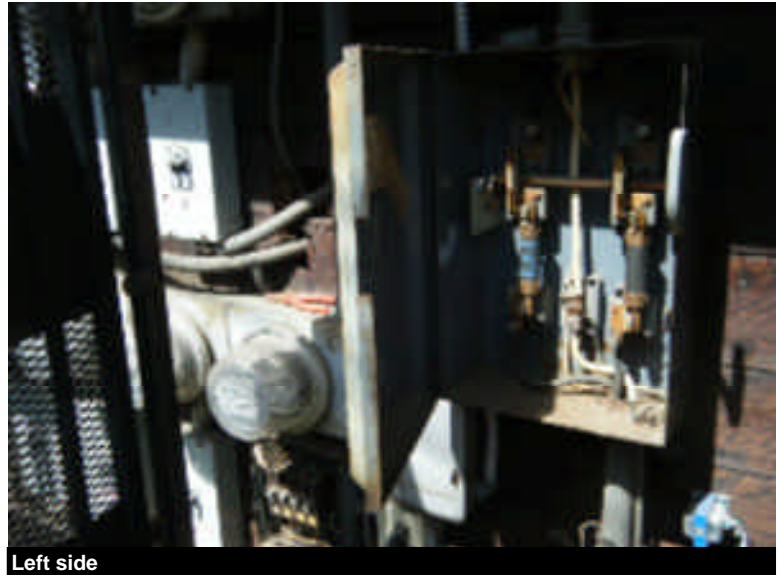
Service Amperage - 100 Amps cartridge was seen on the left side of the building for these 12 meters and panels.

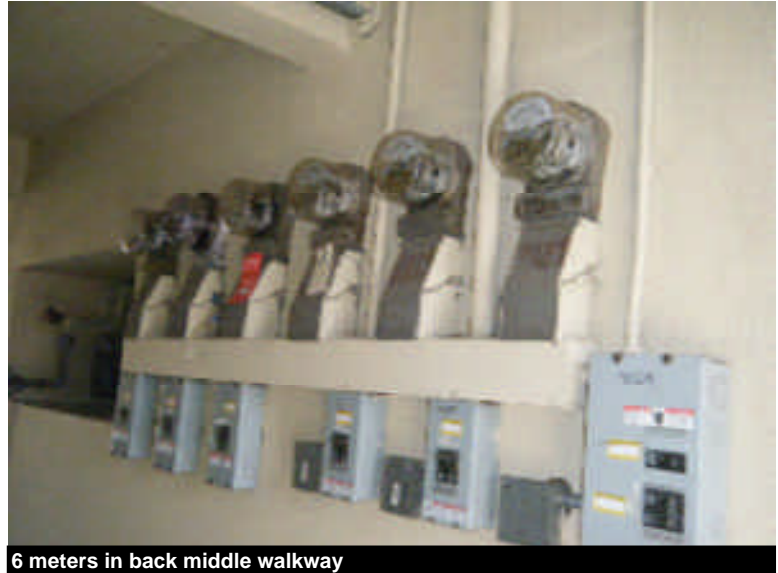
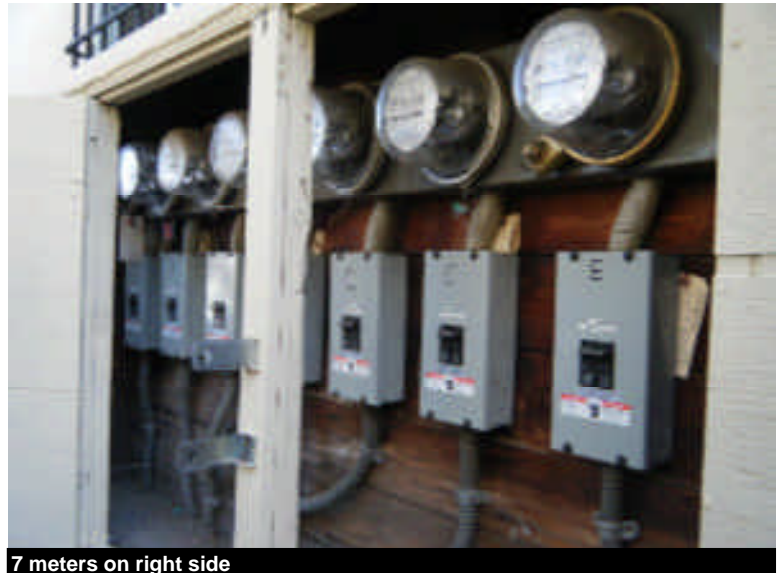
These panels have been upgraded.

The distribution of power supplying power to the various meters is not fully understood. There is only a main disconnect on the left cluster of meters but not for the right side and not for the back middle cluster. This needs to be further examined and repaired as needed by an licensed electrician.

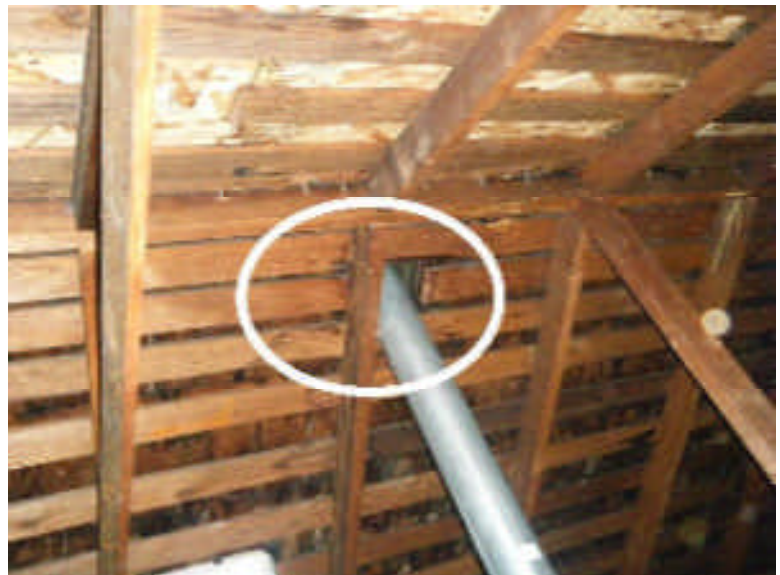
Needs Attention: The furnace vent pipes were found to be too close to combustible materials in the back building. This is a hazard and the vent line needs to be repaired to have the proper clearances. All furnaces should be checked and corrected as needed.

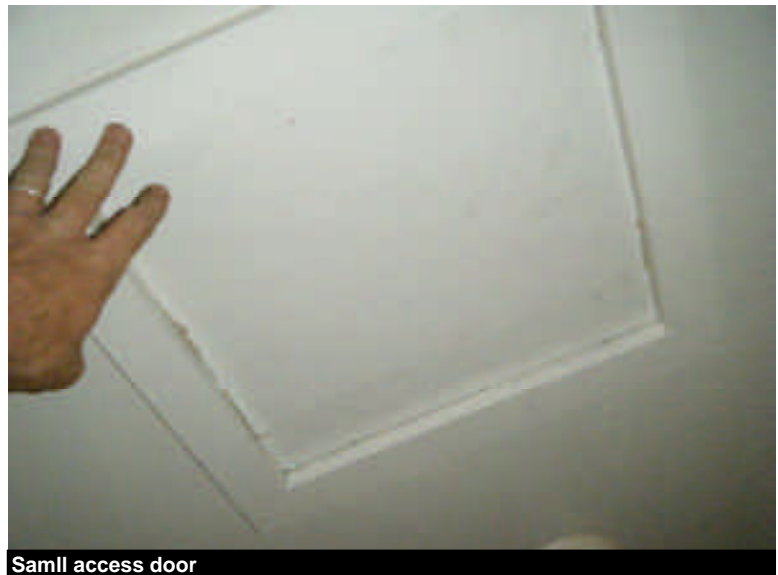
Small access door

Needs Attention: the front building access is smaller than normal and the low clearance in the attic restricts normal access to the entire building. Due to the size of the attic space it was observed from the access opening only

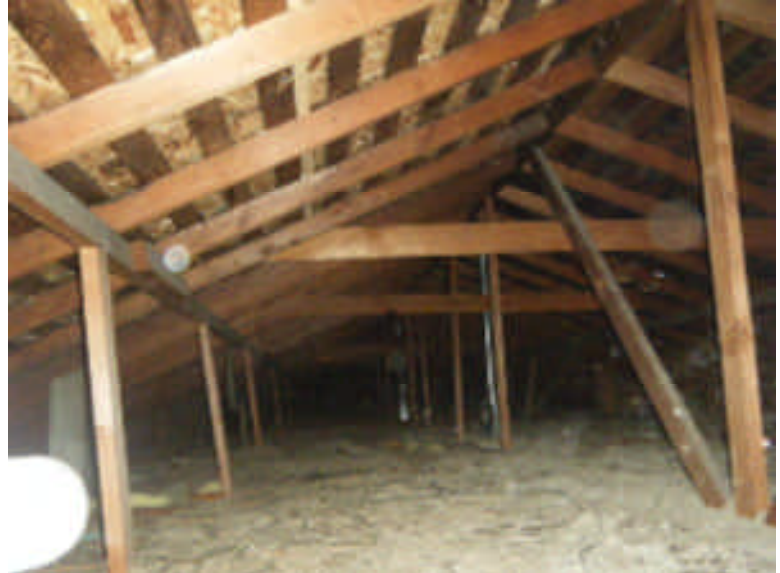
Serviceable for the back building.

Note: There is not a complete firewall separating each unit's attic space in the back building as is recommended to reduce any risk of fire, The association could be contacted about the possibility of installing this.

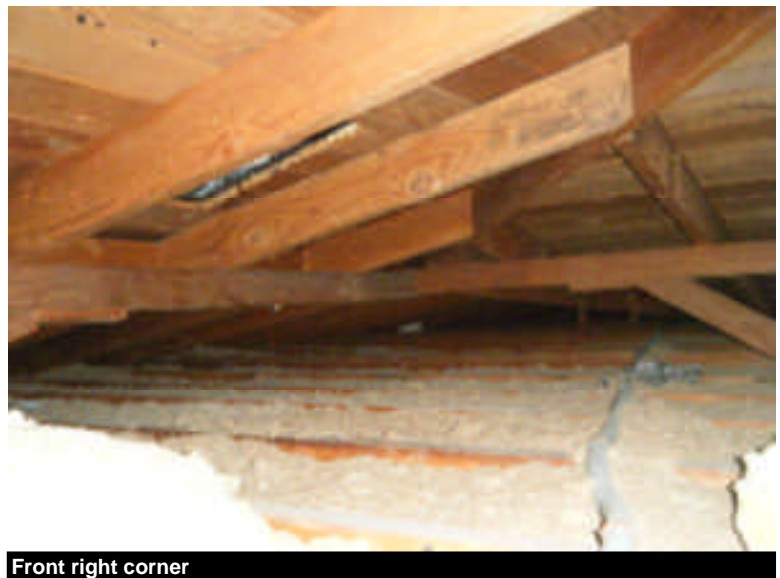
Front right corner

Needs Attention: the low clearance and only one small access door makes access to the entire building restricted and difficult for the front building

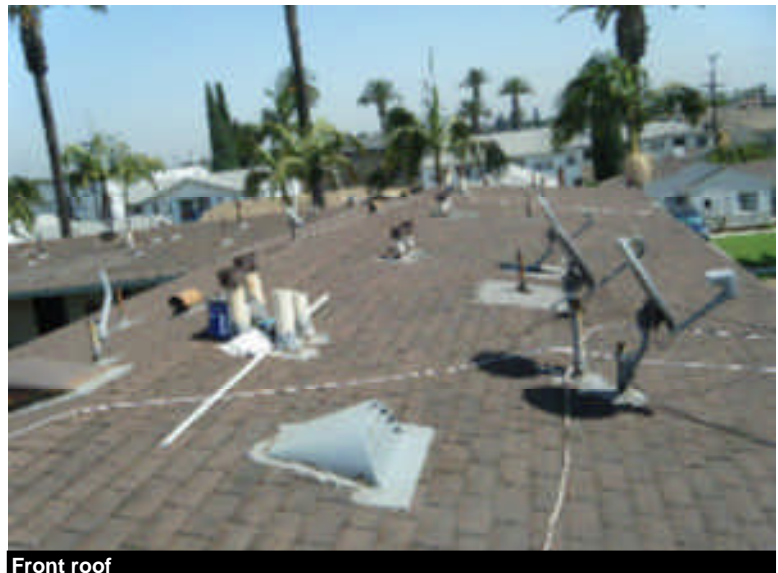
Front roof

Needs Attention: On the composition roof of the front building, the shingles are older, deteriorating and losing their surface granules. It is nearing the time to replace this roof.

There are many patched areas with mastic (caulking), some missing shingles and areas of replaced shingles.

There are moisture stains seen inside the office on the ceiling and along the walkways and in the manager office. The roof has many patches in this area but these repairs do not appear reliable.

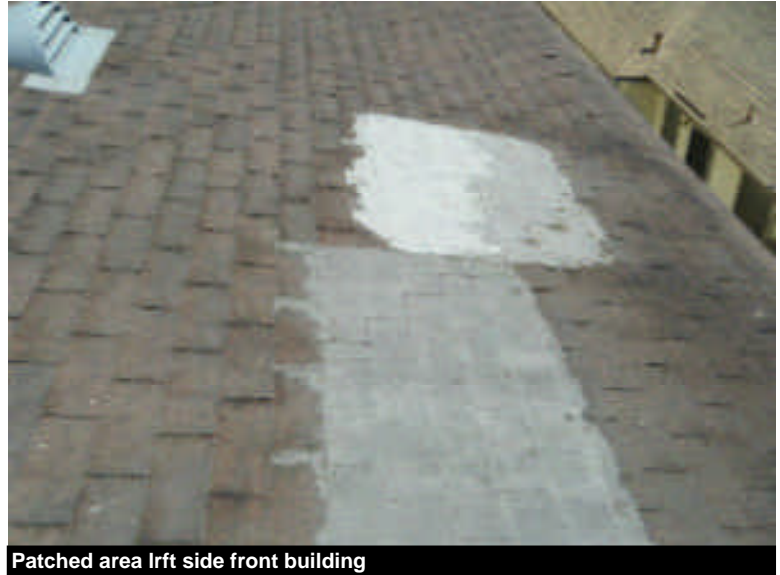
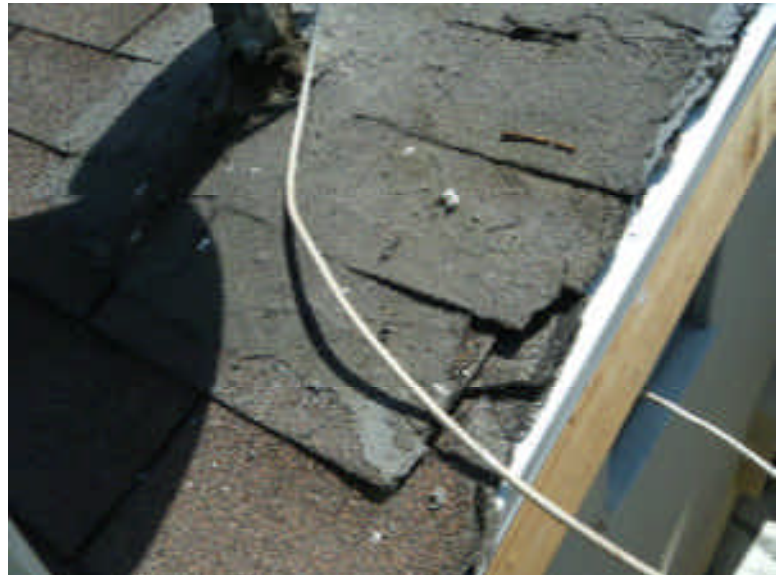
There are damaged areas on the back left area along the edge.

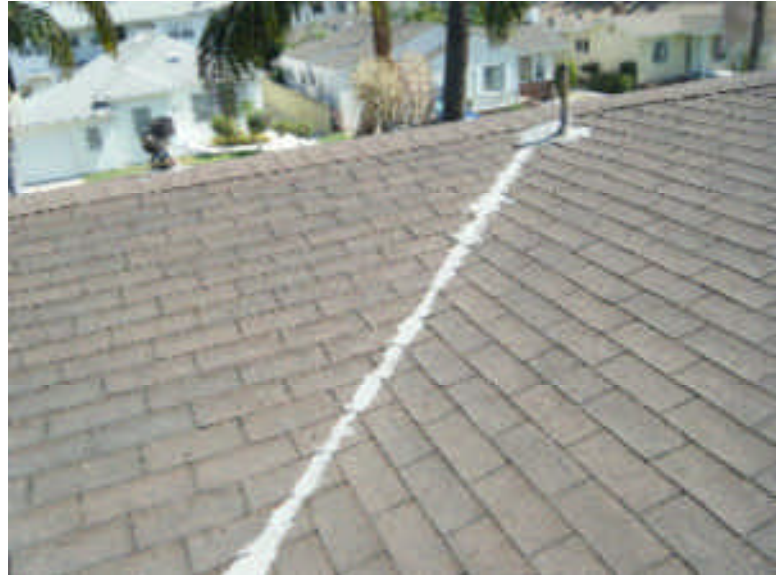
Excess caulking is used in the valleys in the front.

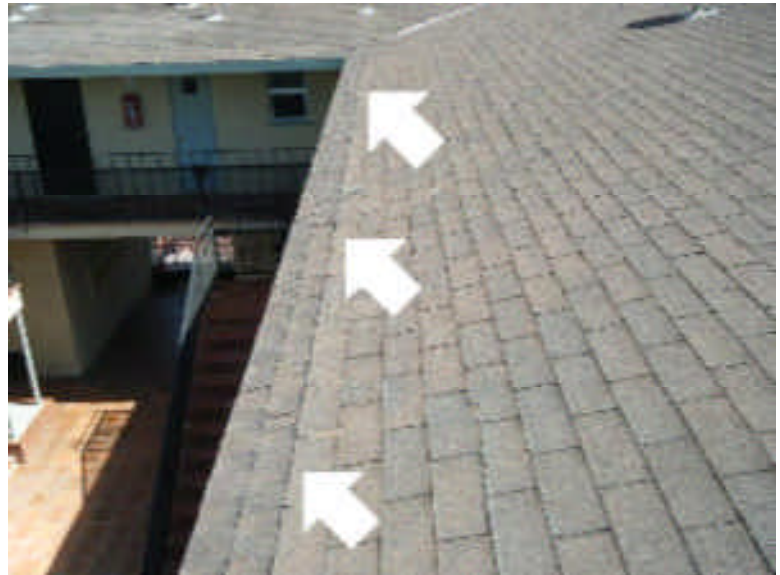
The front courtyard edges of the roof the roof appear to have been repaired recently.

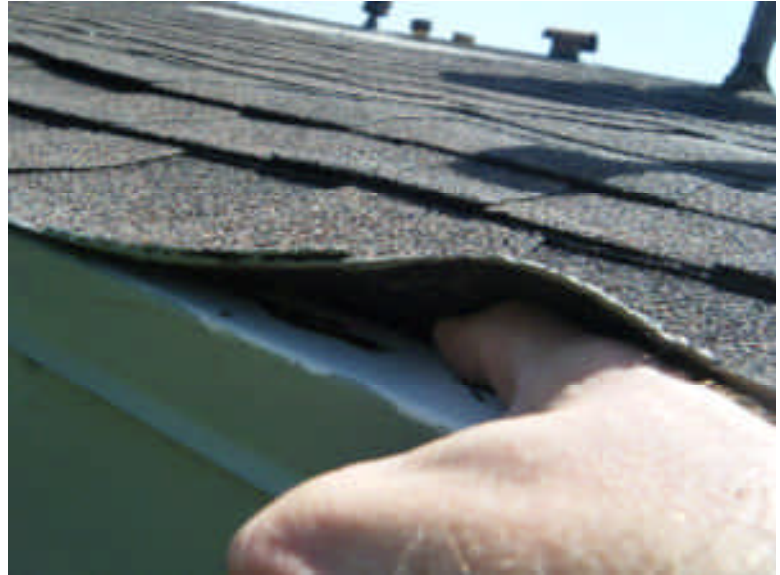
Needs Attention:, the front drip edge metal along the lower edge of the roof at these repaired areas is installed over the felt paper which may trap water and cause moisture damage to the wood supports and fascia trim.

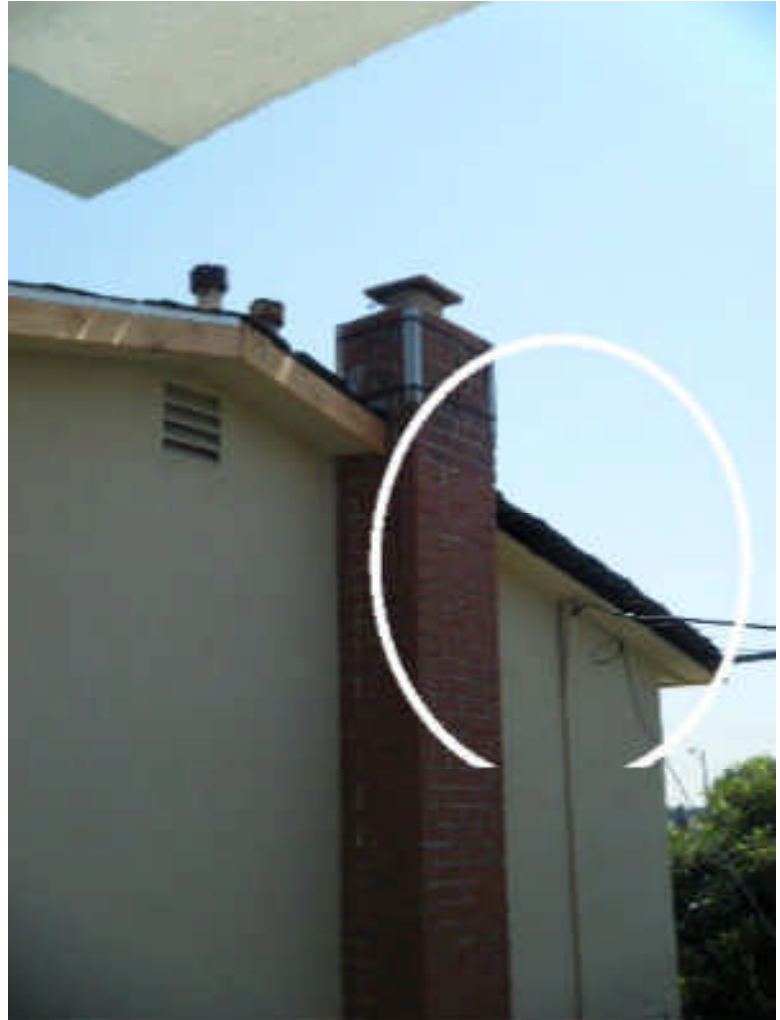
The back left edge along the roof is mid repair and the metal edge flashing is missing and the wood fascia piece.

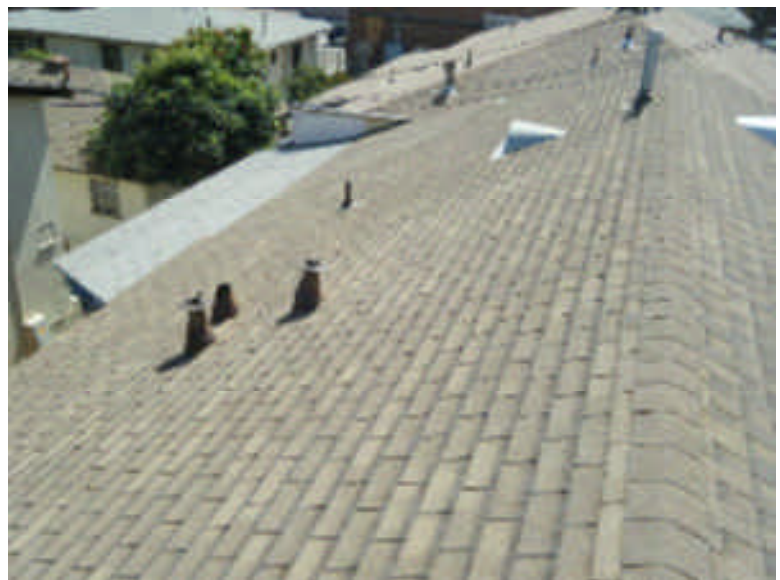
Note: The back building roof appeared generally serviceable with

some typical maintenance needed

The porch covering has a different color shingle as if recently replaced.

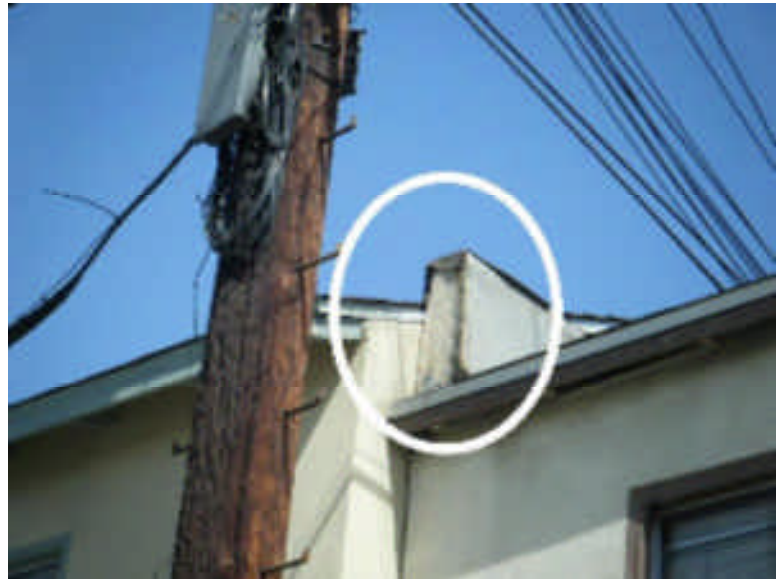
The back roof and structure comes in contact with the neighboring building and some special maintenance is needed at this connection.

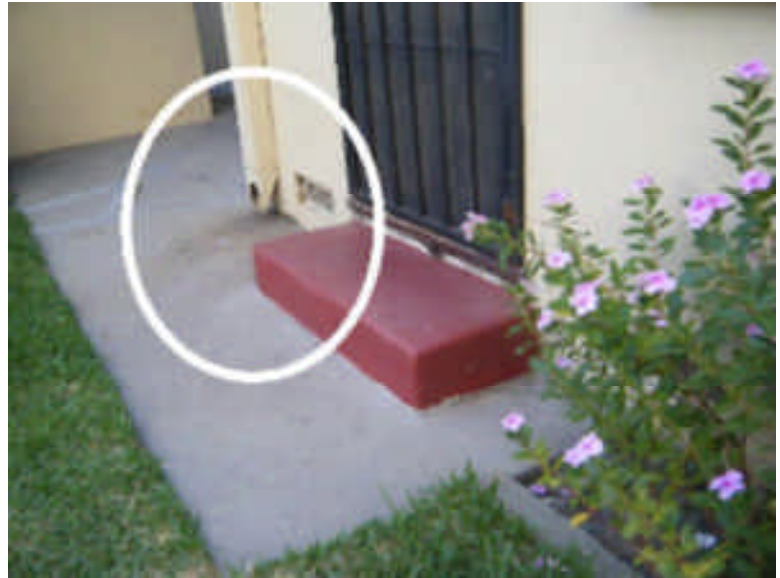
Needs Attention: The downspouts do not all route the water away from the building but instead deposit it next to the structure which can cause problems to the foundation over time such as at the back right area (there is evidence of dampness under the building and a green plant is growing under the building)

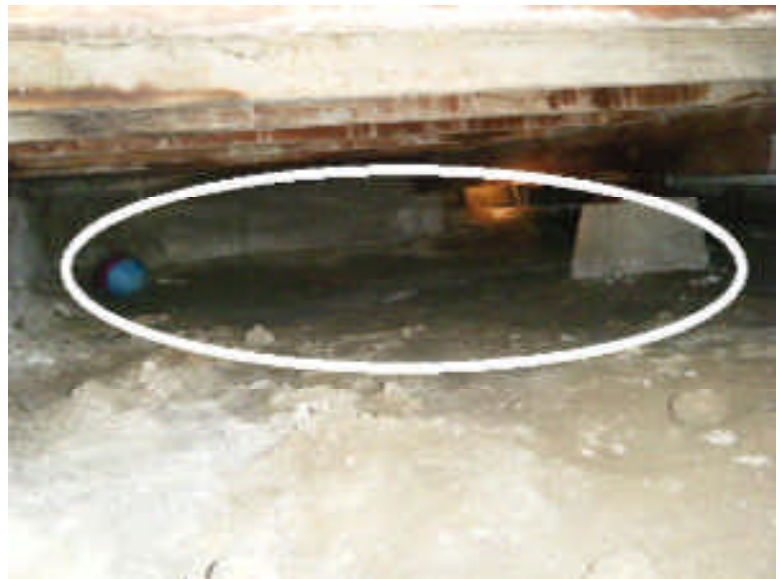
Needs Attention:, There are areas of excessive dampness in the soil under the building in the back middle area (near the leaking waste line). This may cause the building to feel damp and create the growth of mold and/or mildew. It is advised to have this examined by specialists to have the source of the moisture detected and any needed corrections performed plus any growth properly abated.

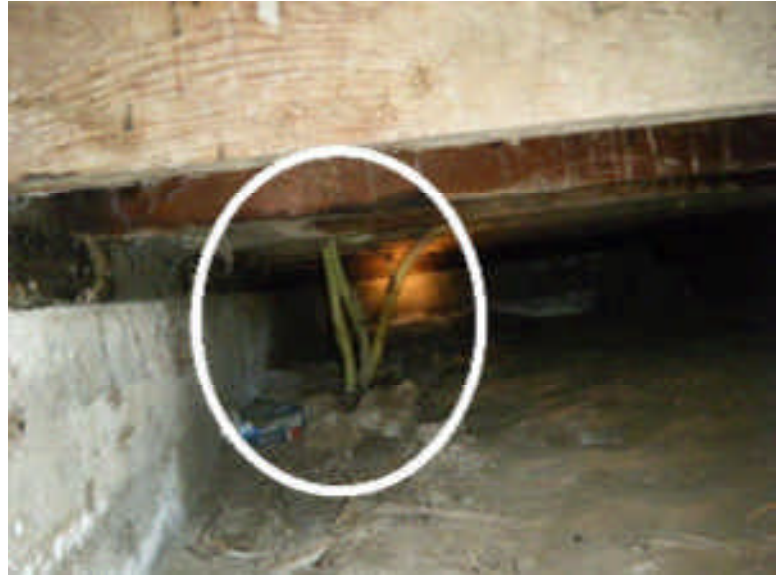
There is evidence of excess moisture under the back right section. A green plant is growing in the soil, This is near the downspout which has ponding stains on the sidewalk indicating water flows toward the building and can dampen the soil.

Some drainage correction and adjustment to the downspout is needed.

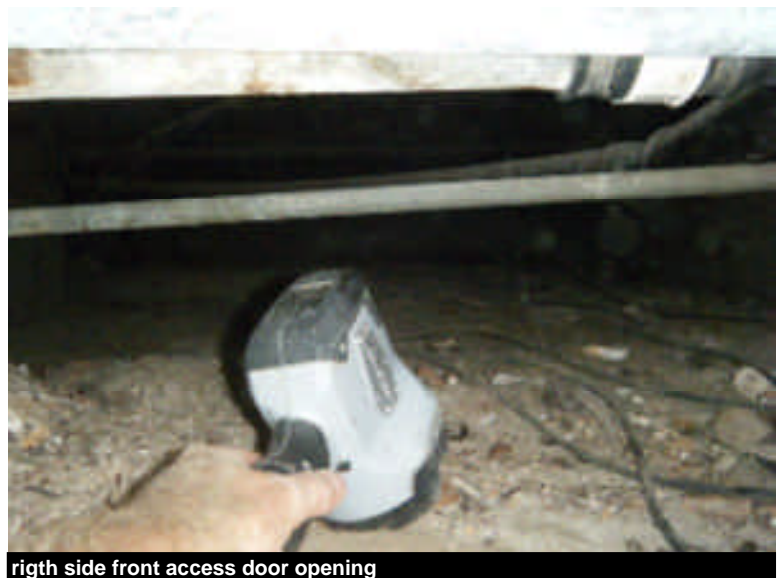
right side front access door opening

Note: The crawl space was not tall enough to enter in areas, 18 inches of space is required for safe access and it was less than that such as in

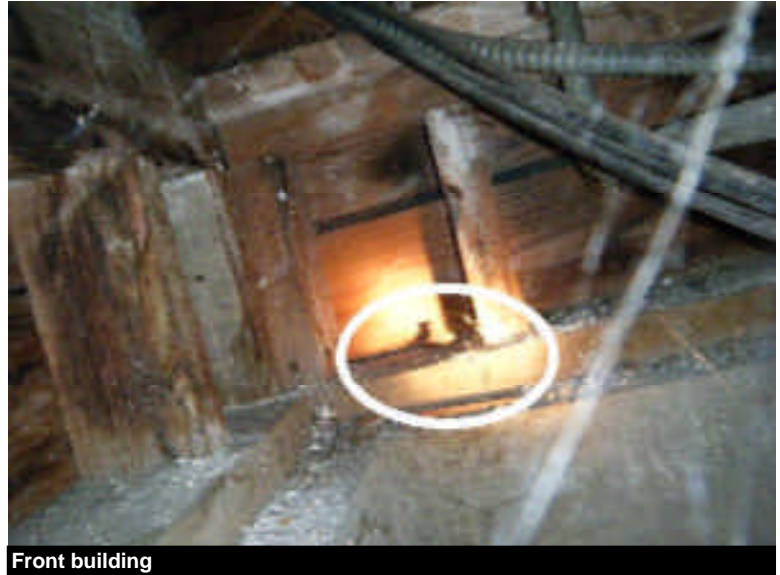
The structure in the front has anchor bolts attaching the framing of the building to the concrete foundation to help prevent movement in case of seismic activity, it is noted that The structure has some original anchor bolts. There are not many of these bolts and it does not meet today's standards that have been established for bolting. This would be evaluated by a foundation expert if additional work was to be undertaken to bring it up to these standards.

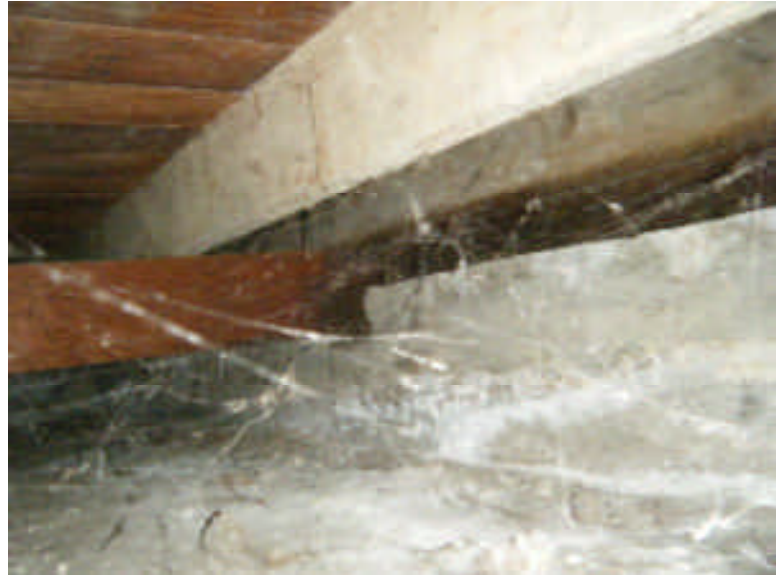
It is unknown if the back structure is bolted to the foundation because the bolts are not visible. Due to the type and style of the framing, the areas where the bolts would be located is closed off and not visible. Demolition would have to be undertaken and walls opened up to get to these areas. This is beyond the scope of this general inspection.

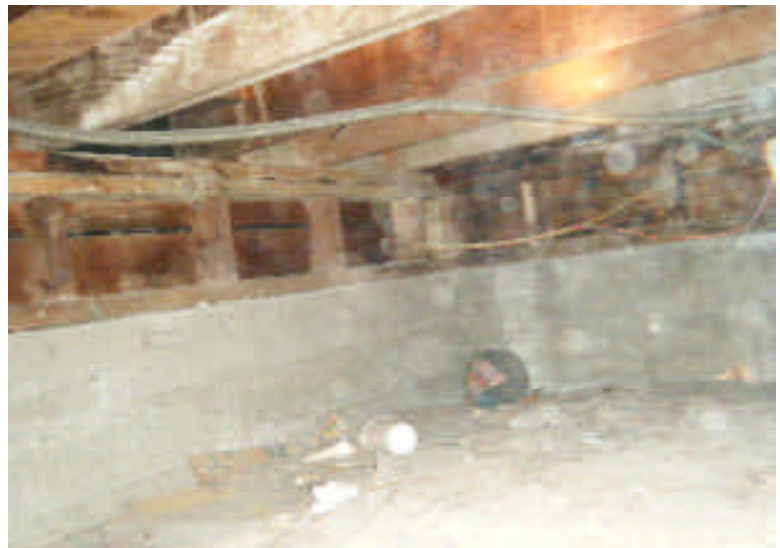
Front building

Needs Attention: The cripple walls, or portions of it in the front building, have not been strengthened with seismic reinforcement (shear panels etc). 'Cripple walls' are short walls between the foundation and the under side of the building framing. Although this may not be required, seismic reinforcement would help reduce damage to the structure during seismic activity. For detailed information consult with a foundation specialist.

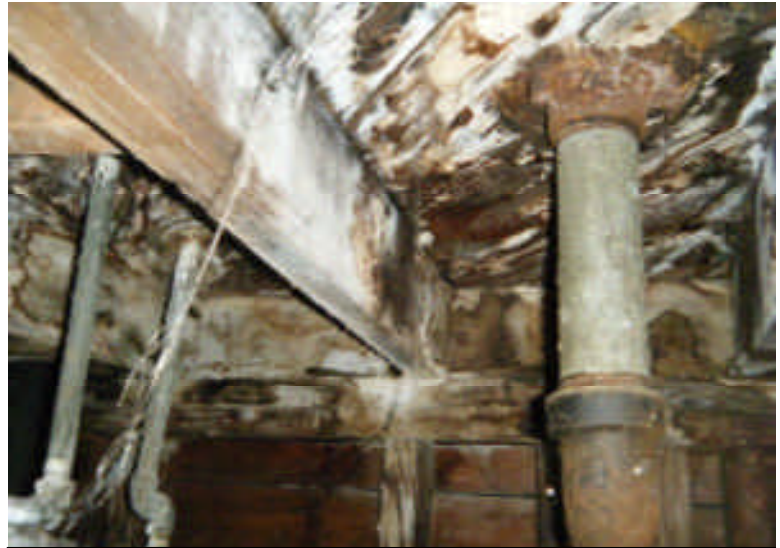
Front left area

Not Acceptable: There are damaged and deteriorated areas of floor framing such as under the front left area and on the left middle area - it is advisable to consult the structural pest control operator report for more information on this situation.

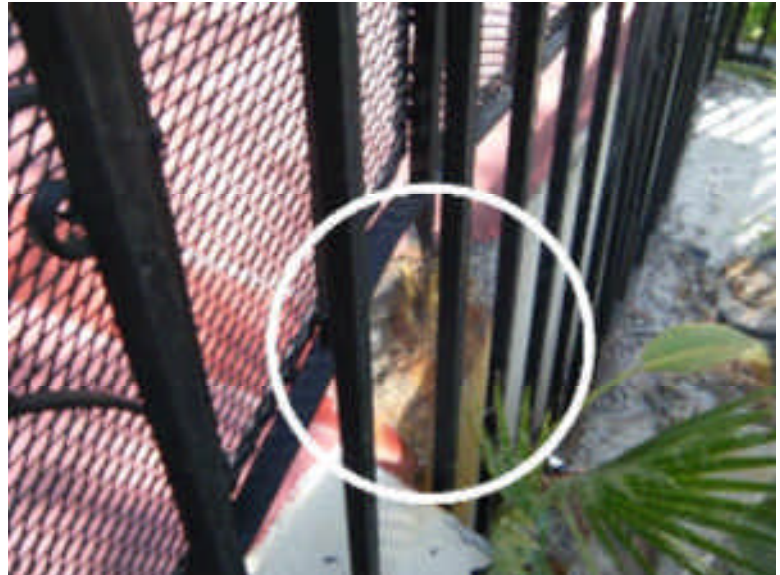
Needs Attention:, the railing is rusting and some damage to the walkway at the pool equipment area.

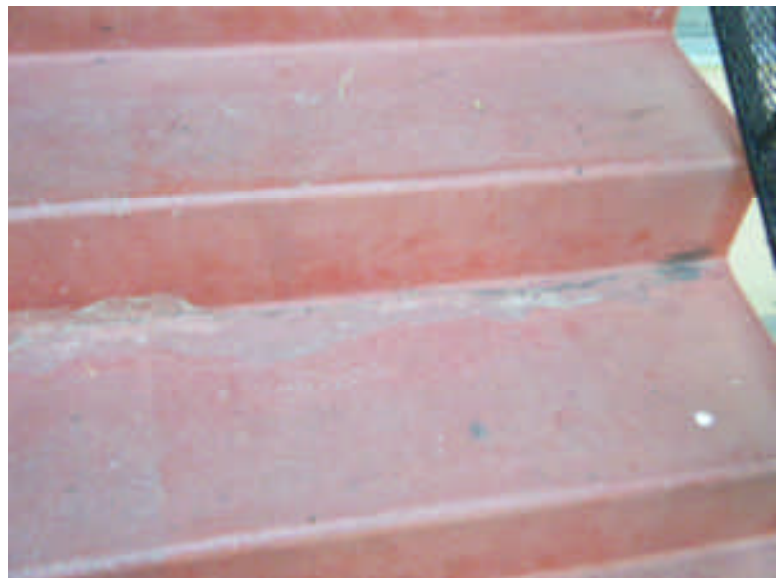
Needs Attention:, the back right stairs have some cracking and need repairs to maintain proper water proofing.

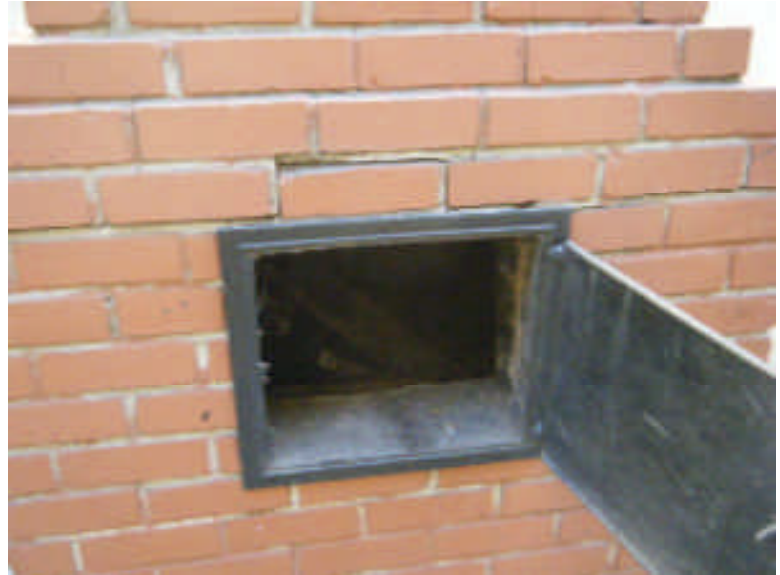
This appears to be an incinerator type unit which is no longer allowed to used for this purpose.

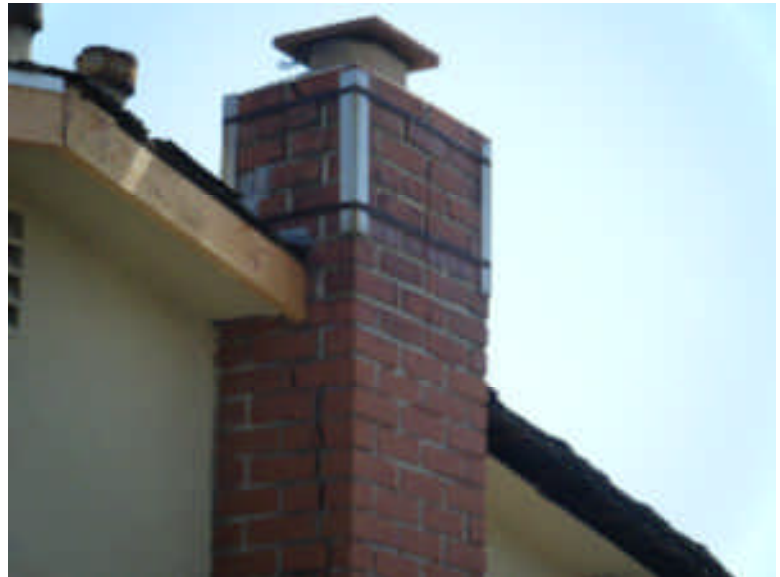
Not Acceptable: The chimney has vertical cracks especially near the top. This is typically caused by moisture intruding and the metal rebar inside of the bricks rusting and expanding. This been excessively damaged and gaps and large cracks are visible It needs to be evaluated by a chimney expert to determine its true condition.

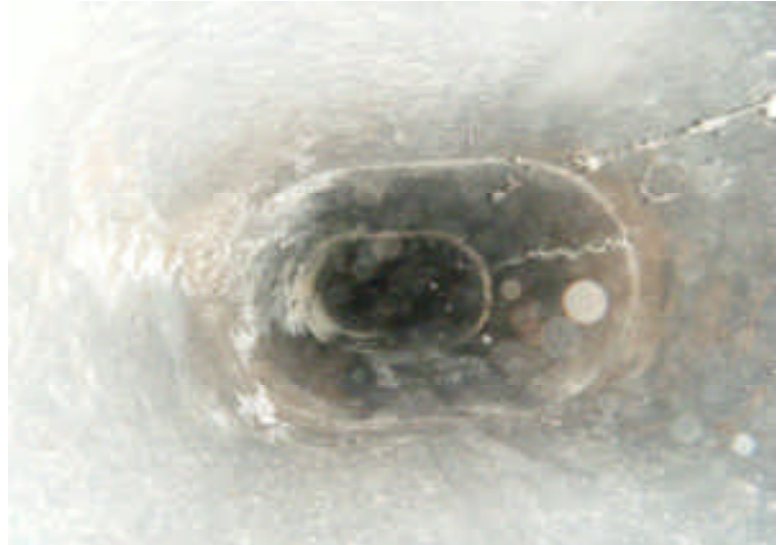
Looking down the flue

The interior mortar between the flue tiles is deteriorated and some of the flue tiles are seen to be cracked.

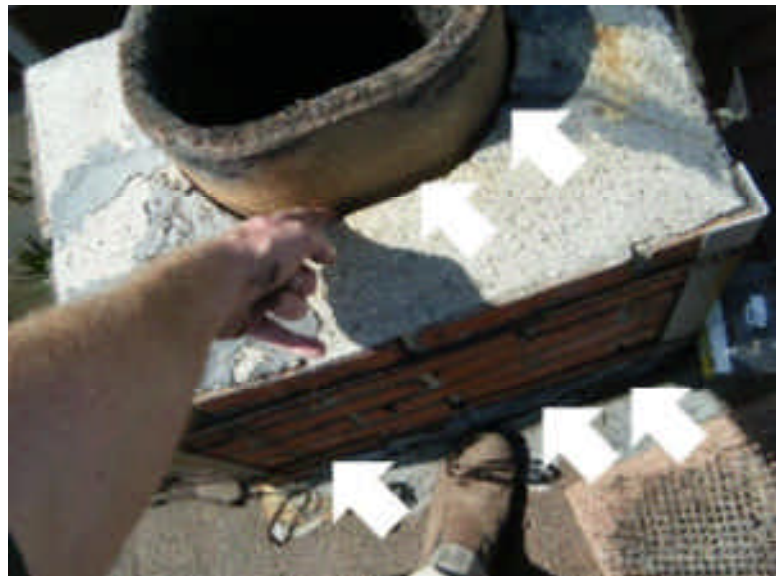
Needs Attention, there is no metal flashing around the chimney where it meets the roof, it is only mastic. This method requires high

maintenance if it is to remain leak free and has gaps around the roof joint and around the flue tile connections to the bricks.

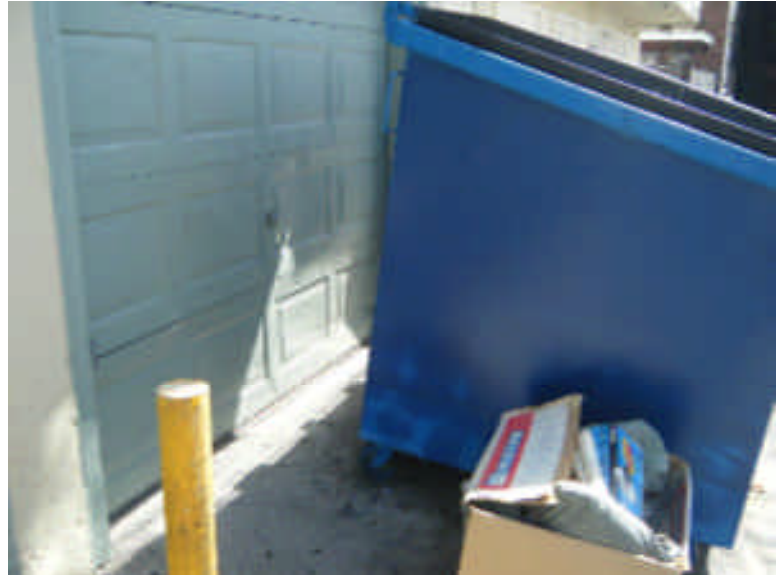
Serviceable, with typical wear and tear in areas, though the door by the dumpster is dented.

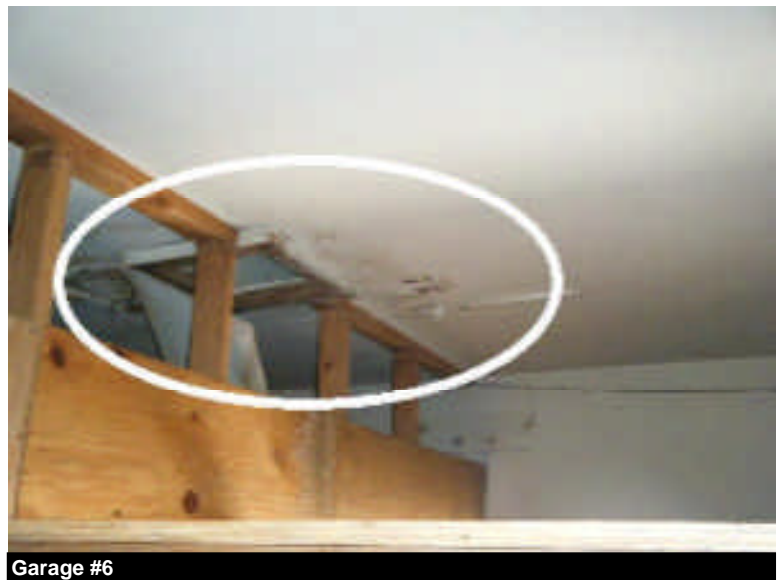
Not Acceptable: The garage interior has areas of moisture stains in #6 & #8. It #6 there is also a black mold like growth and the plumbing access door is missing some the firewall separation to the above unit has been compromised.

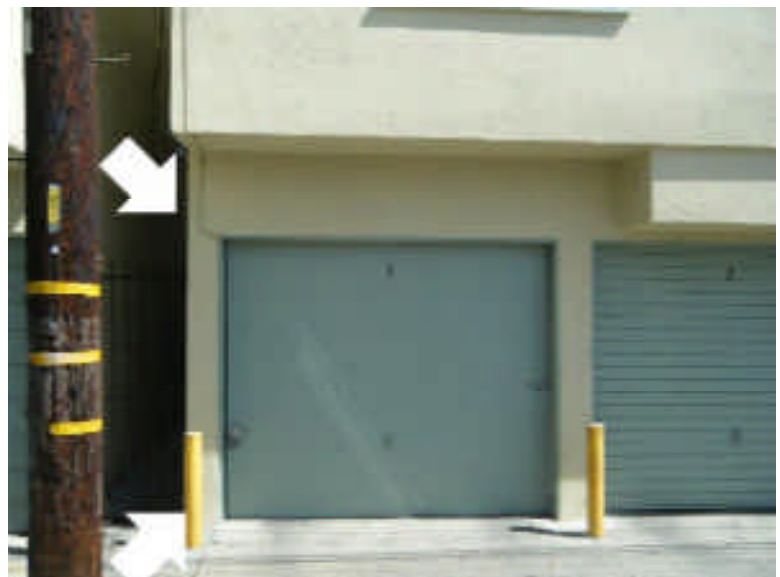
IMPORTANT NOTE: The building appears to have a "soft story" condition over the parking structure (Also called "Tuck Under parking"). This is where the weight of living area is supported by a parking structure below and the corners at each side of the car entry opening are not sufficiently braced to support the stress created by the lateral movement during an earthquake. Refer to

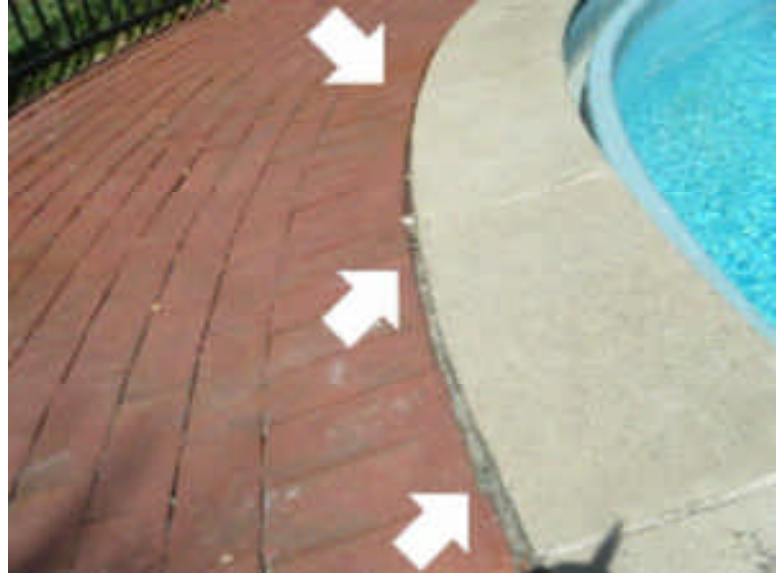
Needs Attention: The caulking between the coping and the decking around the pool/spa is deteriorated in areas. This area should be re-caulked and sealed.
