Real Estate Inspection Report

September 2009.

Sample Apartment Report

Huntington Park, CA 90255

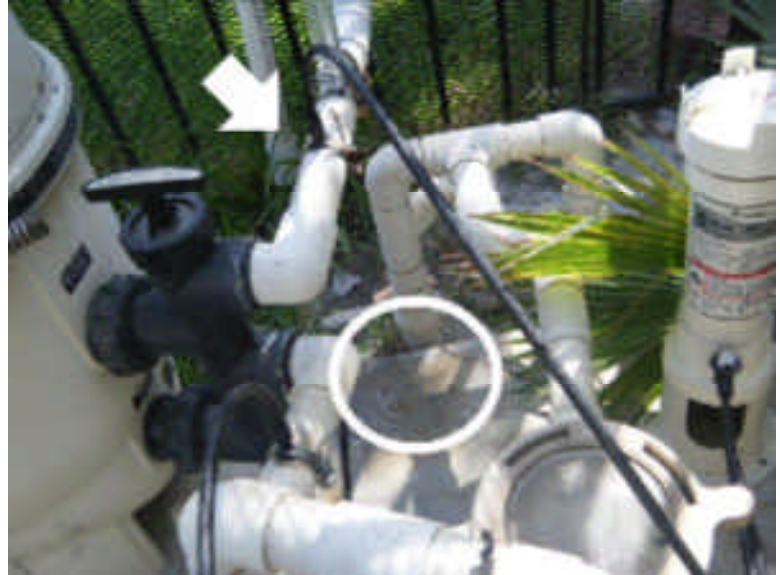
Needs Attention , there is a small leak by the filter.

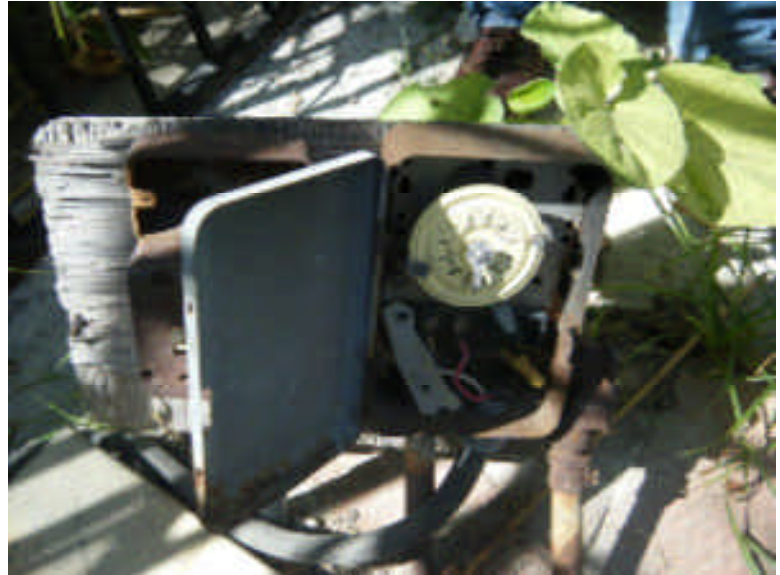
The timer box has a missing plastic cover guard inside it. The electrical wires are exposed to contact in this condition and it is recommended that this be re-installed.
