# Real Estate Inspection Report

## Commercial Sample Report

Inspector - Mark Phillips, Dave Short and David Hamilton  
Confidential and Proprietary

Sample Report

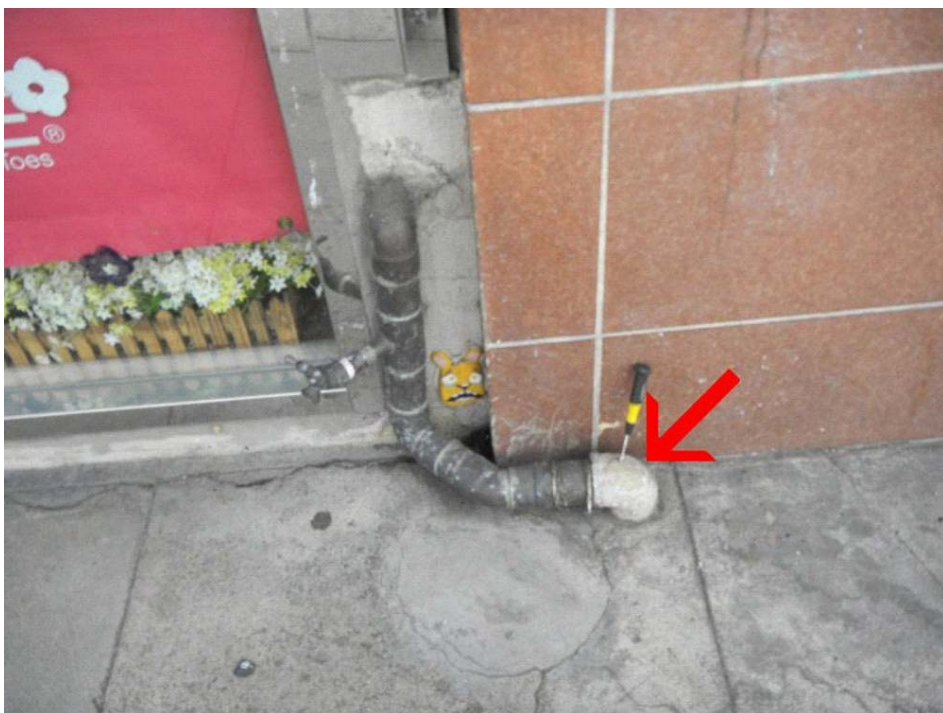
### GALVANIZED PIPE

Galvanized steel piping is viewed coming out of the ground by the building and as the main water line runs underground from the street to the building, this appears to be the main water line.

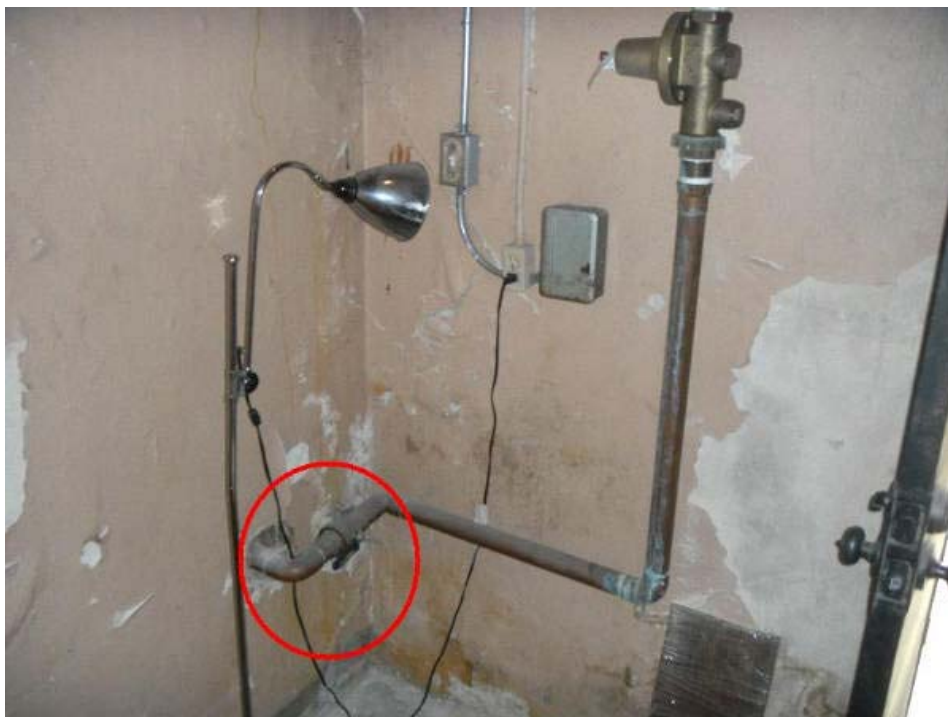
At the back of the building in the hall to the basement.

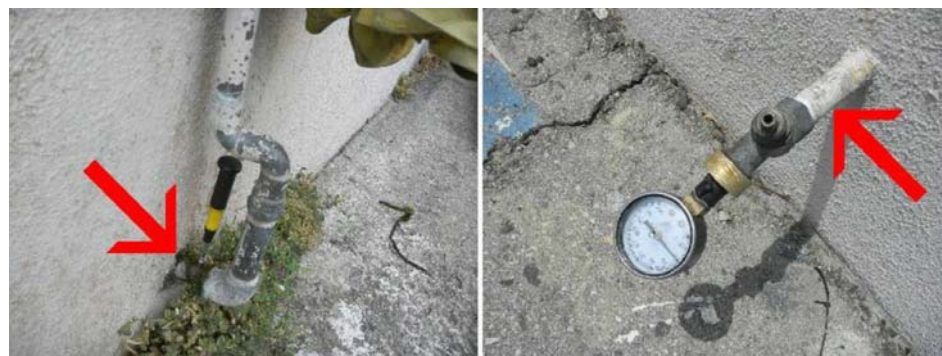
**GALVANIZED PIPE**

**Needs Attention:** The water lines are a combination of copper and galvanized steel piping. Most of the upper floor plumbing appears to be copper where visible. Much of the lower floor plumbing is galvanized. The original galvanized steel piping that is left in the system has rust and is showing deterioration. Some of the original pipes have been replaced with copper piping as they wore out, which is why there is copper in the system. The remaining galvanized steel pipes will need to be replaced in the future as they continue to wear out.

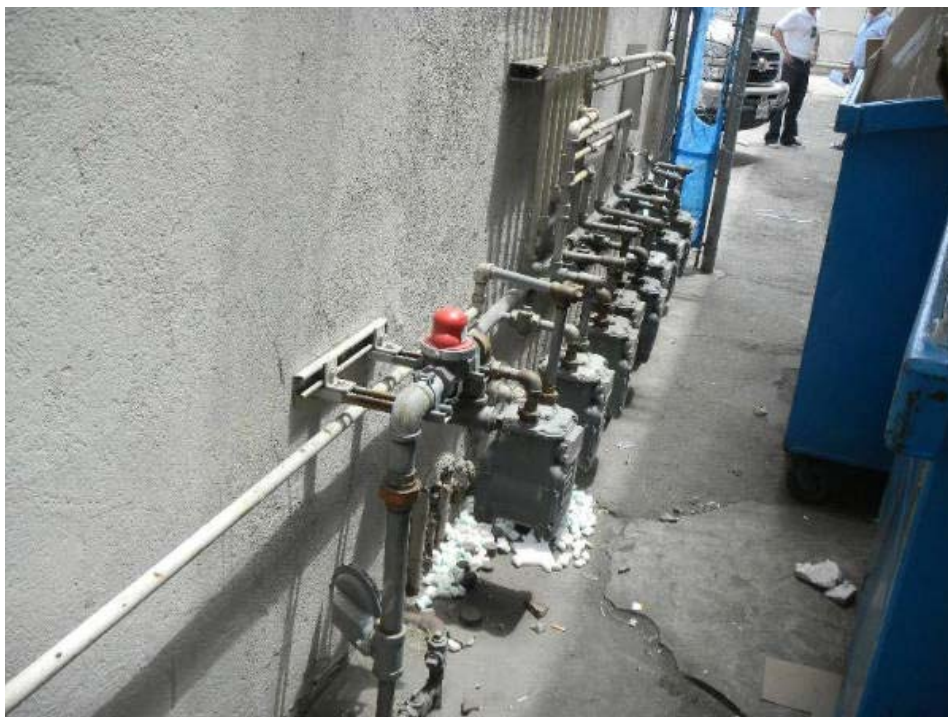
There is one automatic seismic gas shut off valve for all the gas meters in the building. It is beyond the scope of this general inspection to determine its operating status or if it has been sized correctly for this gas system. If further information is desired or required it is advised to consult a qualified plumbing contractor

There is a single safety shut off valve for the 8 meters, Individual shut off valves may be recommended.

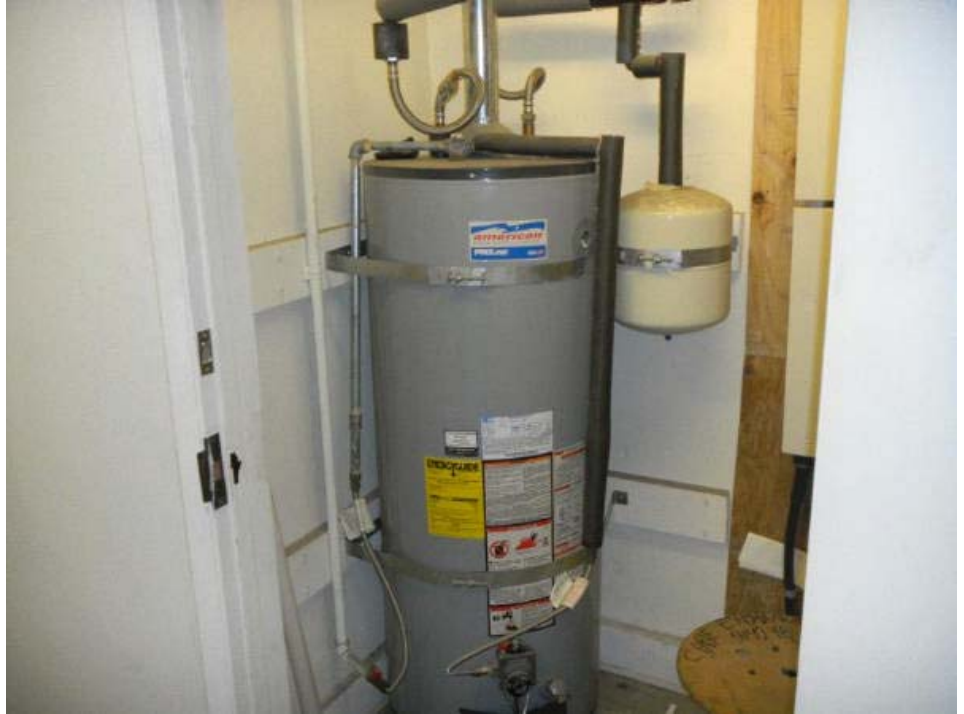
The water heater at the right of the building is located in the upper hall closet.

**Needs Attention, there is no drain pan below the water heater, this is advised in case the water heater leaks so that the water can be carried away from the living space. There are water stains note on the closet floor.**

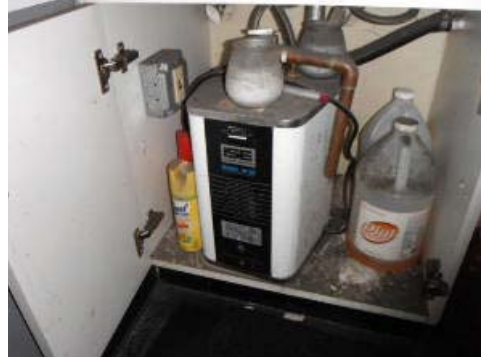
In the Comics store, 7018, Under the bathroom sink.

This was unplugged and not in use, so its condition is unknown, it is old, rusty and worn, beyond its expected working life.

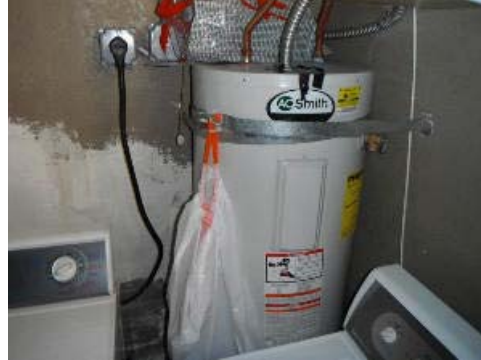
In the Nail Salon, 7022.

Unknown, the name plate label is missing. This appears to be newer.

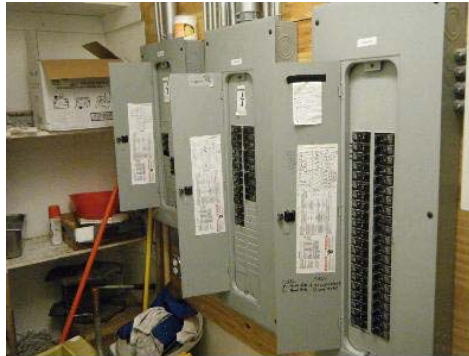
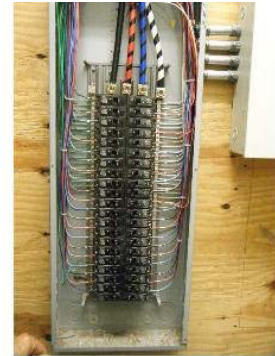
Generally serviceable, however the outside panel by the trash cans in the back of the building has missing knock out openings that should be sealed, and the breakers are not labeled as to what they serve.

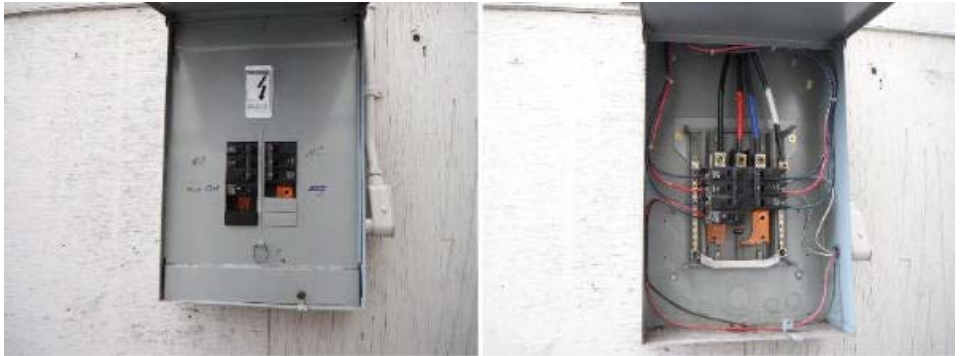
(exterior panel with missing breakers and exposed live components inside.

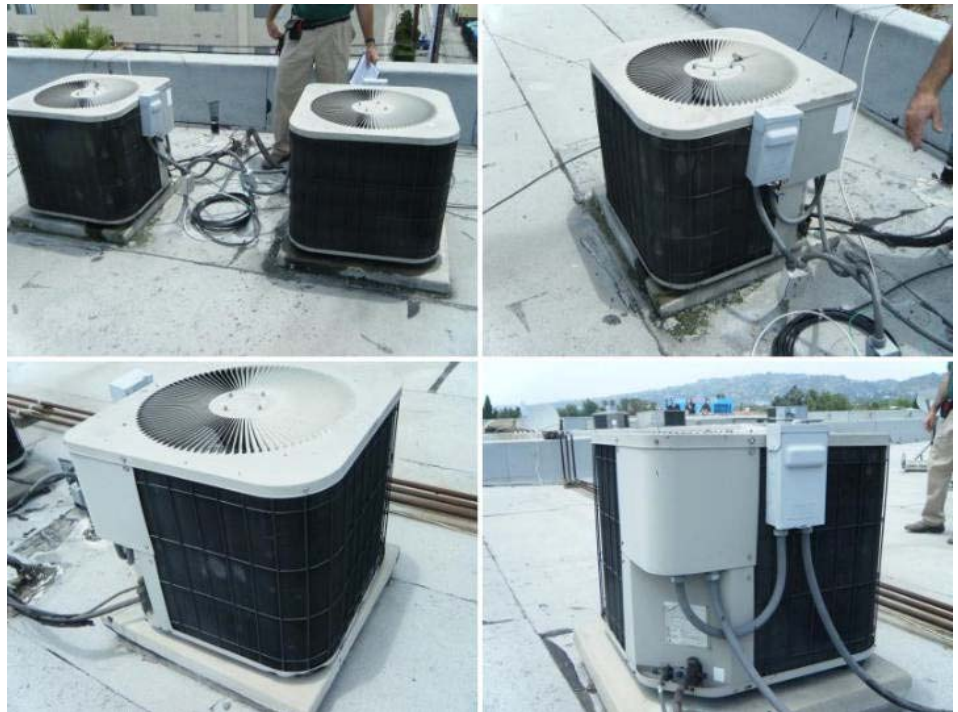
The heat pump units are located on the roof for the 4 systems.

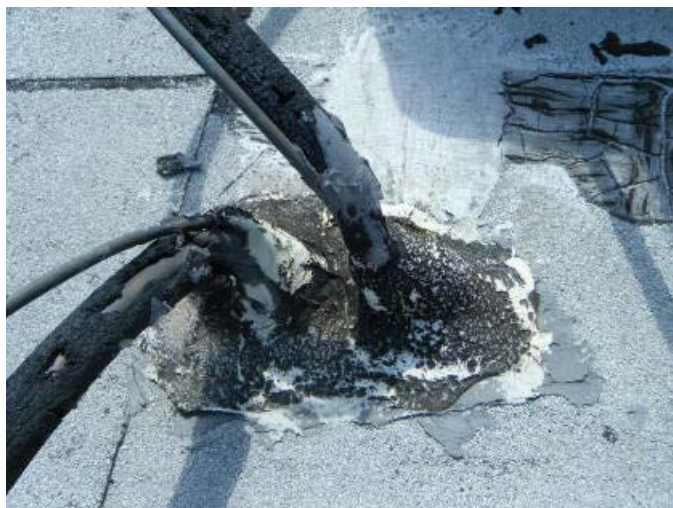
**Needs Attention, the insulation on the coolant lines is deteriorated and failing, in addition to losing efficiency, the holes around the coolant lines passing through the roof create a path for water entry, and need a proper repair.**

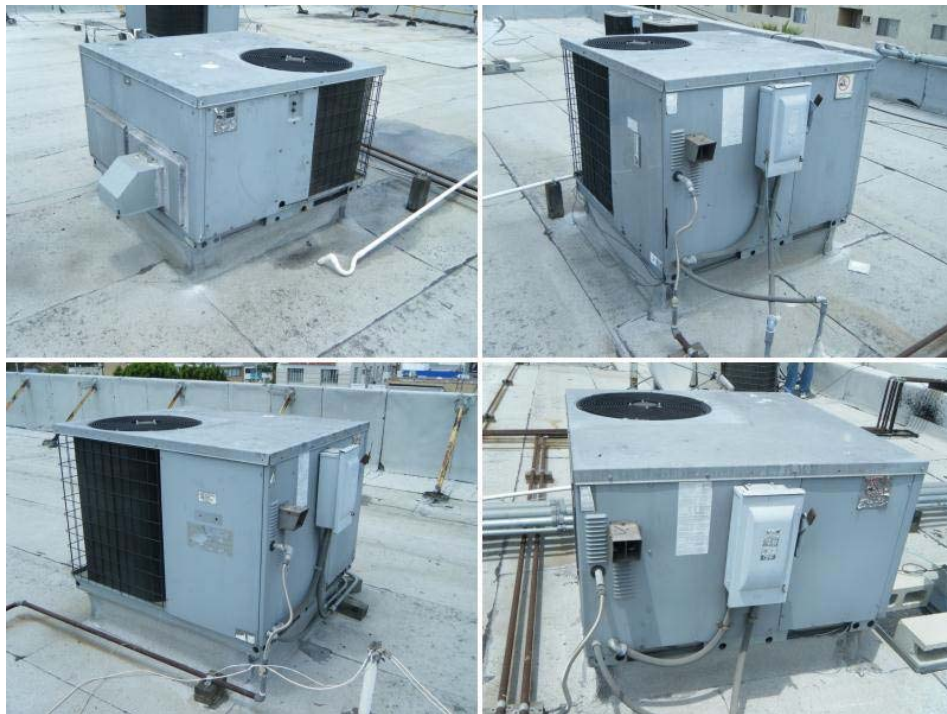
For the 2nd floor, there are 8 units, in similar condition.

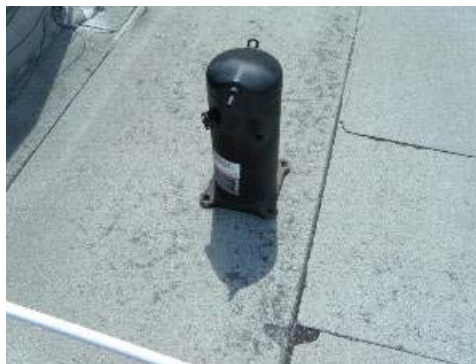
**Needs Attention** it is noted that at least one of the units appears to have repairs, there was an abandoned AC compressor pump on the roof.

The units are working but well into their expected working life.

The units are reported to be and appear to be about 10 years old.

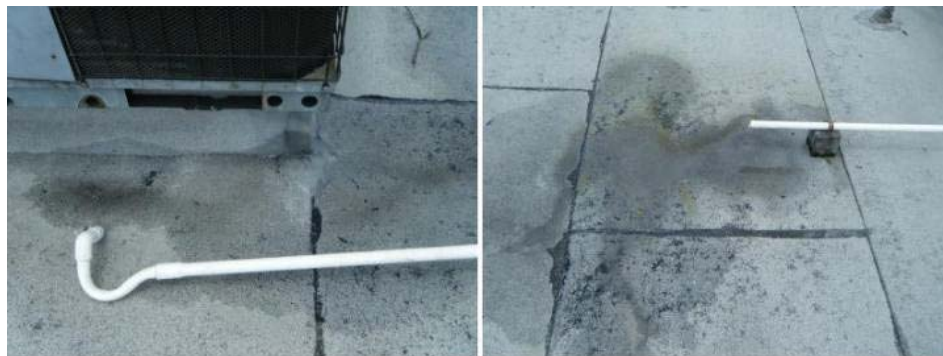
**Not Acceptable** Most of the units have 'short' drain lines that are draining onto the flat sheet roofing. Unit G while running did not appear to have much of a condensate water flow, This may indicate the water is leaking into the unit instead and this will need to be checked and repaired as needed.

Some of the units have broken condensate drains.

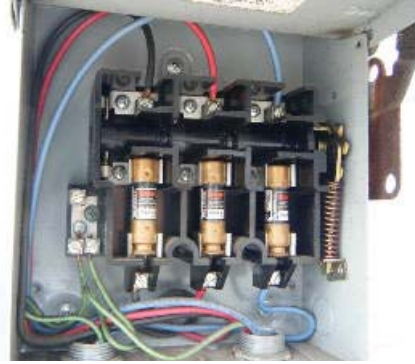
Serviceable These appear to be 3 phase units, which can be a more efficient system.

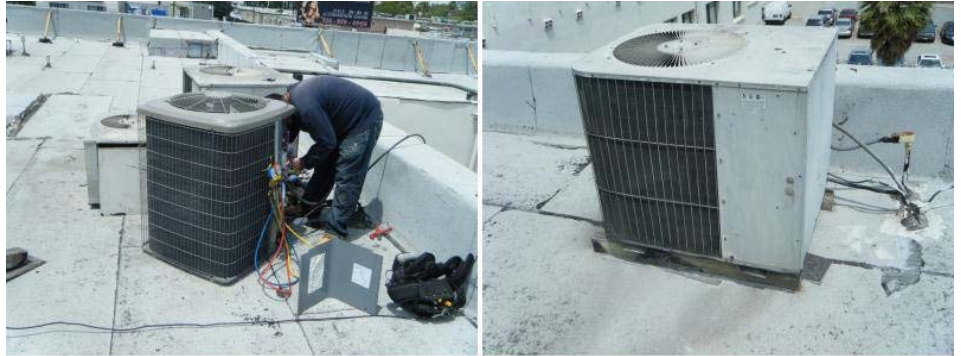
Both units are located on the roof.

**Not Acceptable. One unit is in process of being replaced. This is being poorly, incorrectly installed, it is resting on the roof and not on proper support of wood beams or platform, is not secured to the structure etc.**

**The other unit was off and not working, and was also being repaired by an AC contractor.**

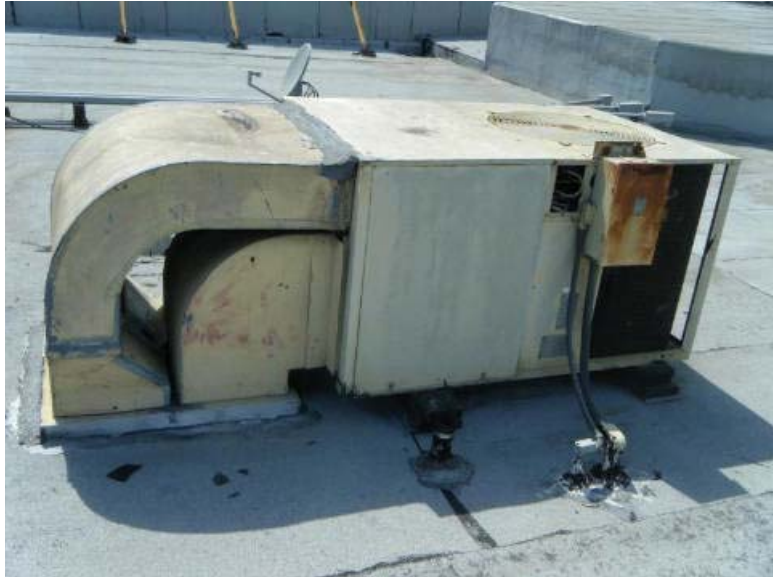
**Not Acceptable:** There is an additional unit on the roof that was reported to have been working 10 years ago but has failed and not been replaced. This is over the La Brea facing side of the building.

**Many of the systems are sitting directly on the roof or sitting on wood boards and not properly mounted on platforms. Also, the HVAC systems do not appear to be fastened down for earthquake safety. Consult with the heating contractor about the proper mounting of HVAC equipment on a roof condition.**

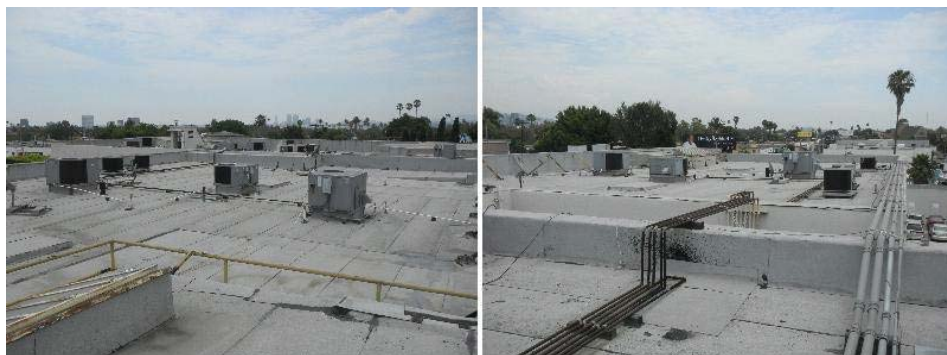
The roofing material on the low sloped roof is rolled sheet composition roofing with a granular surface.

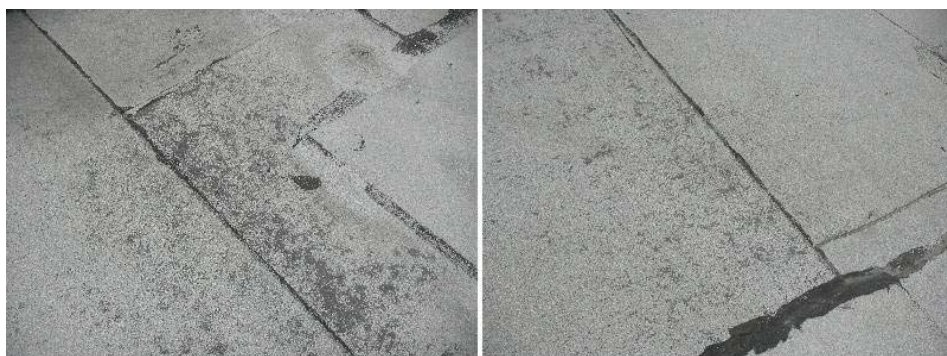
**Not Acceptable:** The roofing material is worn, deteriorating and losing its granule surface with patching in many areas. There are areas of blistering and lifted roofing. The roof will need significant repair and resurfacing or in the near future it will fail and need the roofing materials removed and replaced..

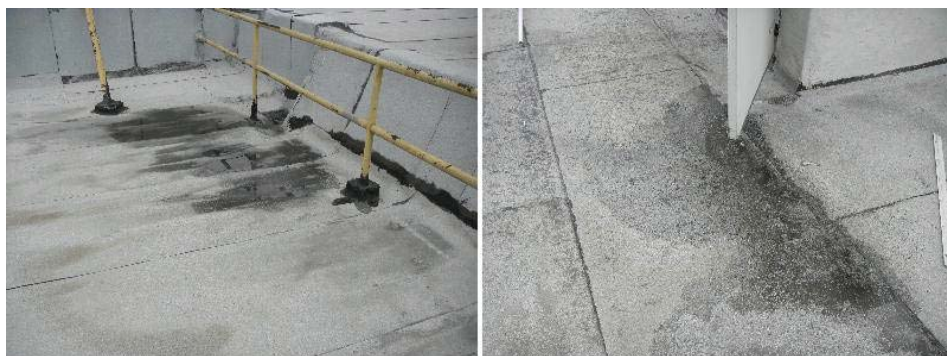
**Not Acceptable:** There are many areas where the roof is poorly sloped and water collects and ponds and does not fully drain off. This can lead to premature wear and failure. A roofing specialist may be able to remedy this with repairs and modifications.

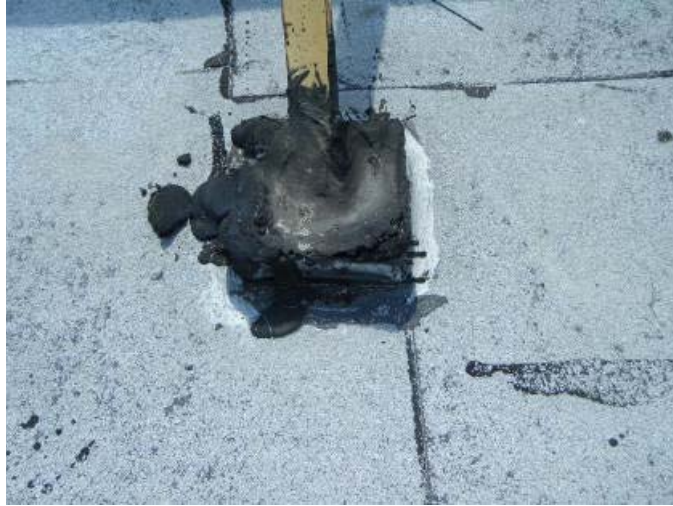
**Not Acceptable:** The mastic is cracked in areas and is not reliable to ensure a watertight seal around the roof penetrations.

There are gaps around the AC coolant lines for some units that are not sealed and may allow water through and into the building.

There are 'pitch pockets' where the iron wall supports attach to the flat roofing, these are cracking and deteriorated and need repair to remain waterproof.

Some of the parapet walls have metal cap flashings, and for some the metal cap flashing is covered with the sheet rolled roofing lapping up the side walls and over the top. This is a poor and less reliable installation.

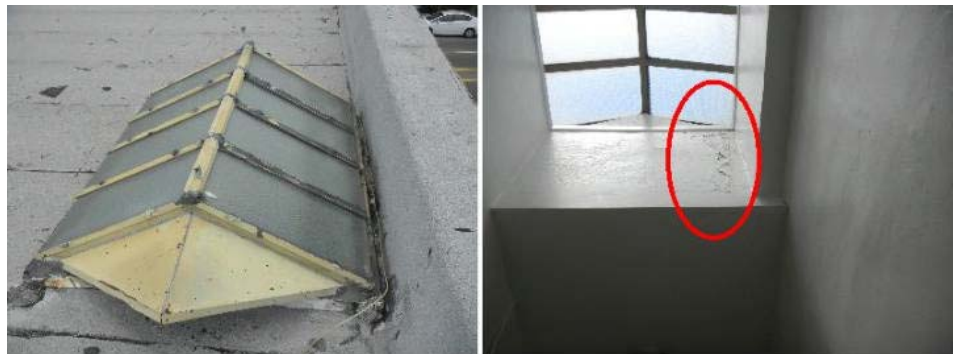
**Not Acceptable:** The skylight is a home made skylight and does not have a factory sealed frame on it. The mastic is deteriorated and worn on the skylight and needs to be checked out and repaired at this time. Water stains and water damage are noted in the stairwell below.

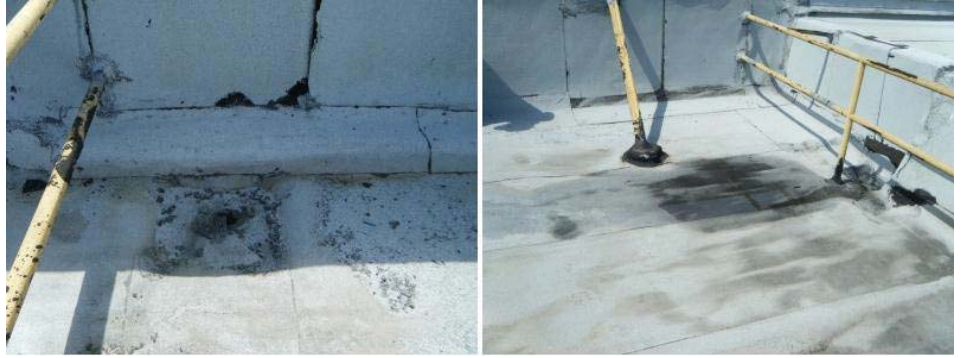
There are 'scupper' drains through the side (parapet) walls of the building to let water off the roof.

It is recommended that an overflow scupper drain be added to prevent ponding and flooding. Consult a roofer.

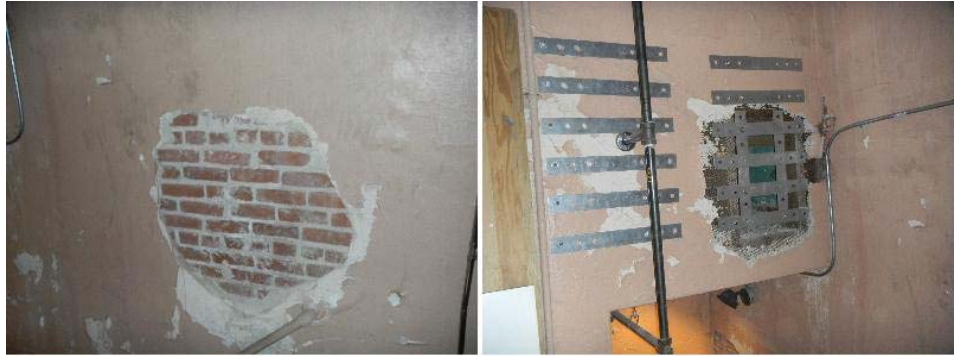
**Needs Attention:** there is wall damage with missing plaster and exposed brick on the side wall, that may be from water. The wall over the stairwell has a large hole, unusual strapping or repairs. There are dark mold-like stains on the ceiling of the stairwell.

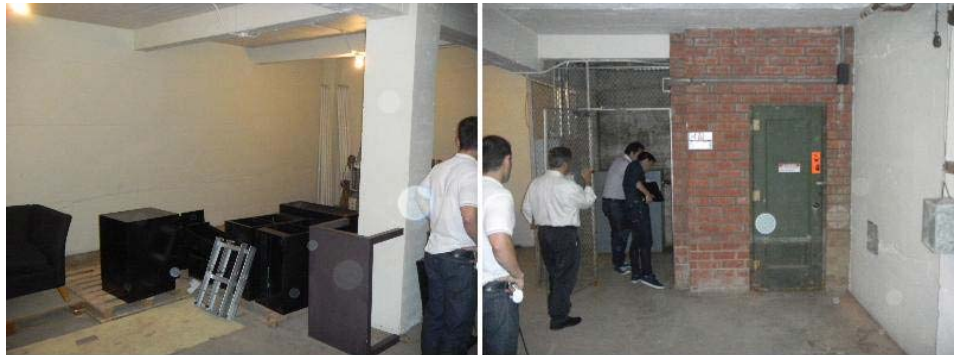
**Needs Attention:** There is some deterioration and water staining to the basement walls and floor, this is one medium size room with a caged or fenced area in the corner that houses the elevator equipment.

There is what appears to be a self closing metal fire door, this has a rope tied to it so it stays open. The door has rust damage to the bottom several inches of the door.

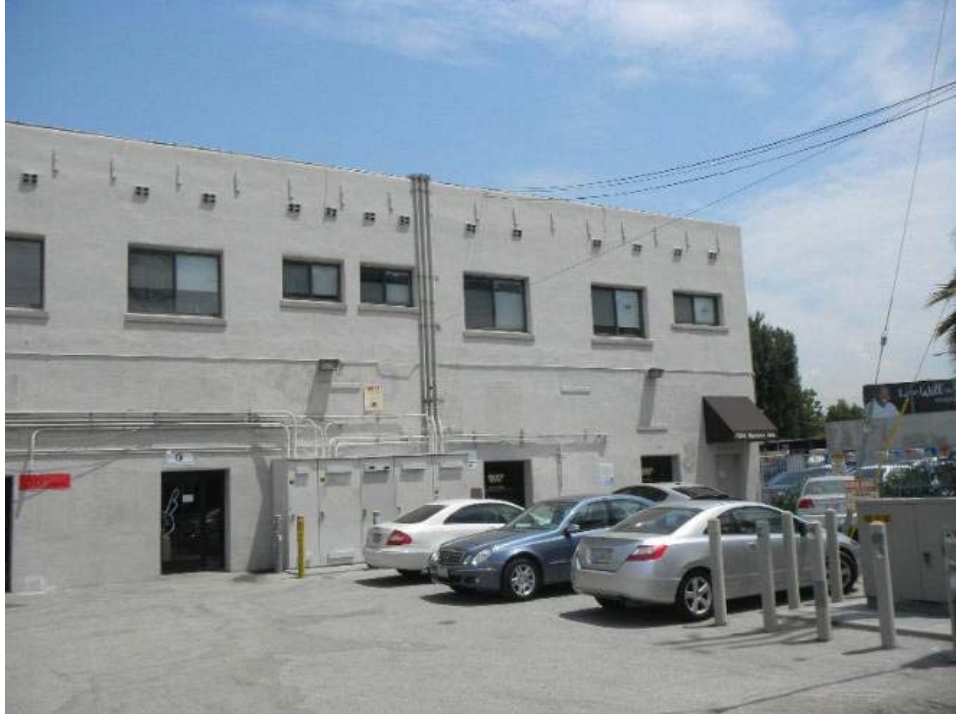
**Needs Attention:** There are areas of weather beaten stucco and peeling paint on the exterior of the building.

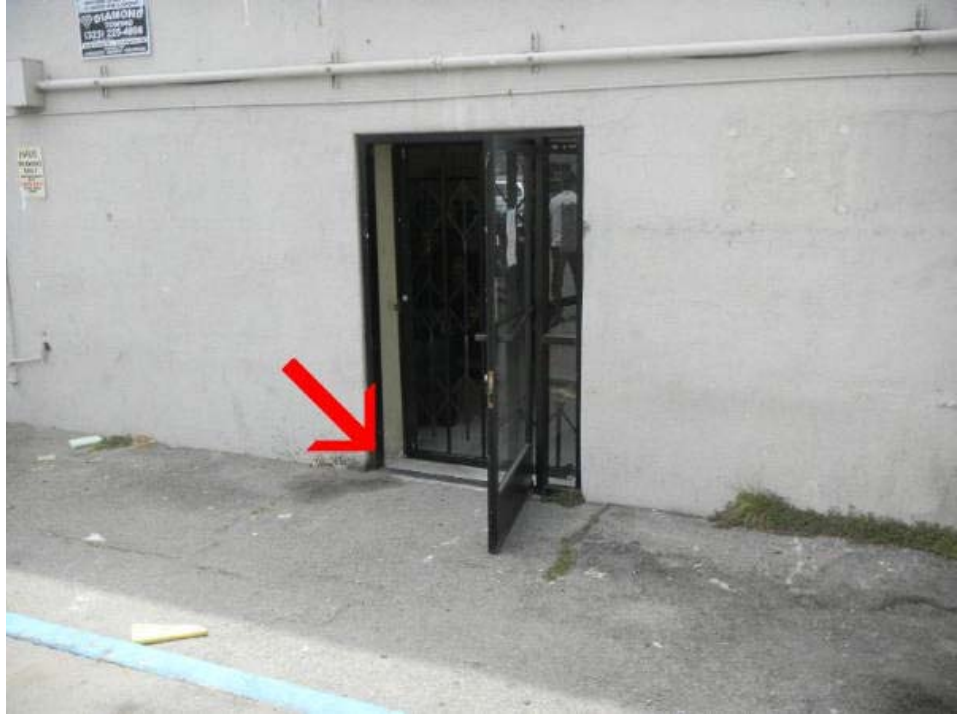
**Needs Attention:** The exterior door thresholds are not sufficiently raised above the exterior walking surface to prevent moisture intrusion in all circumstances as at the rear of the 652 furniture store. They appear to have allowed moisture to enter at times which can damage the structure.

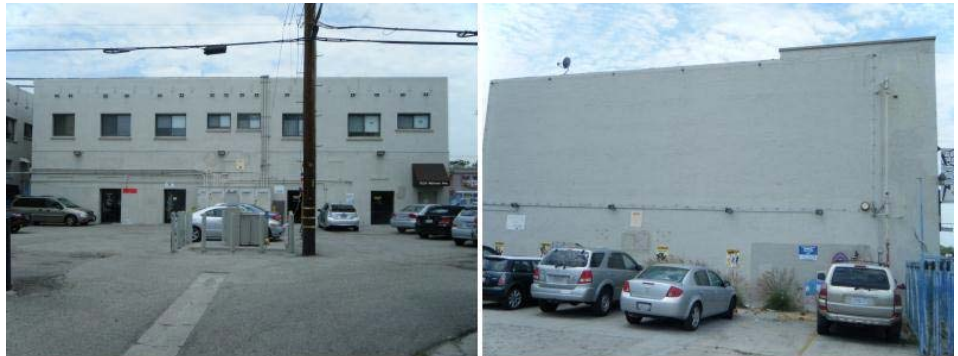
**Needs Attention:** There are raised and shifted areas of the parking areas that may to be a trip hazard. There is a considerable amount of deterioration to the entire surface of the parking areas.
