Real Estate Inspection Report

Sample Short Sale Report

La Canada, CA 91011

Inspector - Bud Hayes
Confidential and Proprietary

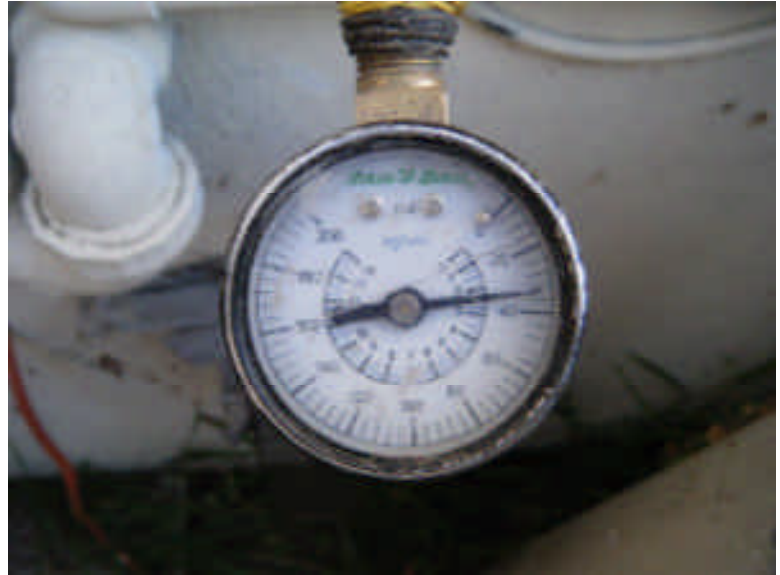
Needs Attention: The pressure is under 40 psi. This is too low, it should be between 40 and 80. There may be a pressure regulator that could be repaired or replaced. The pipes may also need to be replaced to increase the flow or a 'booster pump' may be needed.

(Measured @ left side hose faucet near water softener)

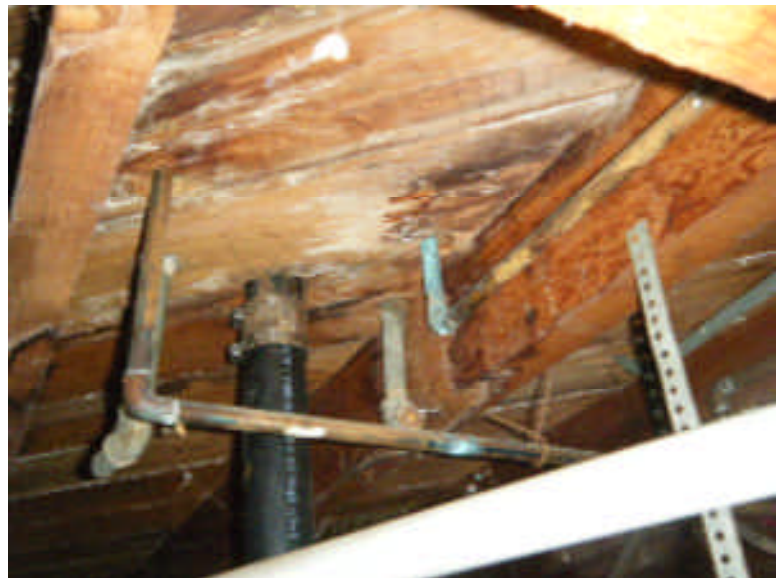
Serviceable , though there is some corrosion seen on some of the copper probably from the soldering.

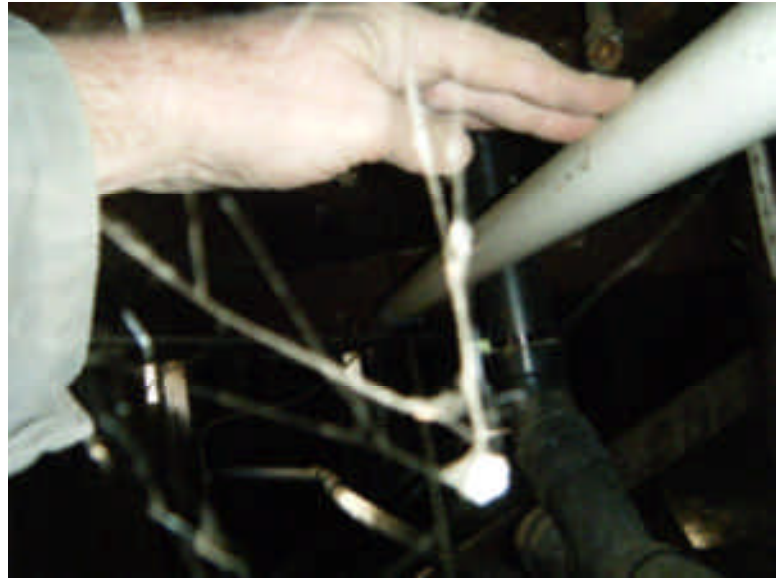
There are what appears to be pressurized plastic sprinkler pipes passing under the house. This material is not approved for use here due to the risk of leaks and flooding. These should be relocated to outside the foundation, or replaced with approved piping as with copper.

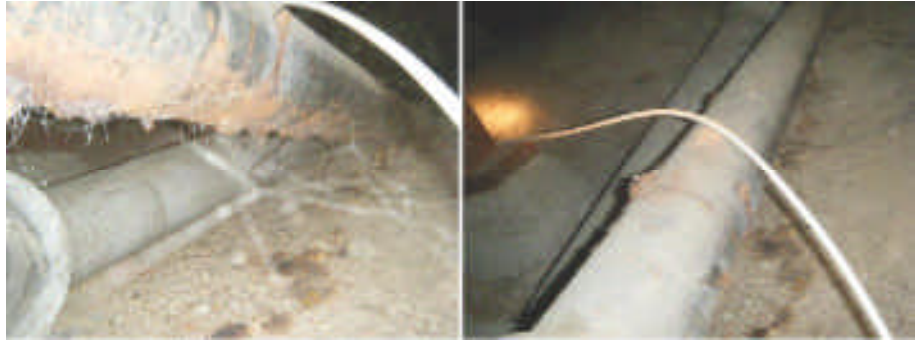
Not Acceptable: There are areas on the waste lines with rust blisters where the material is failing and may seep or leak at any time. These sections of pipe have failed and are ready for replacement at this time. The waste system should be fully evaluated by a plumbing specialist and repaired / replaced as needed. This is seen on the top and bottom of the main building drain.

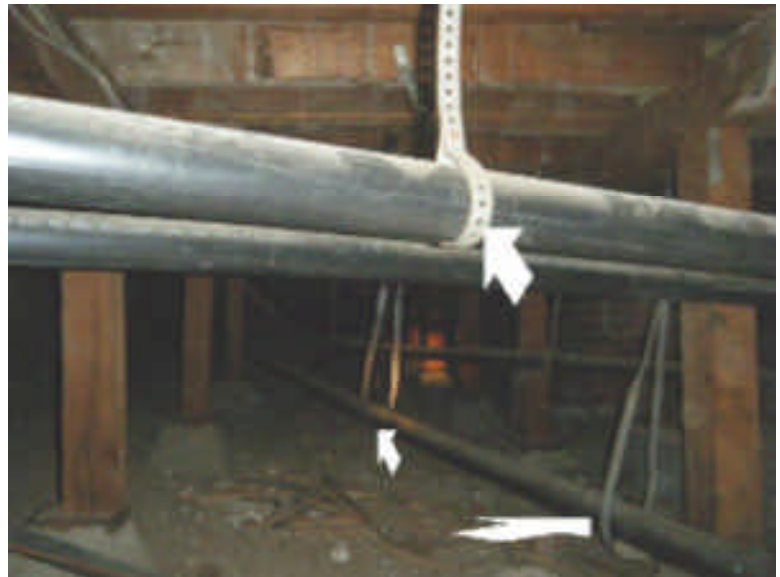
Needs Attention, there are metal straps seen in direct contact and supporting the plastic lines which is non standard and will eventually wear and cut into the pipes.

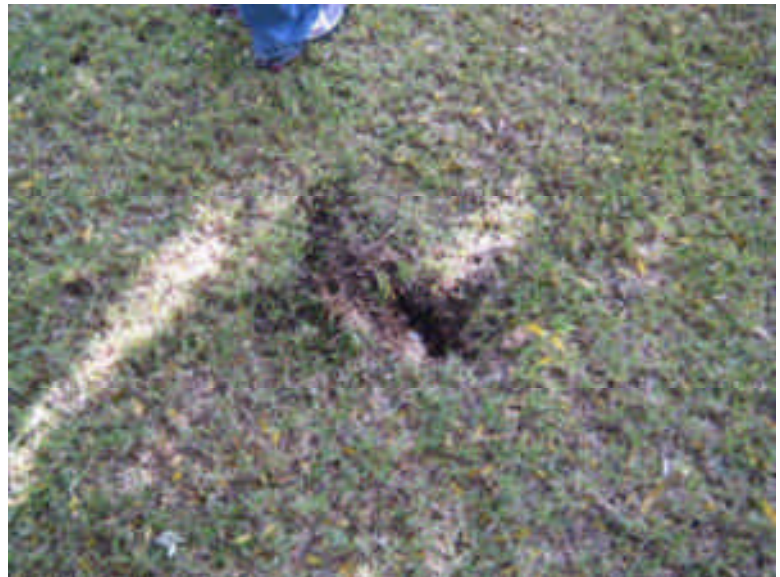
The property appears to be on a septic system. This type of system is beyond the scope of this inspection. It is advised to have a specialist in this field examine and certify the system.

The owner showed several clean out caps in the front yard area.

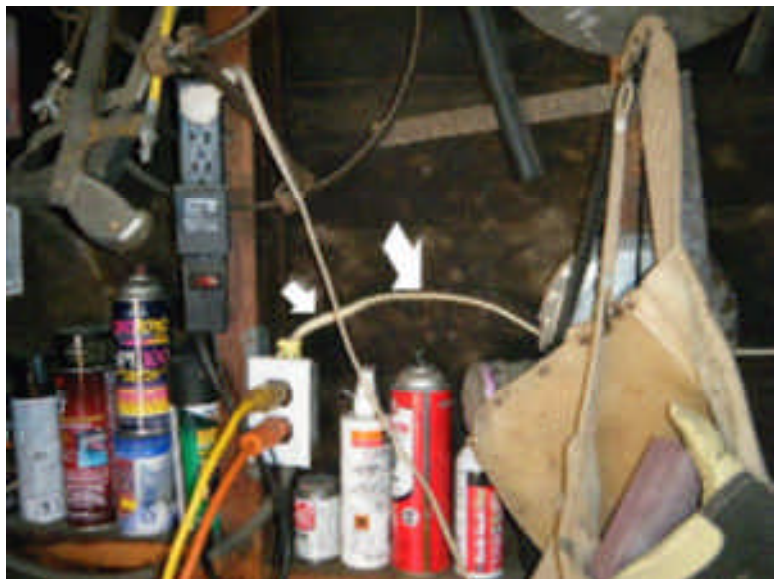
Needs Attention: The non-metallic sheathed wiring, romex, is installed where it is exposed and can be damaged. This is non-standard and needs to be corrected such as in the garage.

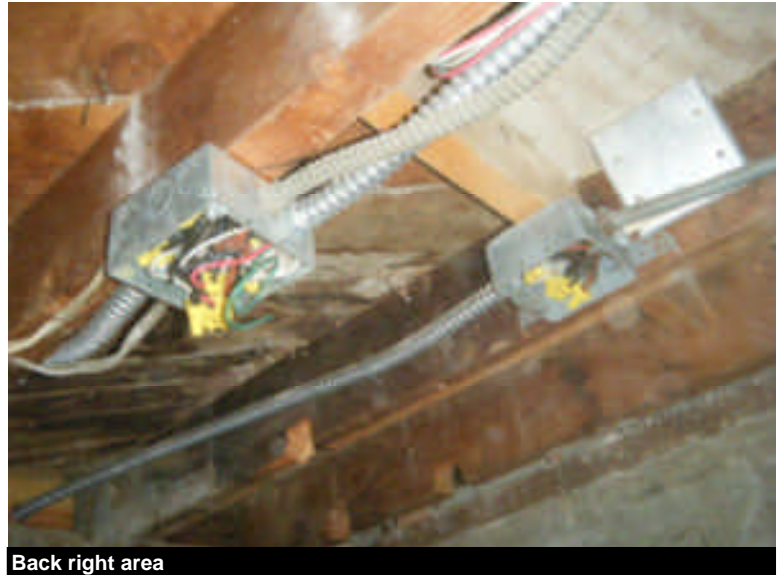
There are open junction boxes with wires exposed. These need to have covers installed over them for safety, in the crawl space under the building.

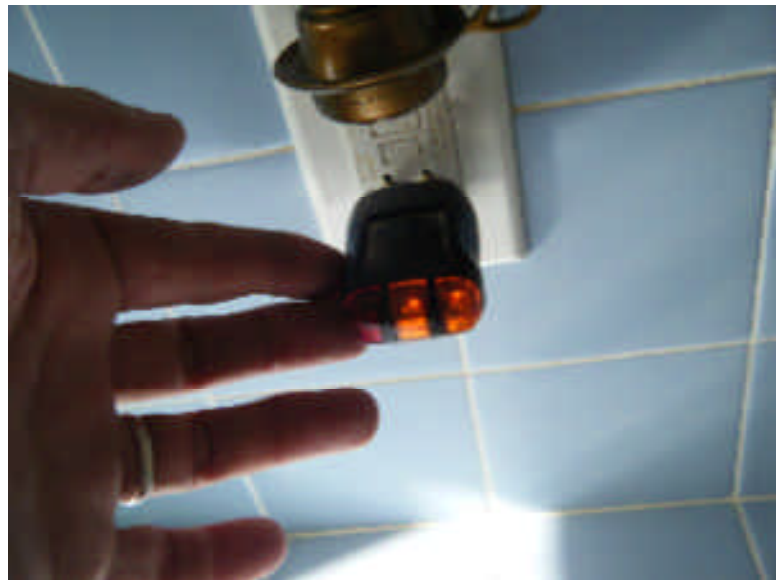
Not Acceptable: The Ground Fault Circuit Interrupter (GFCI) outlet did not turn off (trip) when tested. It should be replaced, in the hall bathroom.

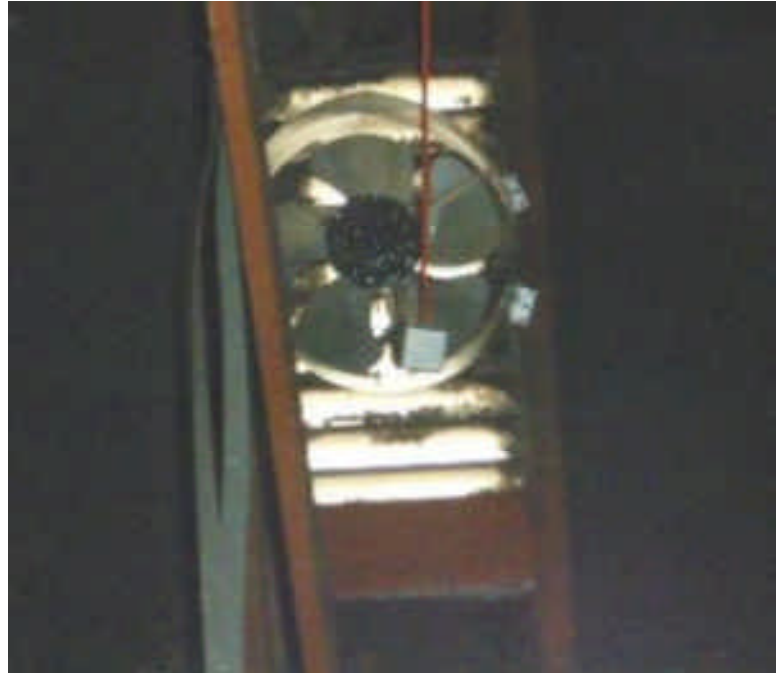
Needs Attention: The vents that supply a fresh air flow to the attic are damaged in areas. This may allow animals or insects to enter.

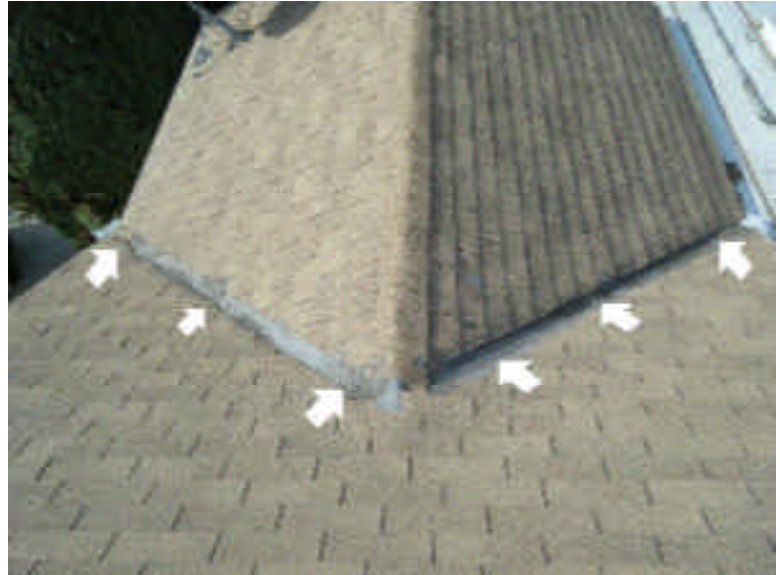
Needs Attention: On the composition roof , there is excessive mastic used in the back left valley joint.

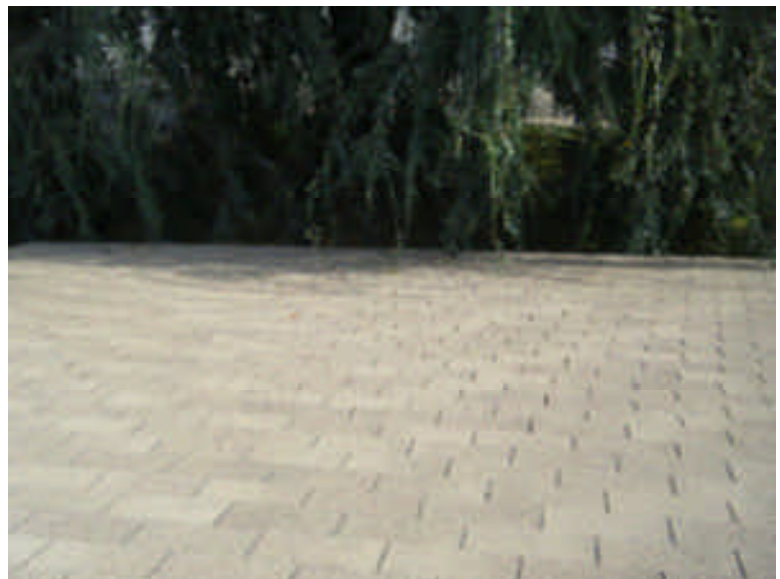
Needs Attention, there are tree branches growing over the roof and brushing against the structure which needs to be trimmed back.

There is composition roofing which has been installed on top of another layer of roofing. The shingles are not laying flat and are curling a little. This will allow wind damage and other weathering to wear the shingles prematurely.

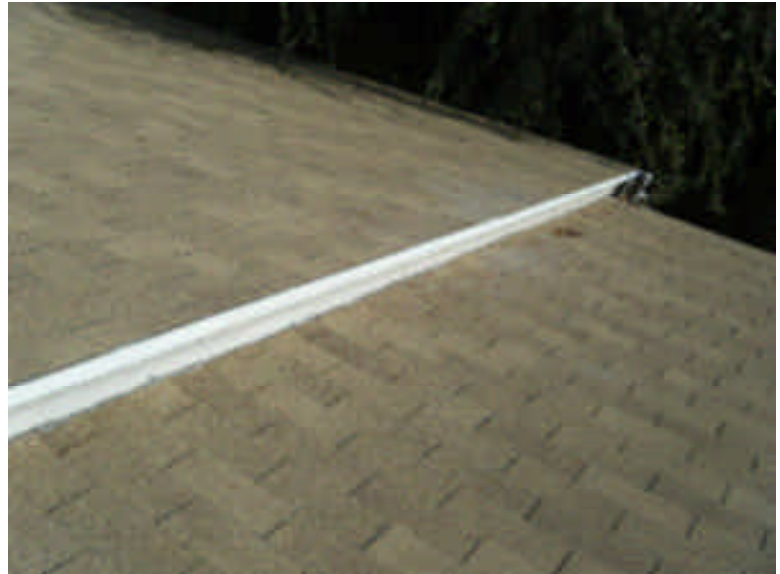
Needs Attention: The connection of the roof to the wall of the building has not been properly flashed and therefore is not a reliable installation. It will require high maintenance in this state.

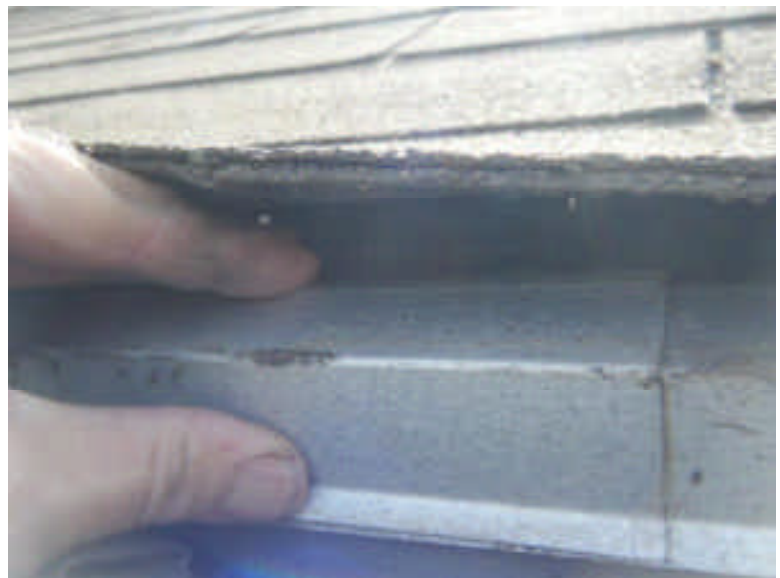
Needs Attention:, the front drip edge metal along the lower edge of the roof is installed over the felt paper which may trap water and cause moisture damage to the wood supports and fascia trim.

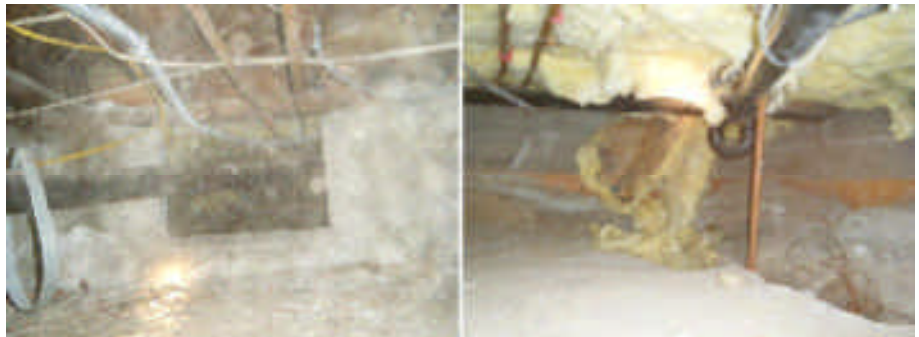
Needs Attention, under the back right bath, the insulation is not well attached under the building to the underside of the floor and is falling down in areas. It needs to be properly secured in place. This also often indicates poor ventilation allowing excess humidity and dampness weighing down the insulation. The vent screens should be checked to insure they are not blocked. Access is restricted into this area and was only viewed from this opening.

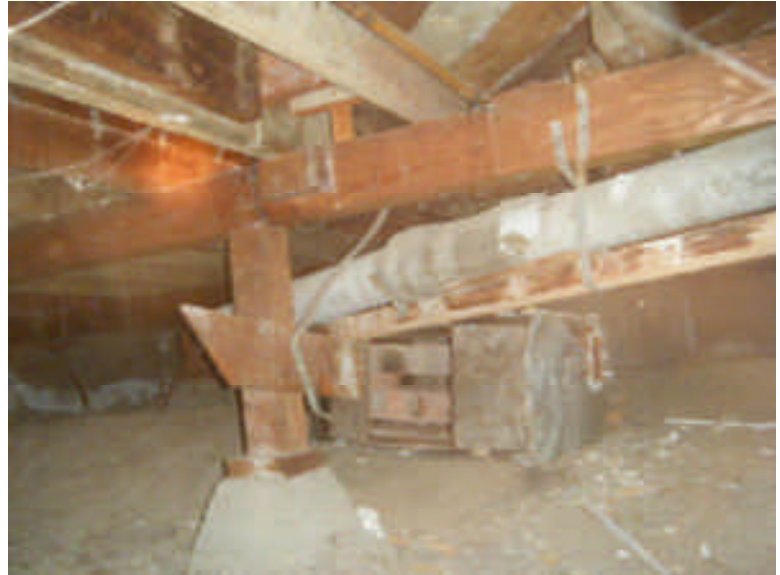
There is an old abandoned floor furnace which appears to have terminated & disconnected properly.

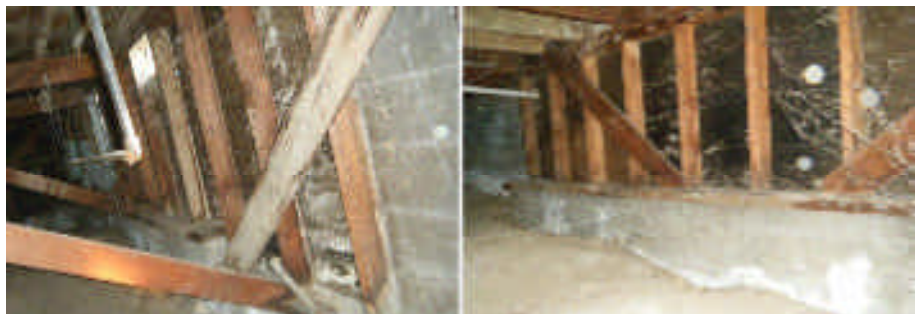
Left side & front areas

Needs Attention: The cripple walls, or portions of it, have not been strengthened with seismic reinforcement (shear panels etc). 'Cripple walls' are short walls between the foundation and the under side of the building framing. Although this may not be required, seismic reinforcement would help reduce damage to the structure during seismic activity. For detailed information consult with a foundation specialist.

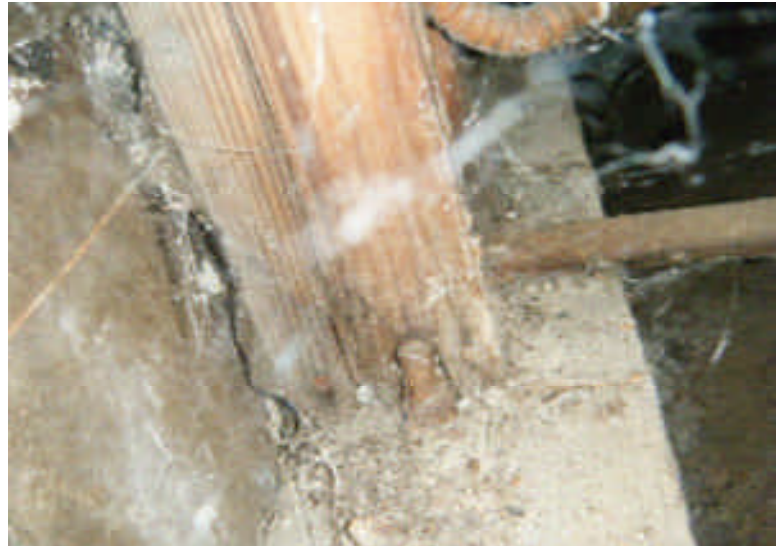
Front left area

There is some deterioration of the wood in some areas, see the pest control report for more information.

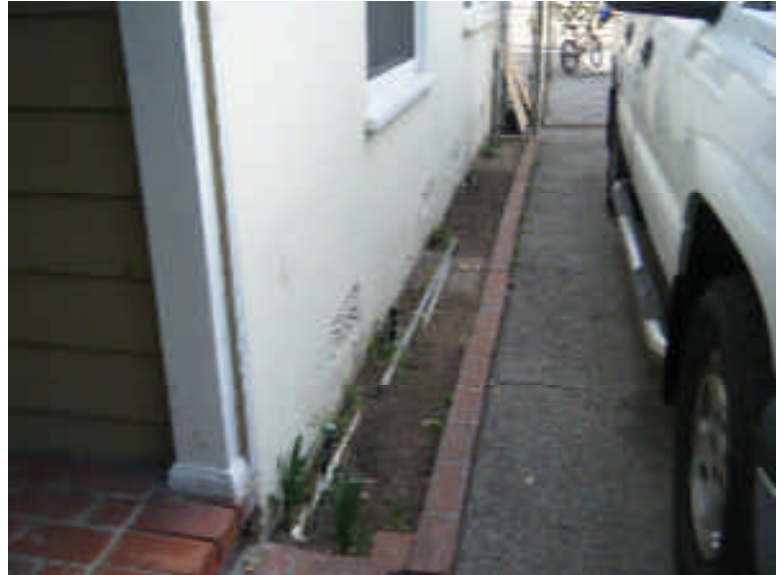
The planters or flower bed along the right side next to the foundation may be trapping water in them and causing the concrete of the foundation in this area to be wet during heavy rains and to deteriorate over time. It is advised to ensure the planters have proper drainage to take the water away from the structure.

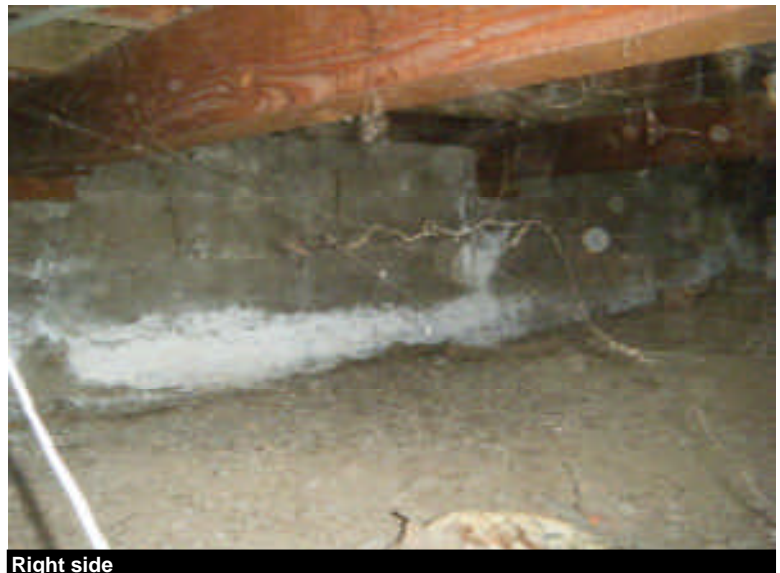
Right side

There are chalky areas on the concrete. These are an indication that water has entered the concrete and crawl space during wet weather and brought salts out of the concrete when it came to the surface.

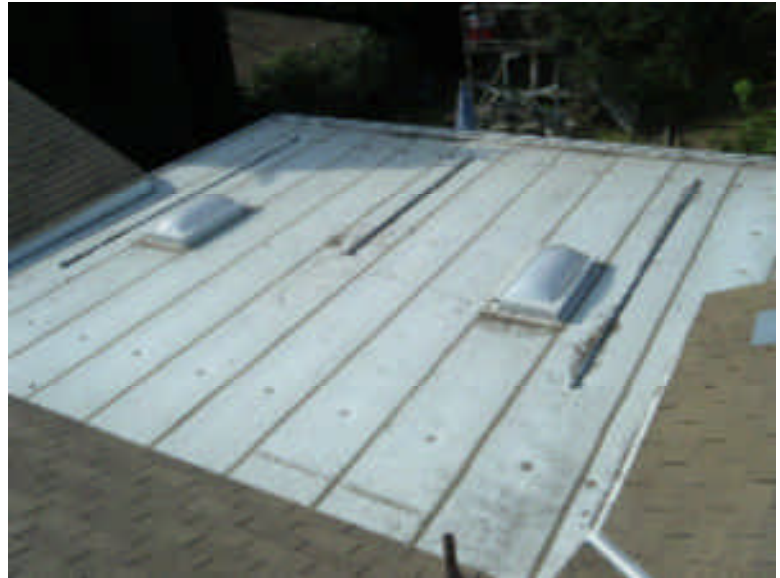
Serviceable, though there is silicone type caulking seen along the joints. Some special maintenance and servicing is required.

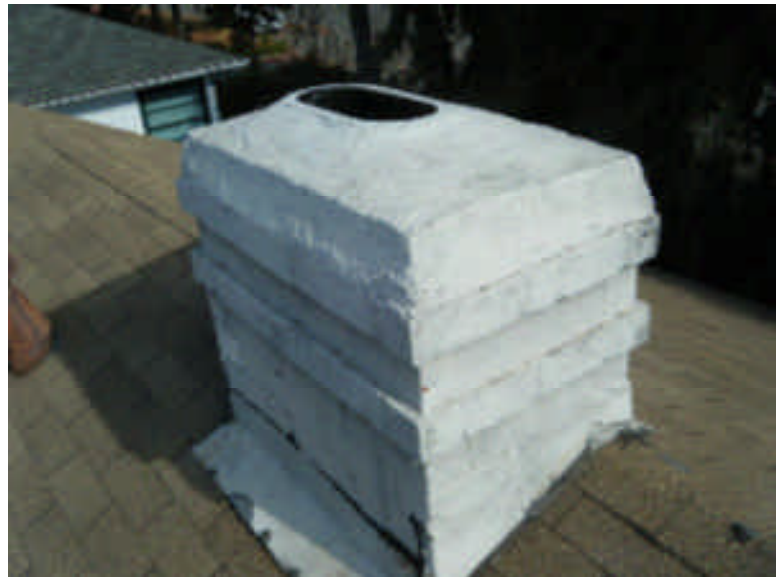
The chimney is made of brick.

CONDITION: Needs Attention: There are cracks in the mortar chimney cap that need minor repair

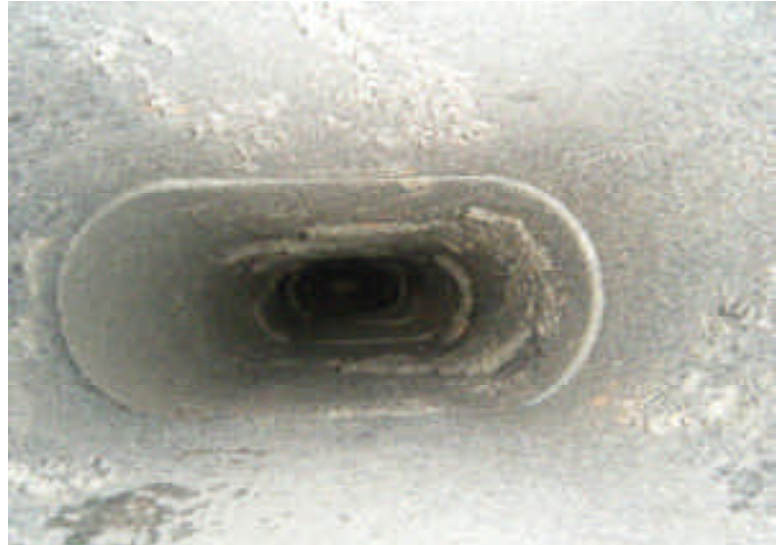
Looking down flue from roof.

There is deteriorated mortar between the flue liner tiles. The flue is dirty and needs cleaning.

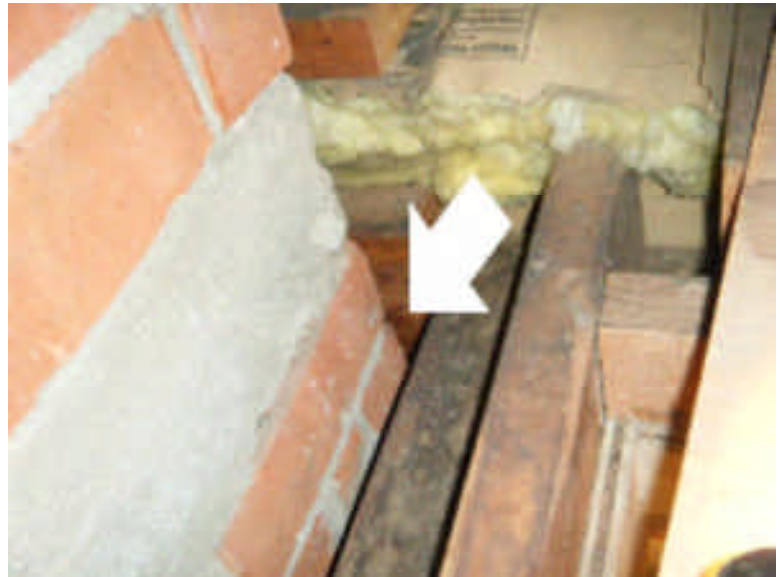
There is no fire blocking in the attic which is typically required by today's standards and there are some gaps. Also, the wood framing is close to the bricks.

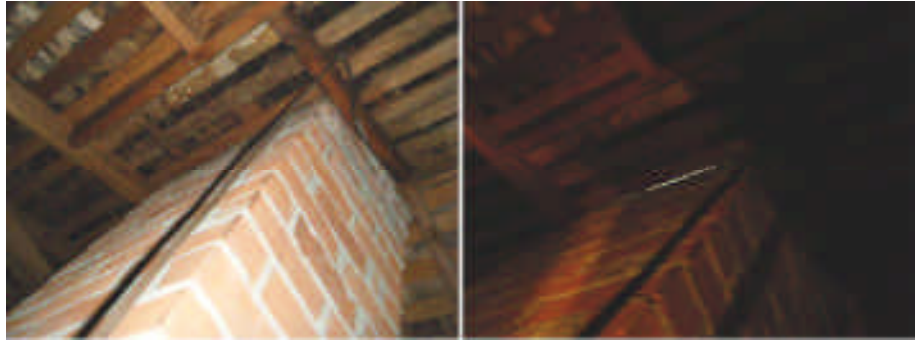
Serviceable, while the flashing appears serviceable on the roof some daylight shows through into the attic area and this should be serviced and insure that it is a water proof seal.

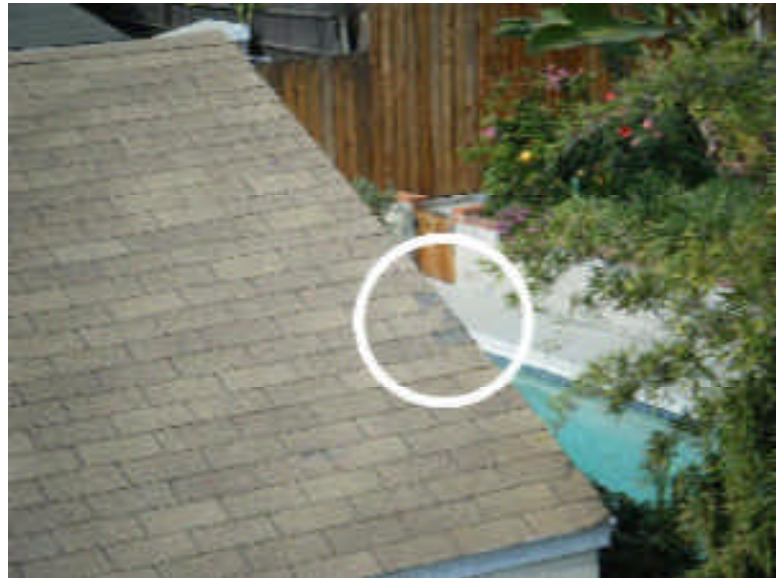
Needs Attention; There is composition roofing which has been installed on top of another layer of roofing. The shingles are not laying flat and are curling a little. This will allow wind damage and other weathering to wear the shingles prematurely.

There are a couple of torn shingles along the right front edge.

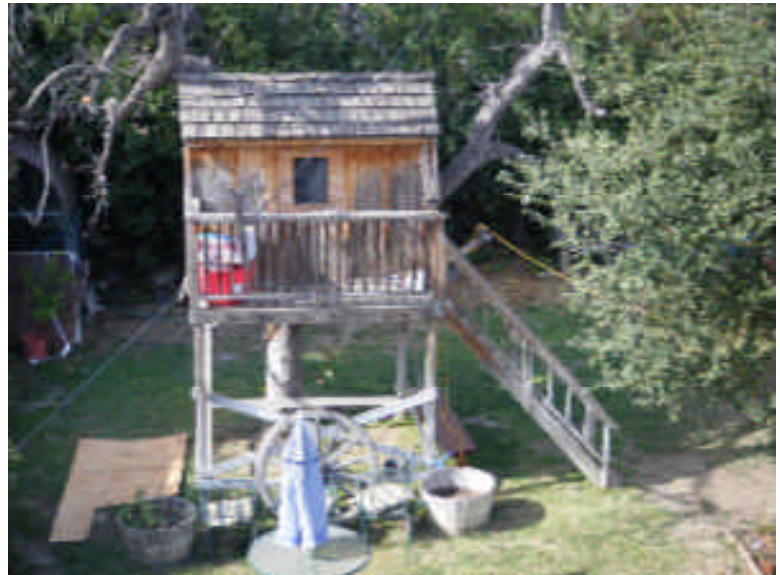
There is a tree house type structure in the back. It is beyond the scope of this general inspection to examine these, but as a courtesy it is noted there is some deterioration to the wood and gaps and wide spaces along the hand rails. This needs some work to make this safe.

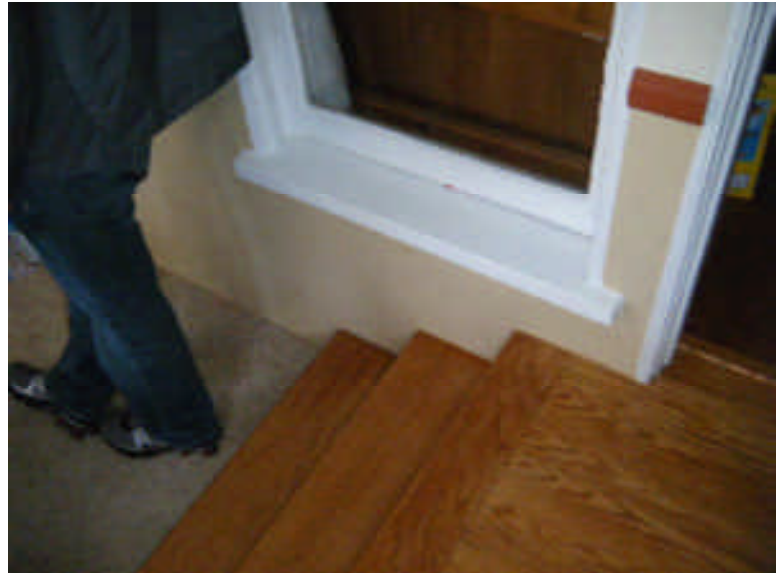
There are panes of glass that are within 18 inches of the floor that do not have safety glass labels. The older windows next the back stairs to the family room appears to be a potential hazard. In newer construction it is required that the glass be a tempered type of safety glass. Making this older glass into safety glass by tempering or putting a safety film on it may not be a requirement for this sale but it is recommended.

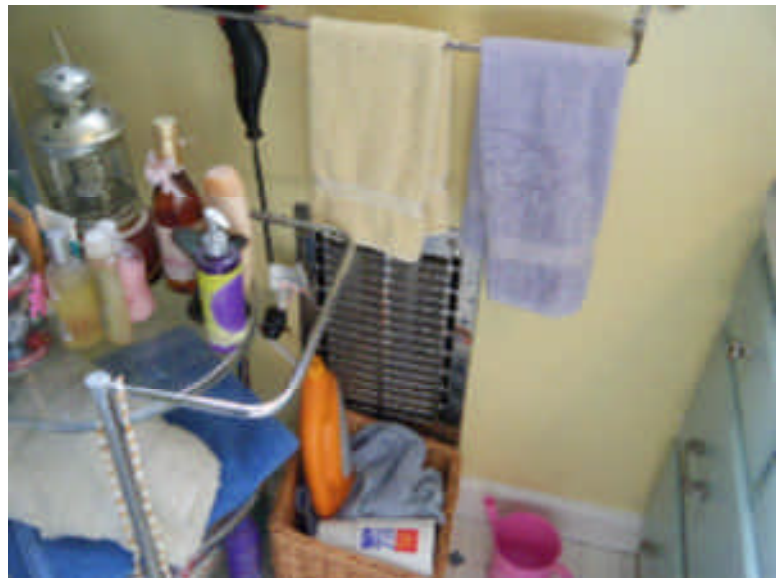
Not Acceptable ; The hall bath wall heater unit trips off the GFCI outlet when turning on even though it is not working indicating there is short ground or short in the wiring. This needs to be further examined and repaired as needed by a licensed electrician.

Not Acceptable: The electric wall heater in the bathroom is not working

These get very hot when in operation and are a potential burn hazard.
