# Real Estate Inspection Report

November, 2009.

## Sample Investors Sale Report

Los Angeles, CA 90064

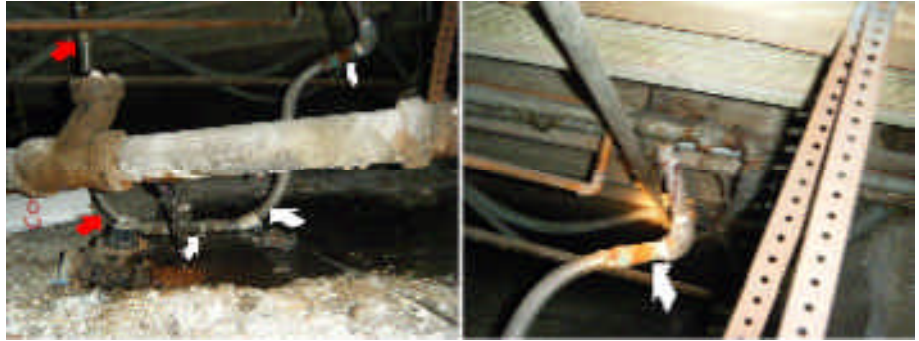
Needs Attention: The water lines are a combination of copper and galvanized steel piping. The original galvanized steel piping that is left in the system has rust and is showing deterioration. Some of the original pipes have been replaced with copper piping as they wore out, which is why there is copper in the system. The remaining galvanized steel pipes will need to be replaced in the future as they continue to wear out.

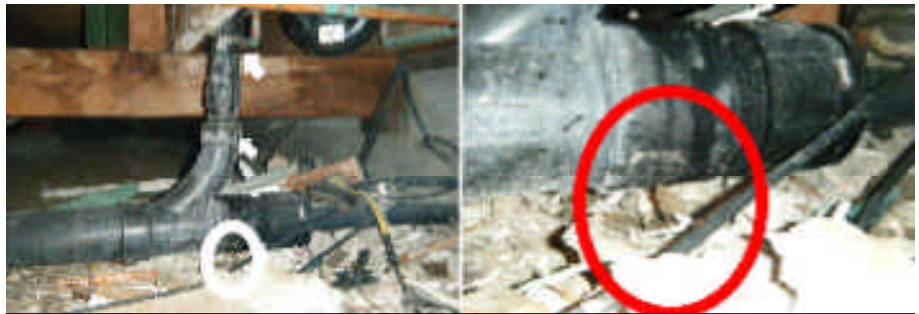
Master bath drain area

**Not Acceptable:** There are several areas of leaking waste lines such as under the master bath, kitchen and Hall shower drains.

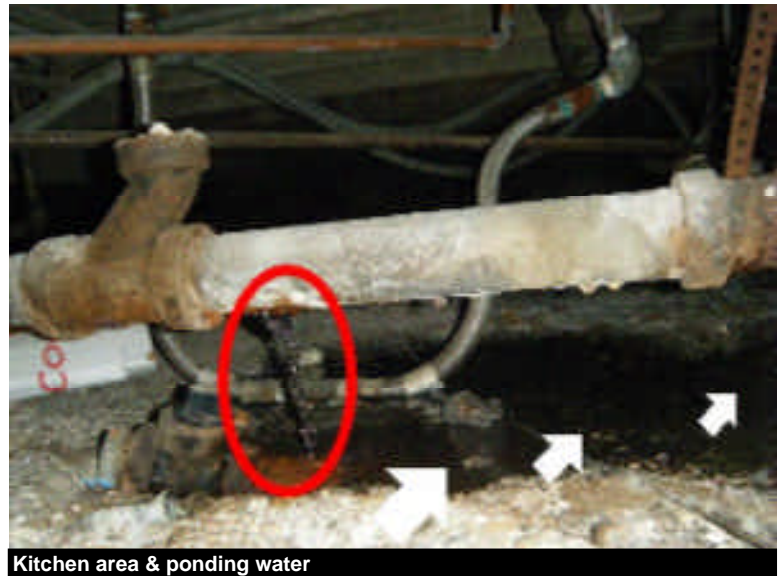
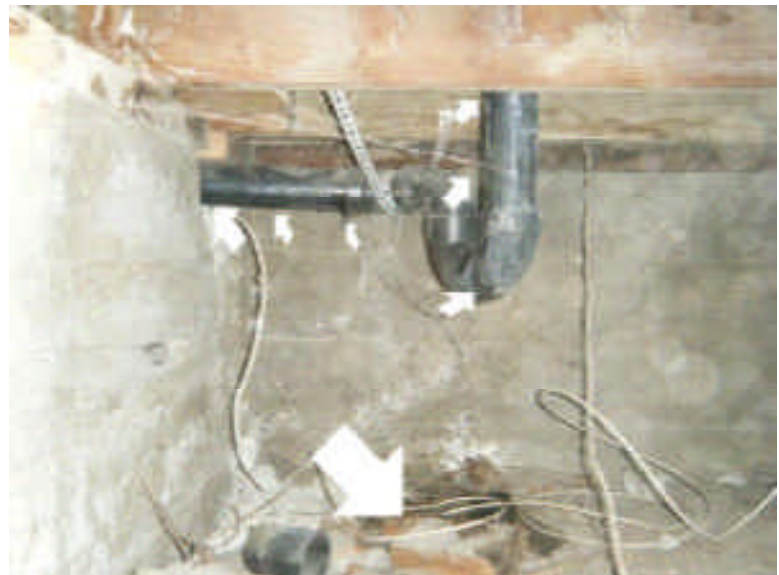
Leak under the hall shower also has the drain line go uphill a little as passes through the concrete stem wall.

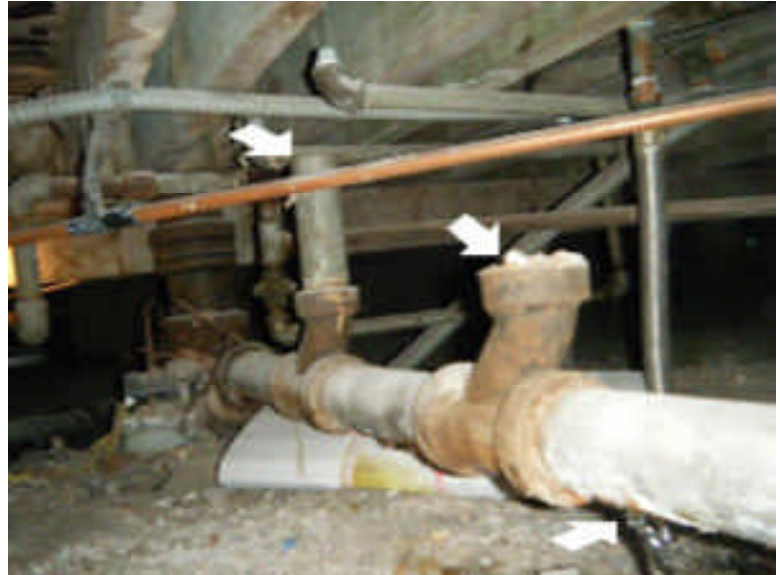
Kitchen drain area has old pipes , rusting and needing repair and some of the old pipes do not appear sealed or capped off properly.

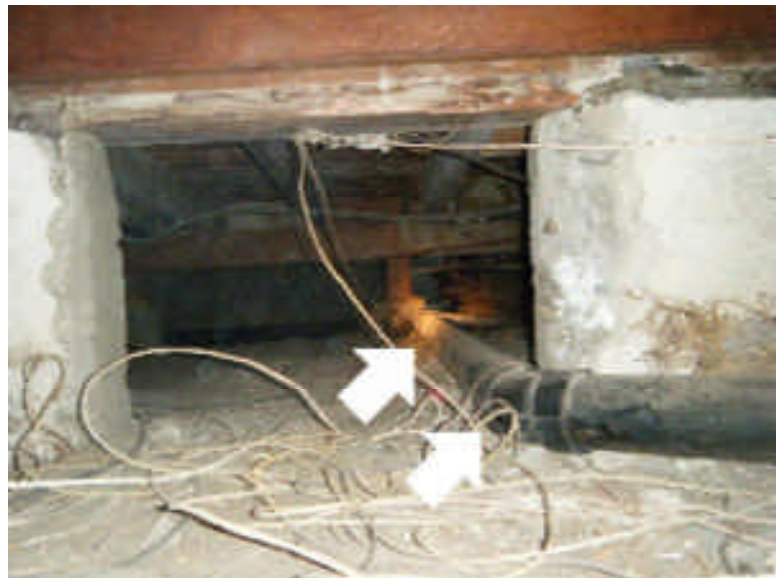
Needs Attention, The waste/drain lines have areas of incorrect slope as the line slopes down and then back up such as at the hall shower drain and there is a very flat area in the middle of the house. This may cause it to block up or fill with sediment and drain poorly and should be repaired by a plumbing specialist.

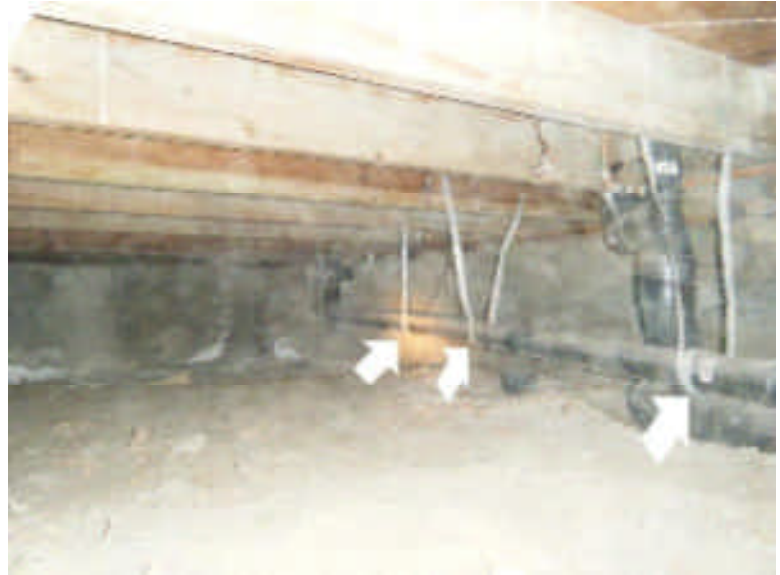
Needs Attention, there are metal straps seen in direct contact and supporting the plastic lines which is non standard and will eventually wear and cut into the pipes.

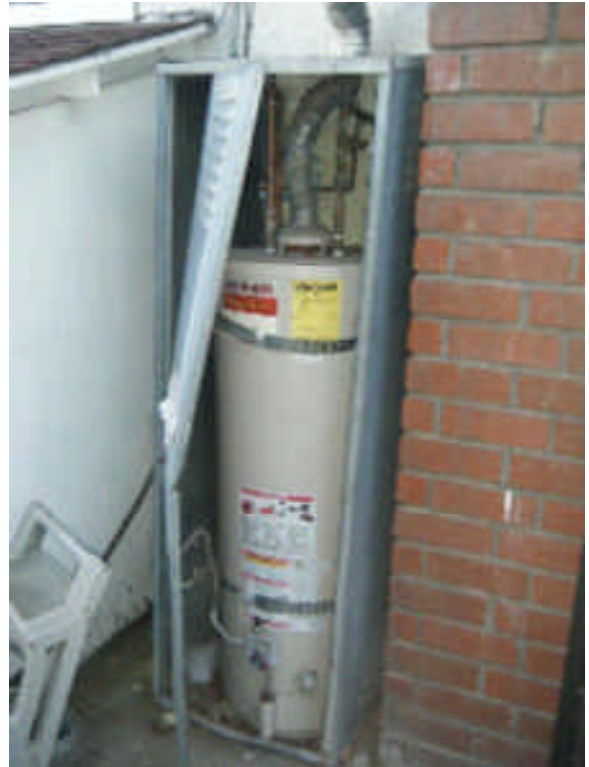
The water heater is located in an exterior closet, at the back.

The metal shed that contains the water heater is in poor condition.

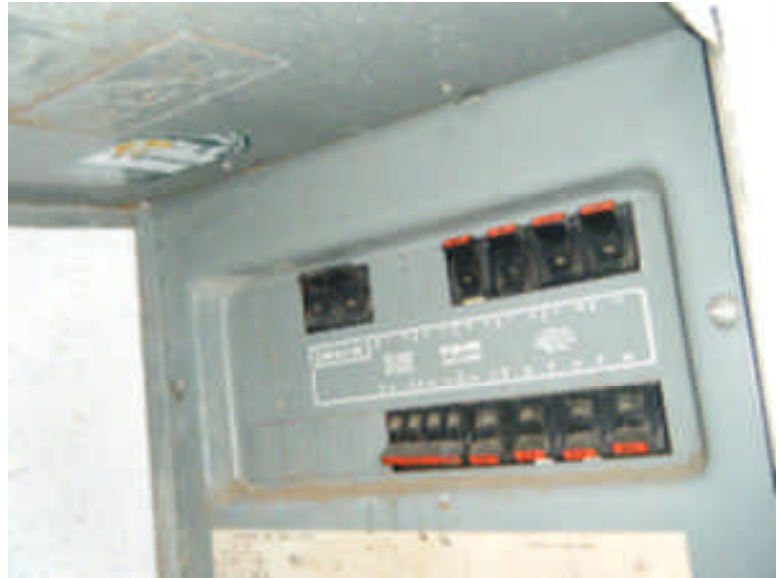
Needs Attention, this is a "Federal Pacific " brand of electrical panel and circuit breakers. This is an older system and they are known for not safely tripping off when they are suppose to and get even less reliable as they get older. Some electricians may recommend to replace the panel if any repairs are needed.It is advised to have an electrician examine the system and verify that it will operate safely.

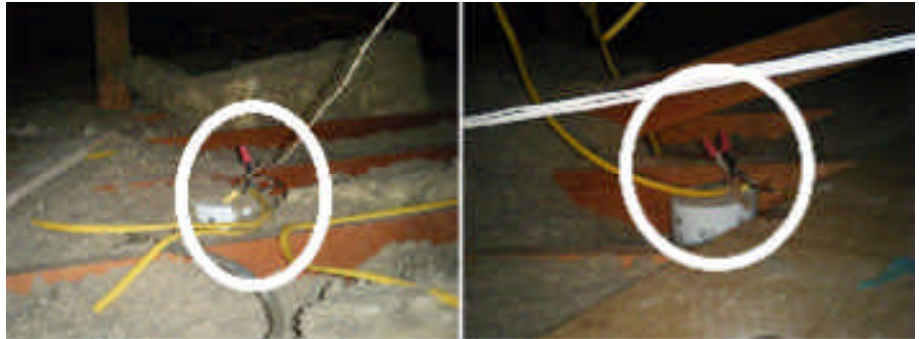
**Not Acceptable:** There are some wiring connections in the building that are not made within junction boxes such as at the lights in the attic area. These connections have exposed wires and are not standard. This is a safety hazard and the wiring needs to be installed properly.

(ADDED NOTE: After the report was done it was found that these older wires had been covered over before the inspection and it is suspect that it was purposely done to hide or camouflage over these older wires and hazards.)

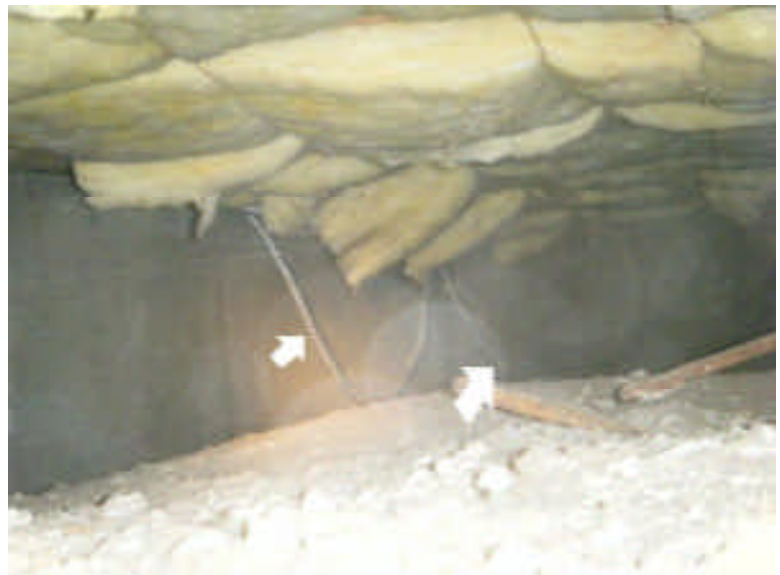
**There are areas of dangling wiring that are not properly secured to the framing such as in the front left corner area. This needs to be further examined and repaired as needed by an licensed electrician.**

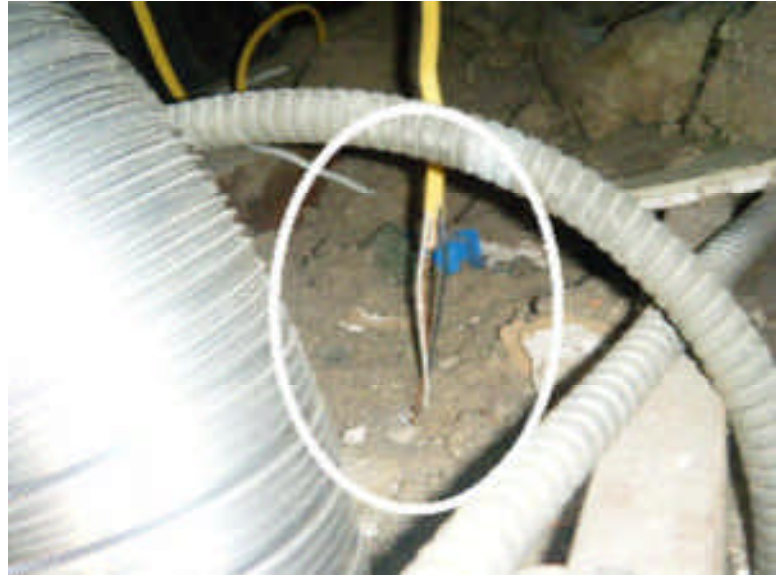
**There are exposed wires in the attic with no wire nut caps and left in a unsafe condition.**

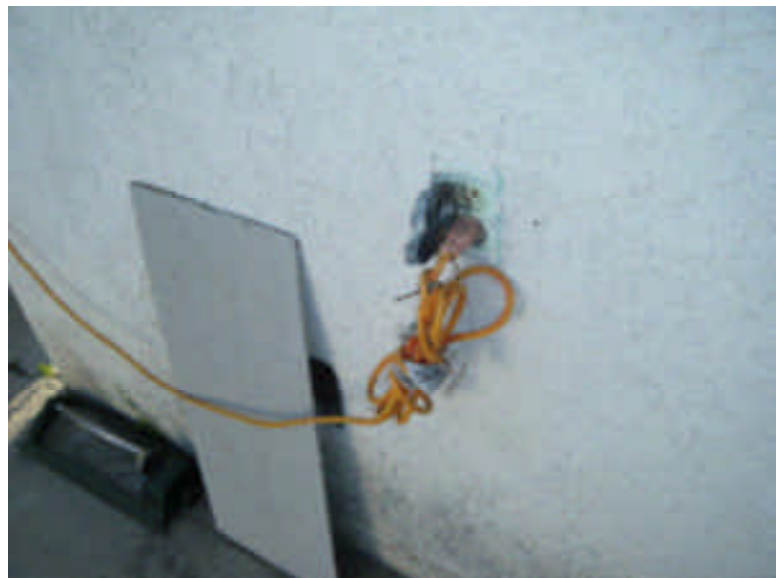
Needs Attention, there is an extension cord plugged in to the back outlet for an out side light. If this is continued to be used it should have a different rain guard type cover

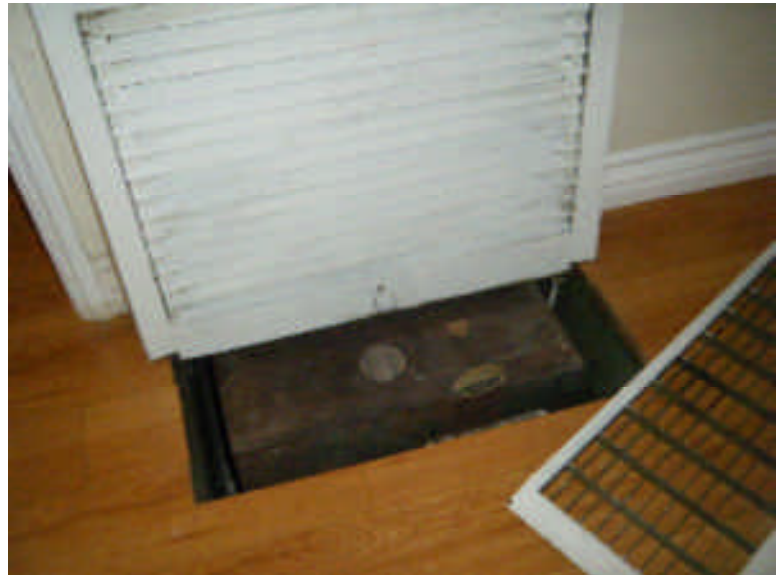
The heating unit is located inside the building in the floor.

There is rust and corrosion in the burner area, this indicates a lack of

maintenance and it should be serviced to ensure that it is working properly and safely. This is older and nearing the end of its expected useful life.

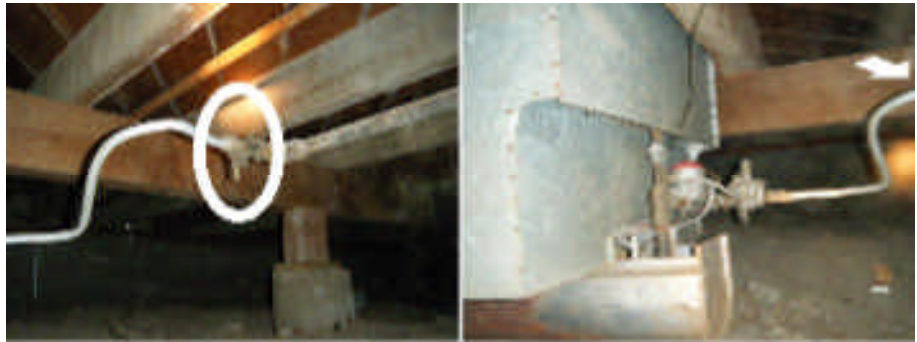
The gas is shut off to the furnace under the house.

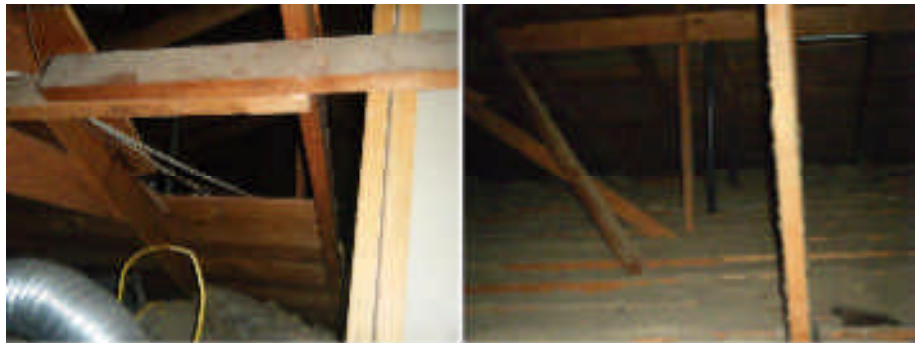
Serviceable where visible. It is noted that the attic was not fully entered and fully inspected since there was difficult access to the back addition area and was just viewed through the opening.

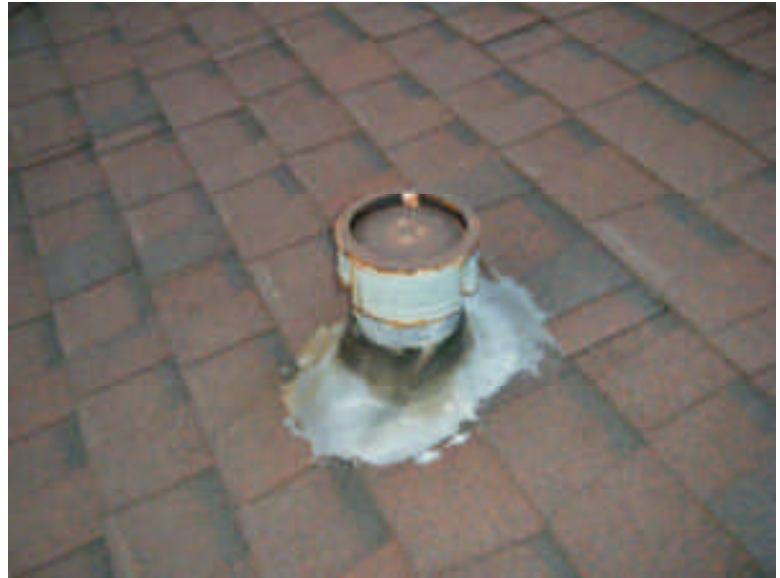
Needs Attention, there is excessive mastic (caulking type material) around the vent pipes and onto the roof shingles. This will will shrink and crack and possibly will crack and damage the shingles. This will require more maintenance to insure it remains leak free.

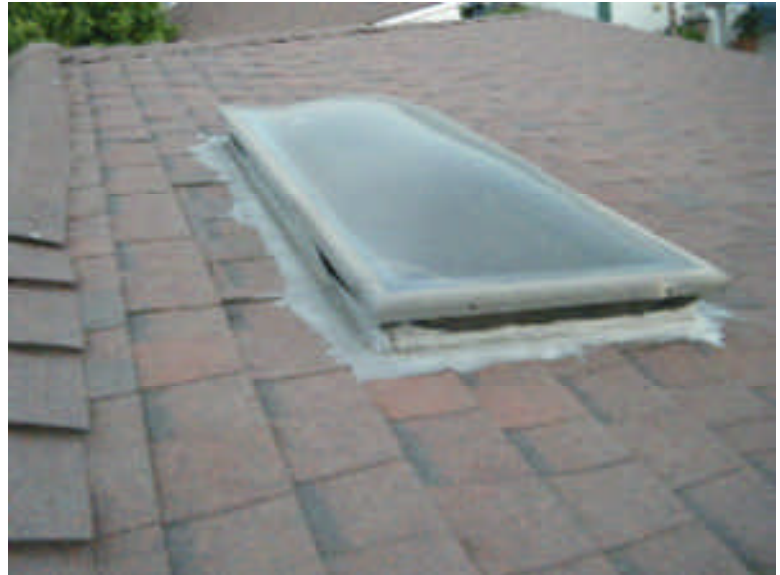
Needs Attention:, there is excessive mastic around the edges.

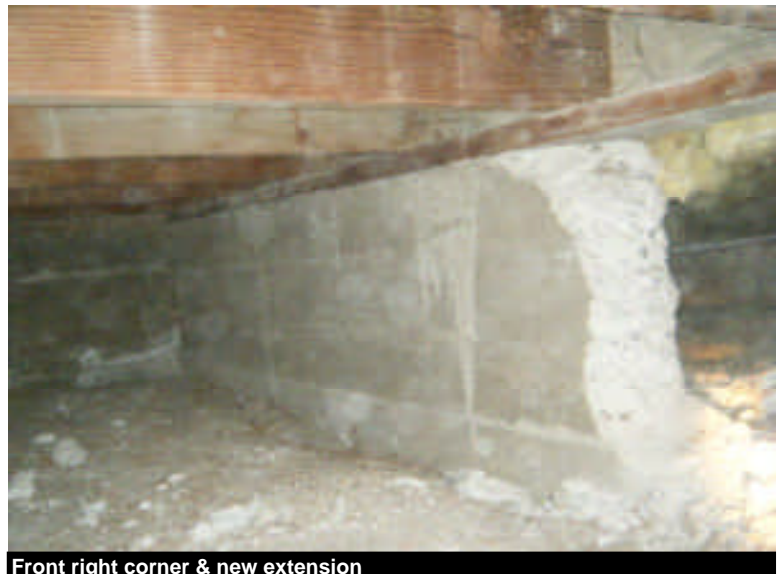
Front right corner & new extension

Serviceable, with typical wear and tear in areas.

However, there is what appears to be a newer section of foundation

and an addition along the front four feet. There are some noticeable humps in the floors in the living room and front bedroom and some leaning and stucco cracking at the right front corner. This appears to be caused from the modifications done but some may be from settling.

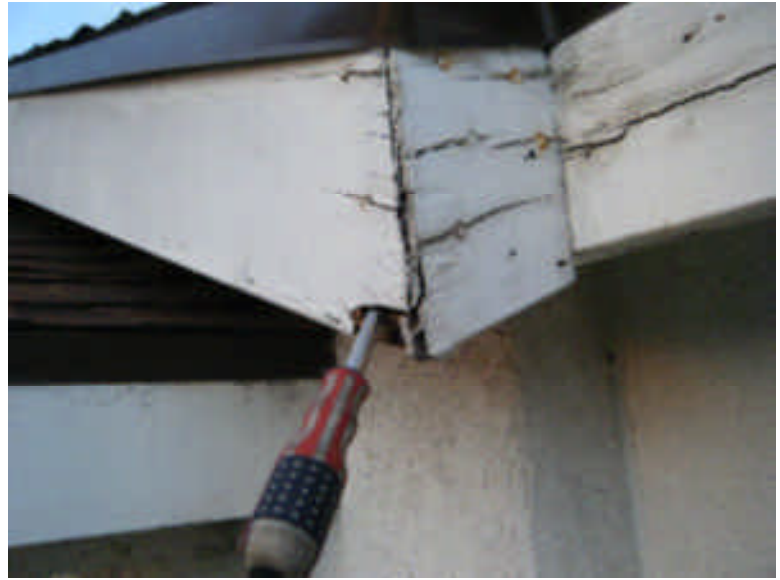
**Not Acceptable: The trim has areas of damage such as at the roof fascia in the front (this is below the valley where the roof slopes come together and funnel the water toward this area), see the pest control report for more information.**

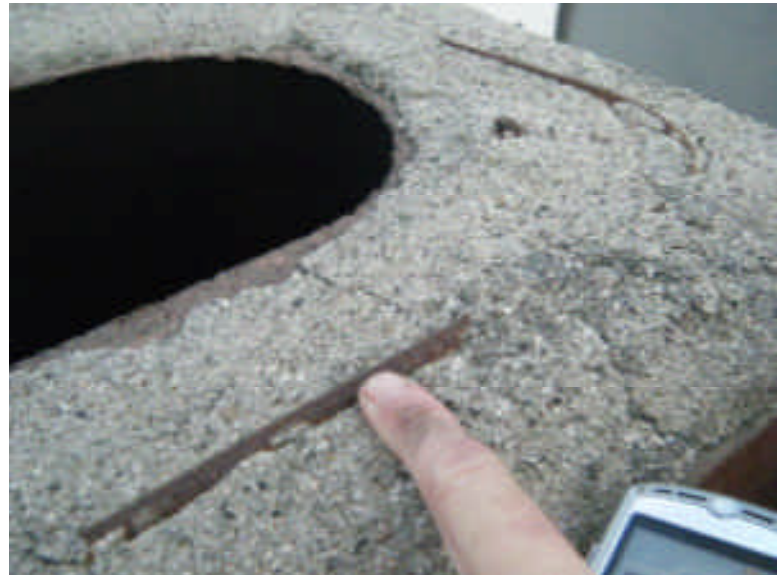
Needs Attention: There are cracks in the mortar chimney cap that need repair. The metal rebar is exposed along the top and will rust and get damaged.

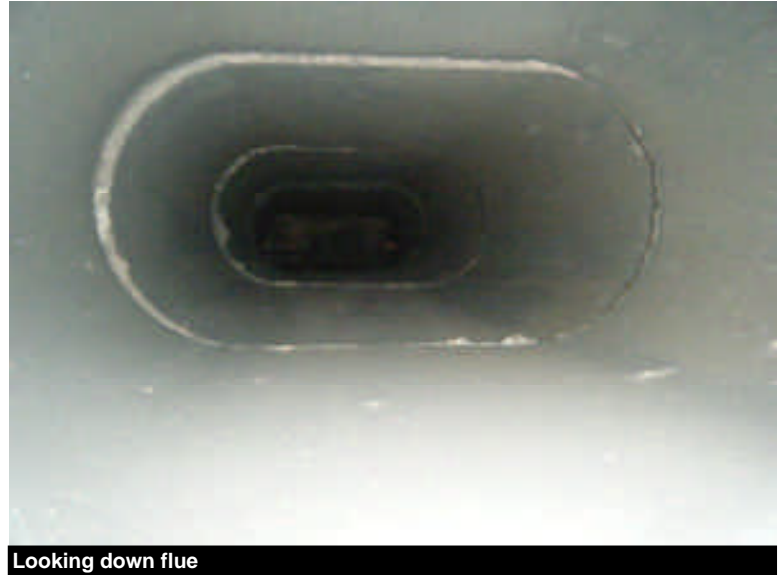
Needs Attention, there is deteriorated mortar seen between the flue tiles.

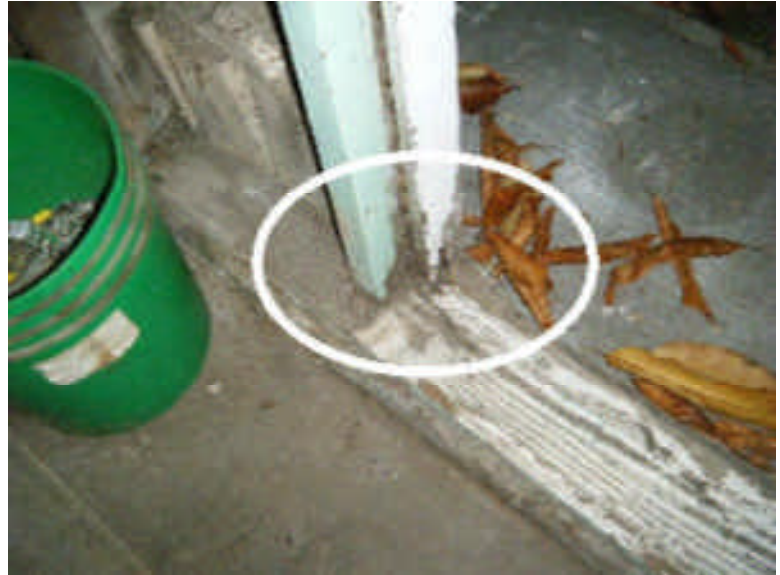
**Not acceptable:, there is rotted wood at the door trim and framing area, see the pest control report for more information.**

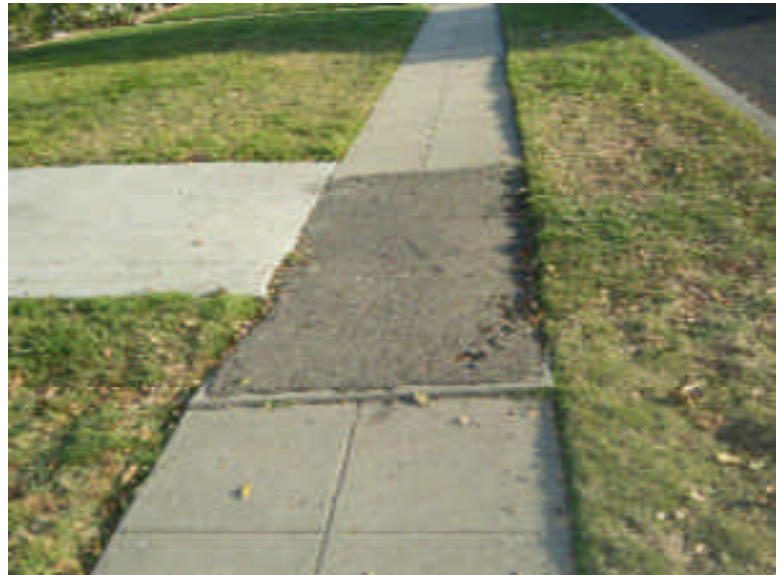
**Not Acceptable:**, there is what appears to be a sink hole at the front and there has been asphalt filled in but there are still some trip hazards.

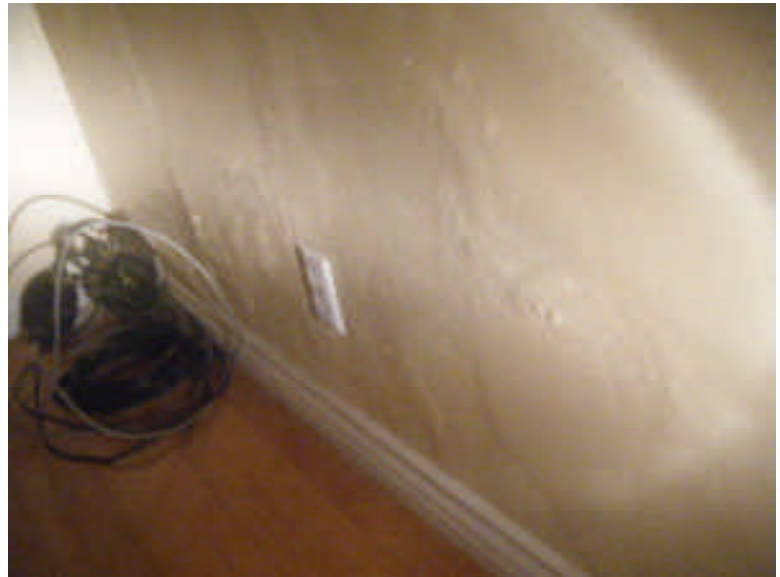
Needs Attention:, there is a patched (poorly done) area in the back wall on the back side of the master bath fixtures.

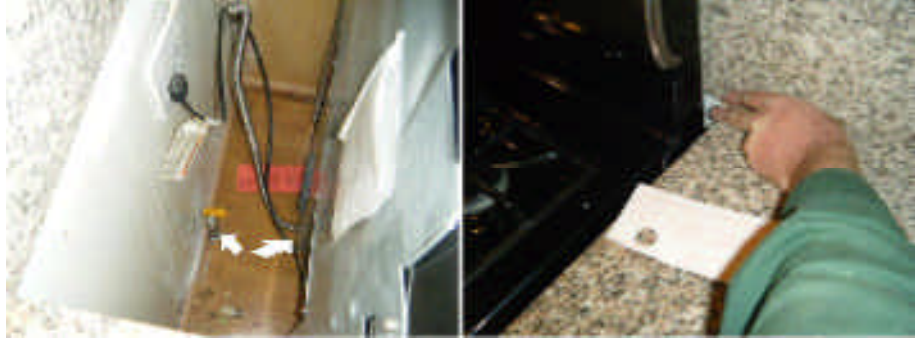
**Not Acceptable, this unit has a "red tag" from the gas company indicating this gas line is capped off and is not connected. This needs to be further examined by an approved professional and repaired to insure this is safe and properly operating.**

**Needs Attention, this gas range does not go all of the way to the back wall. It appears that the gas line behind the unit is in the wrong position preventing this from sliding all of the way back.**

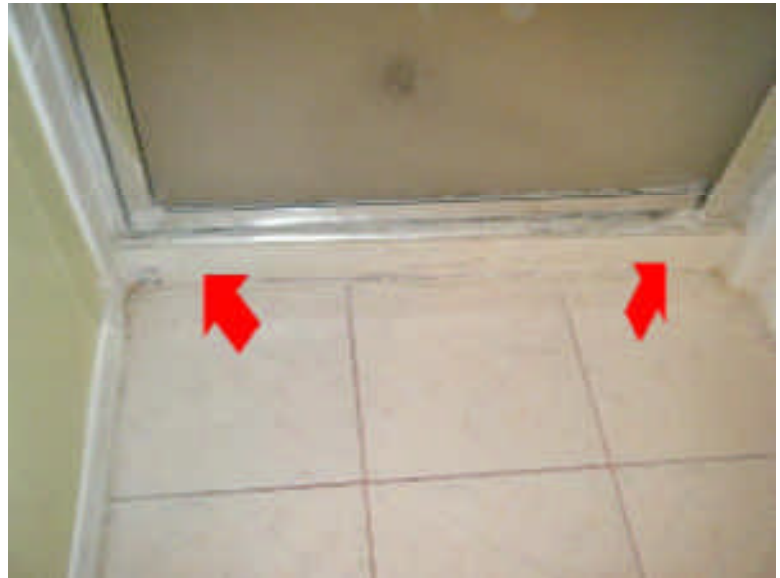
**Needs Attention:**, there is a poorly patched wall section under the shower with some plastic laminate which is not secure when pushed on.

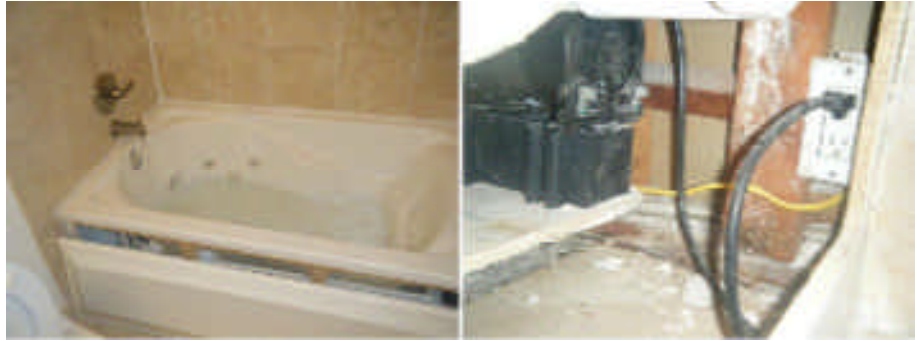
**Needs Attention: There was no GFCI protection device located for the tub motor electrical system. The bonding wire is missing and not connected on the jetted tub.**

**The tub panel is loose and does not secure back in place (the velcro strips have become unglued).**
