Real Estate Inspection Report

SAMPLE REPORT

Beverly Hills (PO), CA 90210

Inspector - Bud Hayes
Confidential and Proprietary
10623 Sherman Grove Ave., Sunland, CA
(818) 951-1795
www.LaRoccaInspect.com

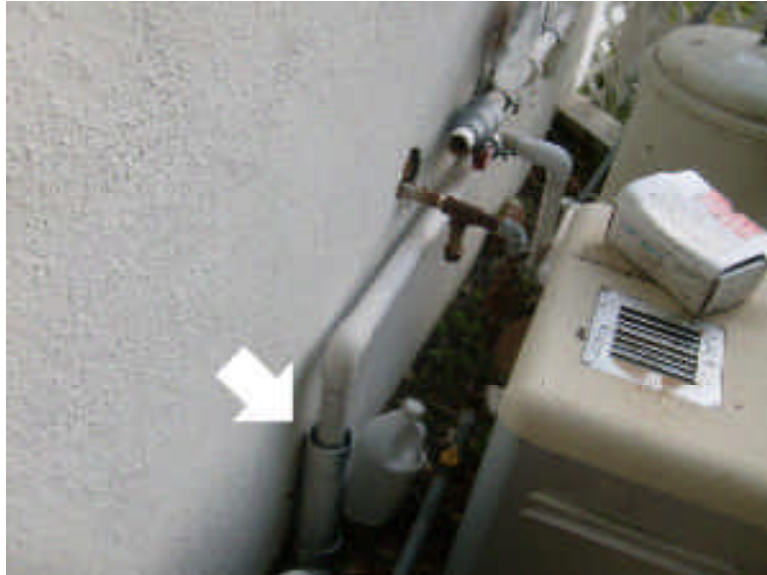
Not Acceptable, the open waste line at the back left side of the guest house has the pool filter back wash drain connected to it.

The clean out access cap was missing on the left side of the house.

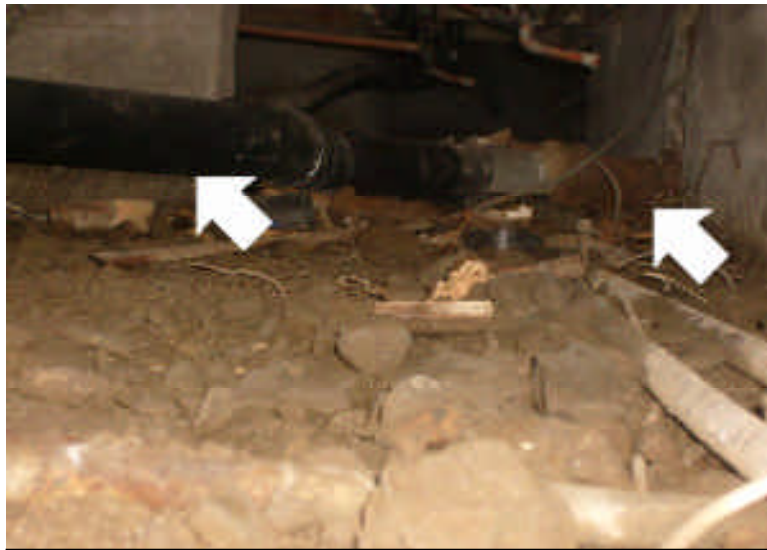
Newer plastic & older rusty cast iron

There are rusty areas on the exterior of the older waste lines. It is not possible to tell when but they will need replacing in the future as they

continue to wear out

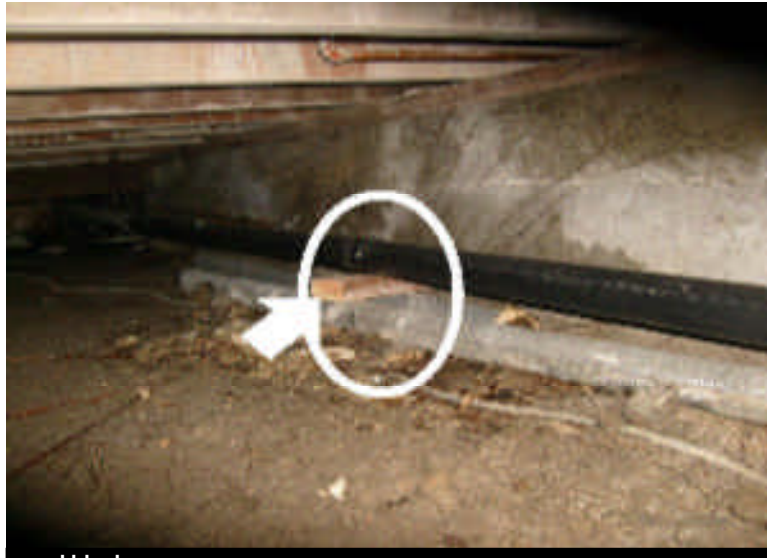
wood block

The attachment of the waste line piping to the framing of the building is substandard and may cause the drains to function improperly in the future (metal straps on plastic and some wood blocks instead of straps are used)

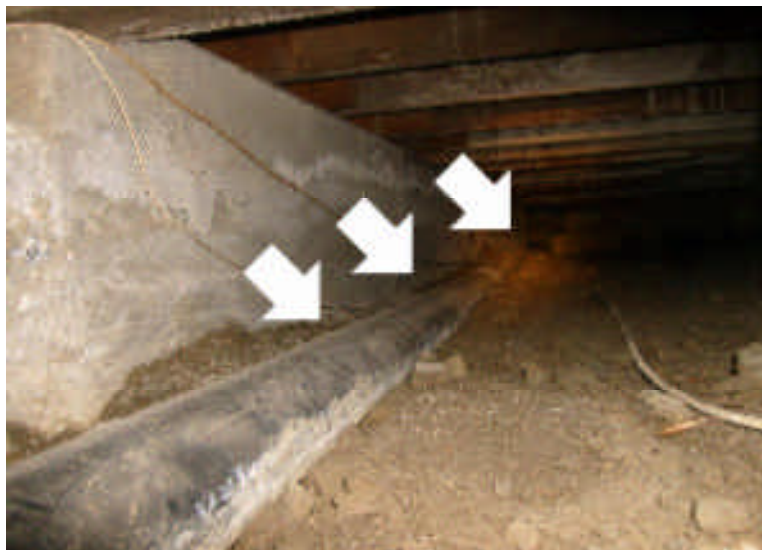
Laying on the ground, uneven, poor slope

The fall of waste line which appears to be the waste line from the guest area is insufficient for adequate drainage as the line slopes down and then back up. This may cause it to block up or fill with sediment and drain poorly.

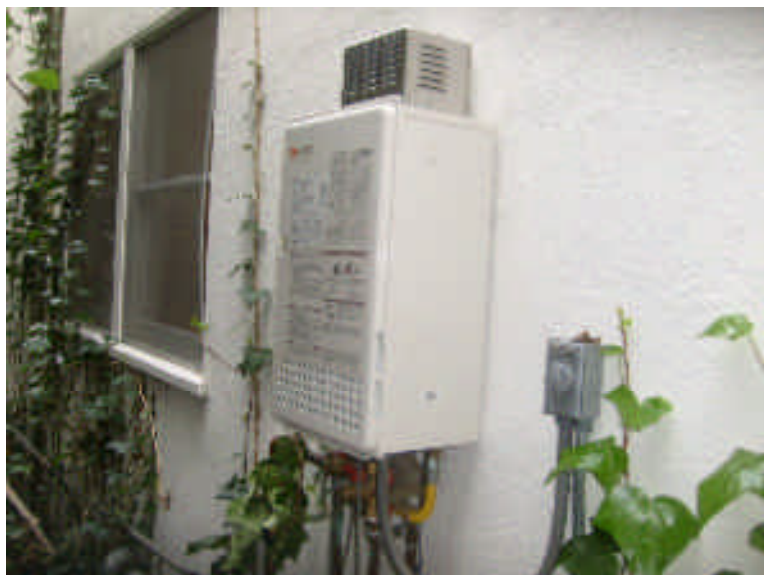
Needs Attention, these tankless units require special installation specifications and it is missing the bonding (grounding) wire between the water supply lines and the gas line and is missing a GFCI (Ground Fault Circuit Interrupter) protective device or outlet.

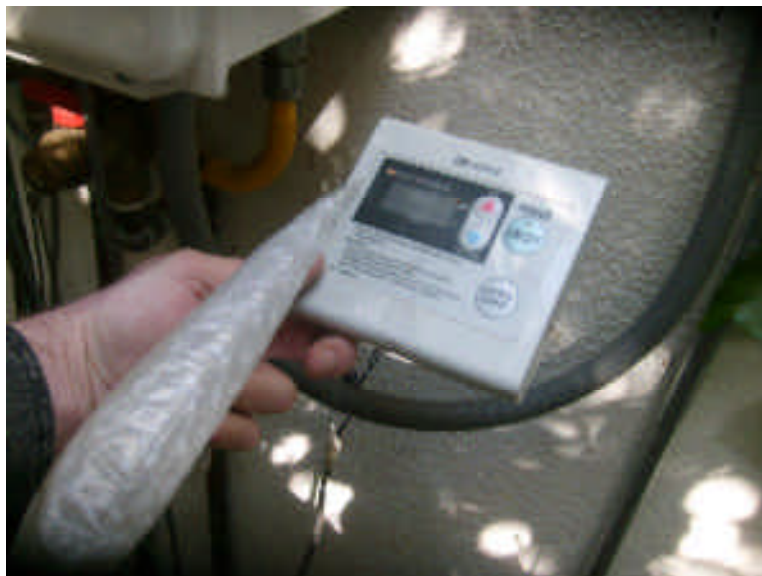
The unit was not turning on until the thermostat control was found loose laying on the pipes under the unit. This is not secured to the building. The owners plumbing contractor was present during the end of the inspection and when mentioned, he reported that this does not have to be installed inside the house per the manufacturers specifications. It is advised to have this properly mounted and the exposed wire connections weather proofed properly.

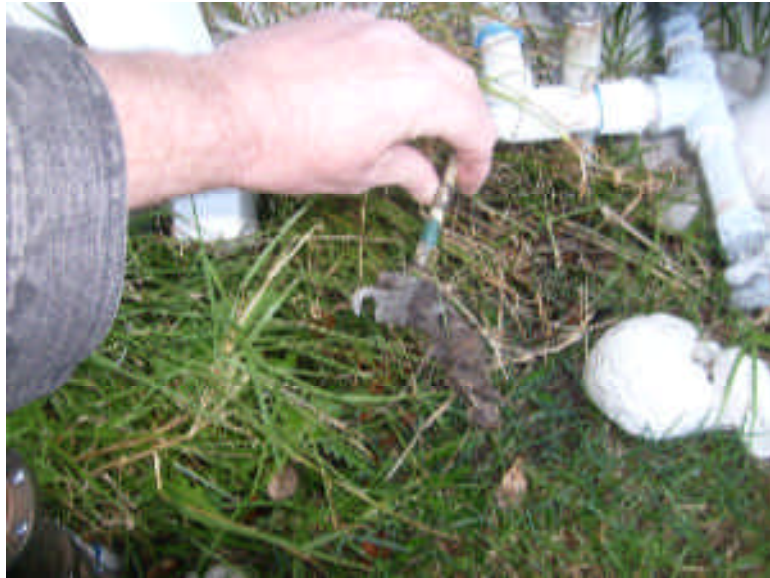
Needs Attention, the grounding clamp to the water line was laying in the ground and was not connected to the cold water line or ground rod. This leaves the system without proper grounding which is a safety hazard.

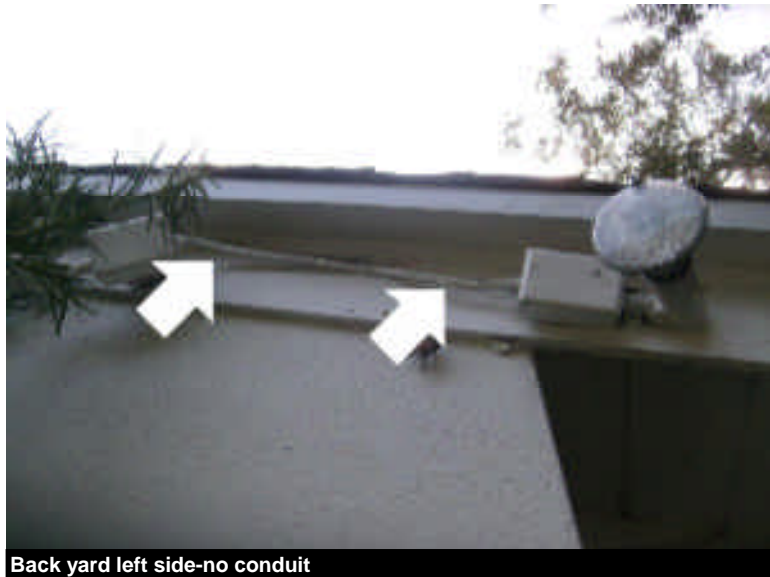
Back yard left side-no conduit

Needs Attention, the non-metallic sheathed wiring, romex, is installed where it is exposed and can be damaged. This is non-standard and needs to be corrected.

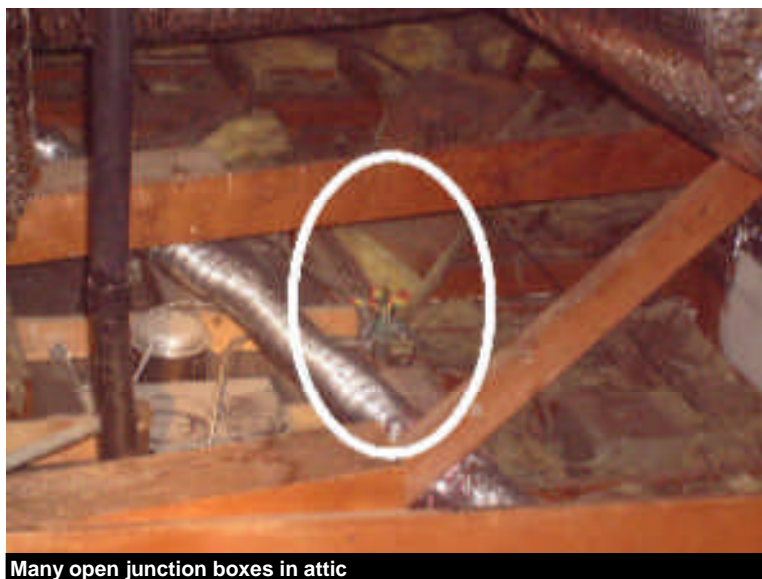
Many open junction boxes in attic

There are open junction boxes with wires exposed. These need to have covers installed over them, in the attic.

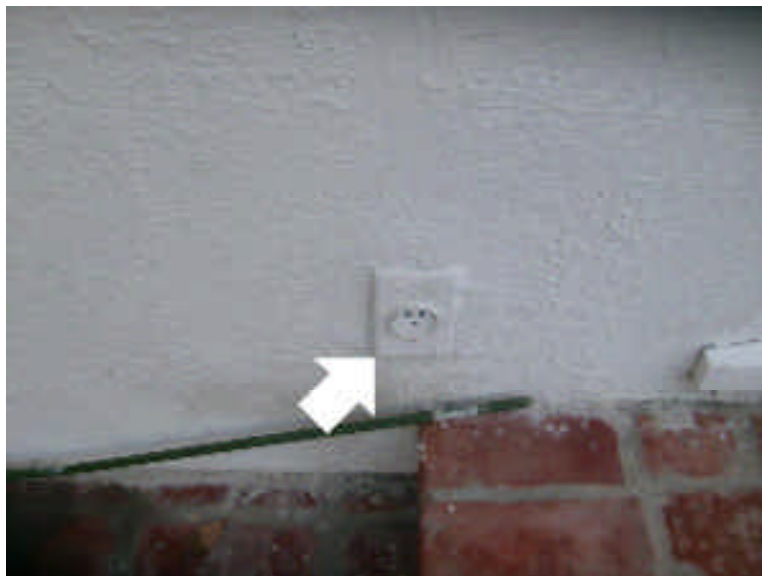
The exterior plug in the back patio and the switches at the pool equipment do not have the proper weather caps.

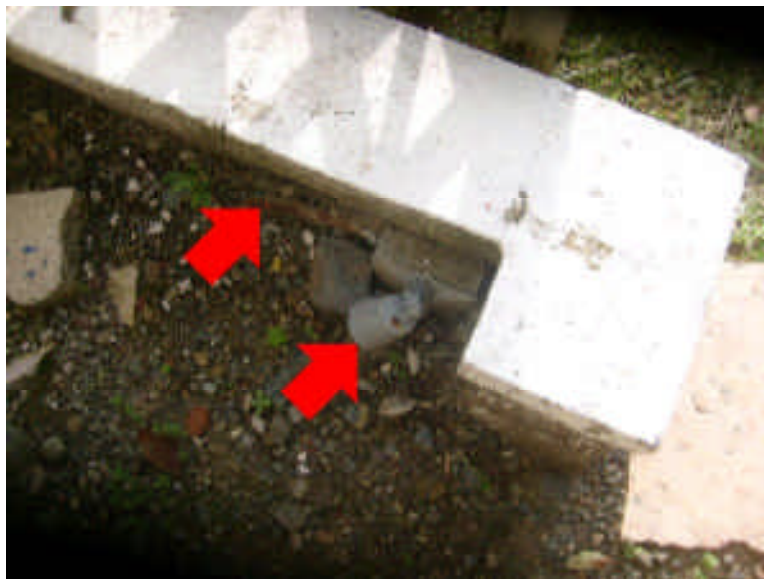
There is an older light which was not seen to be operating and the conduit is very rusty in the back near the pool equipment.

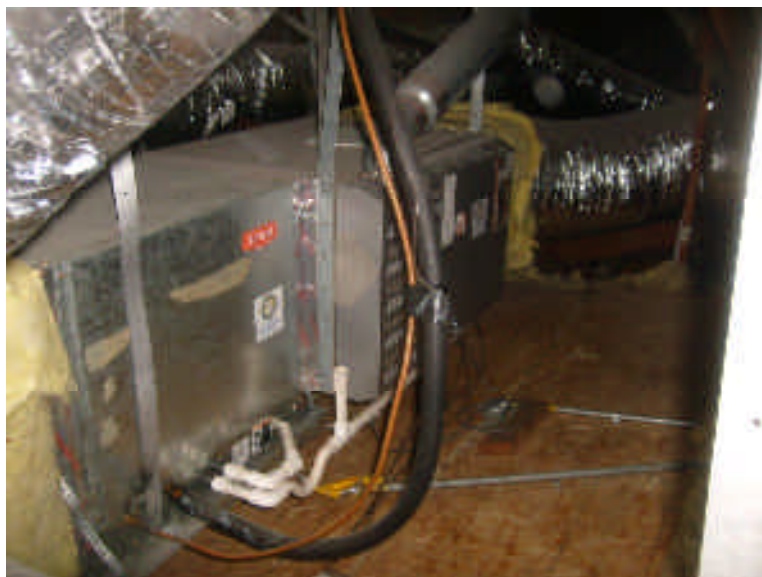
The heating unit is located inside the building in the attic.

Needs Attention, there is no cat-walk installed to access the furnace, this is a standard requirement for safe working conditions around the furnace.

Also, there is no service light above the furnace. This is a standard requirement for safe working conditions around the furnace.

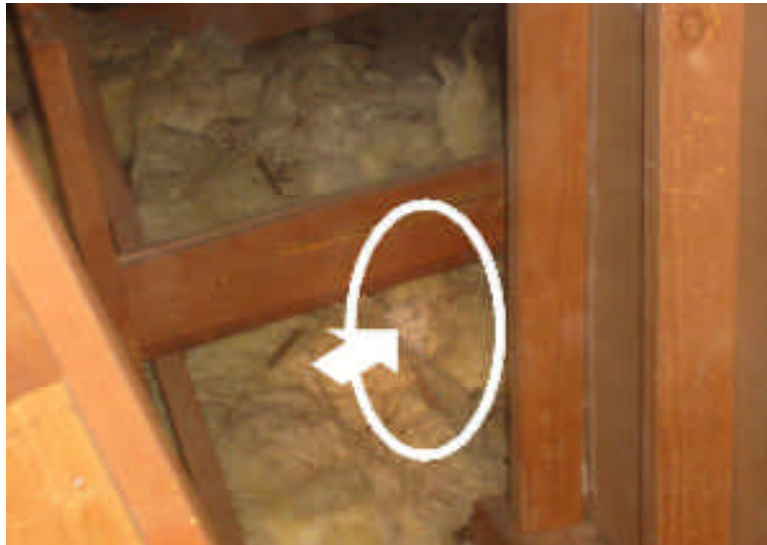
Loose piece of insualtion

Not Acceptable, there are many pieces of loose older insulation, remnant duct connectors and the older remaining connectors where newer ducts have attached have the older insulation which is torn and was not encapsulated properly.

The insulation of the ducts is the type of material that is often found to contain asbestos. It would have to be tested in a laboratory to confirm what its composition is. These torn and damaged pieces of insulation now appears to be in a friable (dusty and breathable) condition.

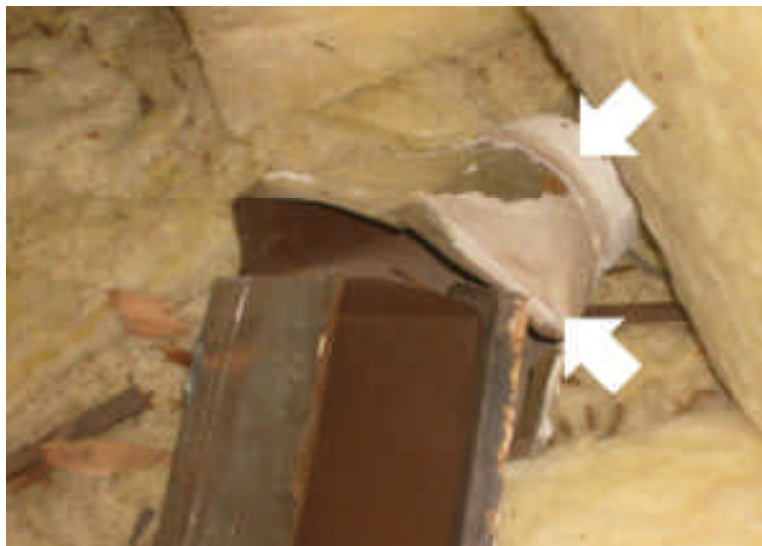
Loose old sections with insulation

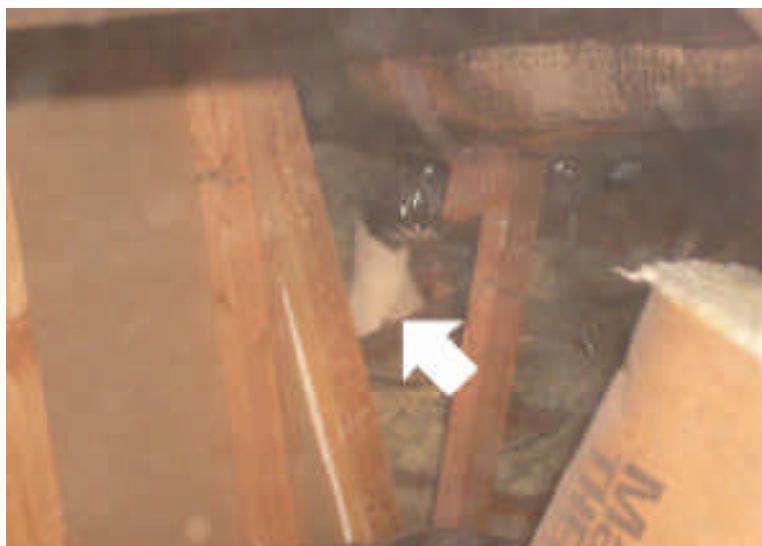
unencapsulated older insulation

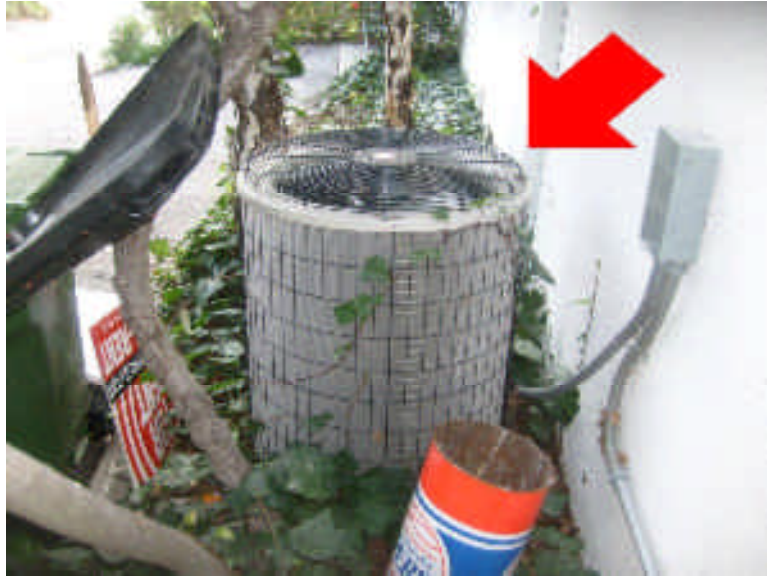
Needs Attention, the condenser is leaning a little and not level. This can cause the system to not operate efficiently and wear out rapidly. It should be positioned so it is on a flat level surface.

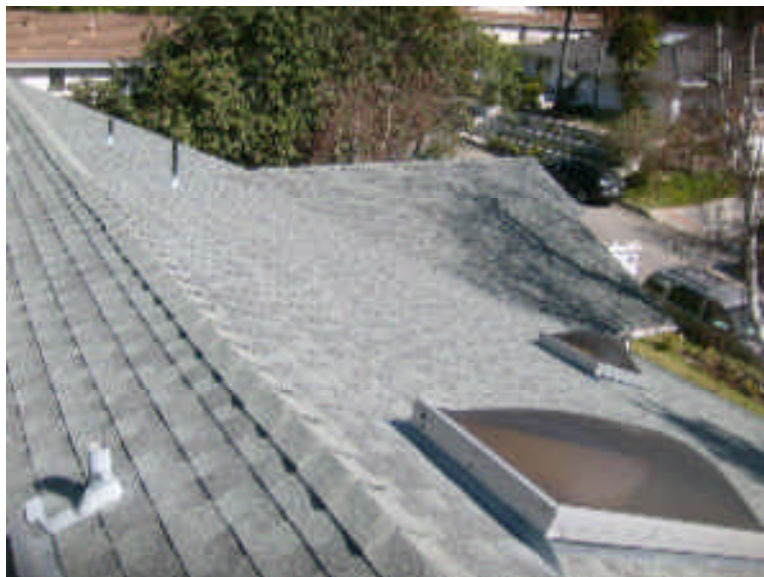
The roof appeared generally serviceable.

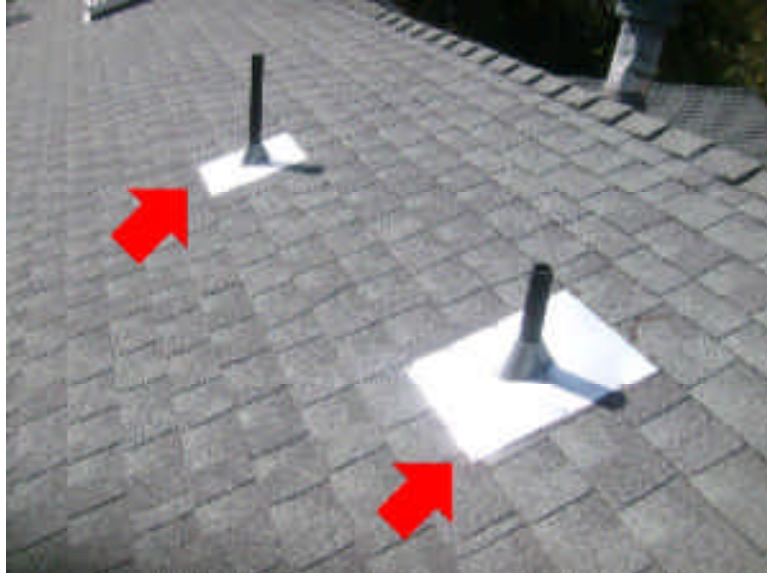
Needs Attention, there are two vent pipes seen which have been added and the flashing is on top of the shingles instead of below them. It will require high maintenance in this state.

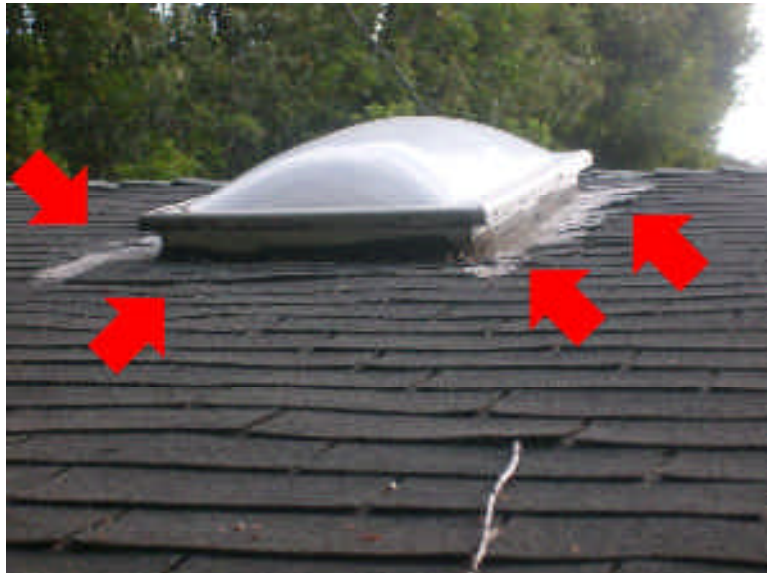
Needs Attention, the guest area skylight, the mastic is deteriorated and worn on the skylight and needs to be checked out and repaired at this time. This appears to have been added after the roof shingles were installed and does not appear to be a reliable.

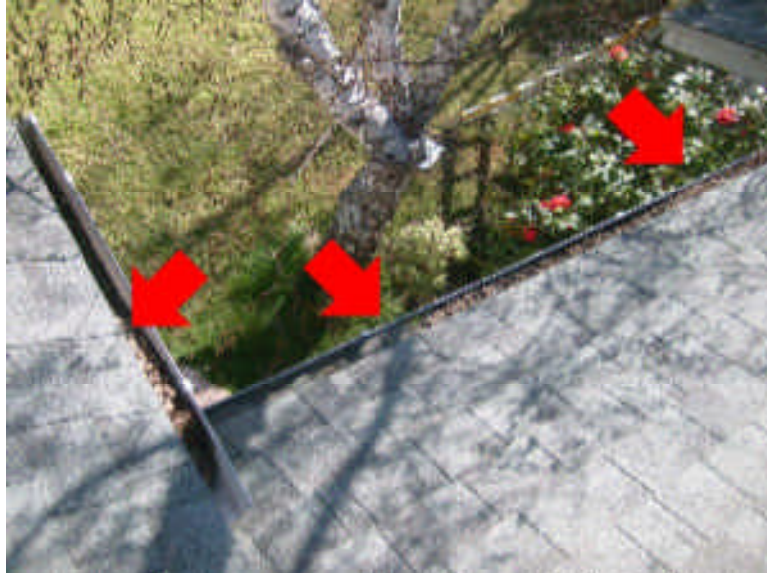
Needs Attention, there are areas where the gutter system is filled with debris and needs to be cleaned out. This includes all accumulated roof debris on the roof itself.

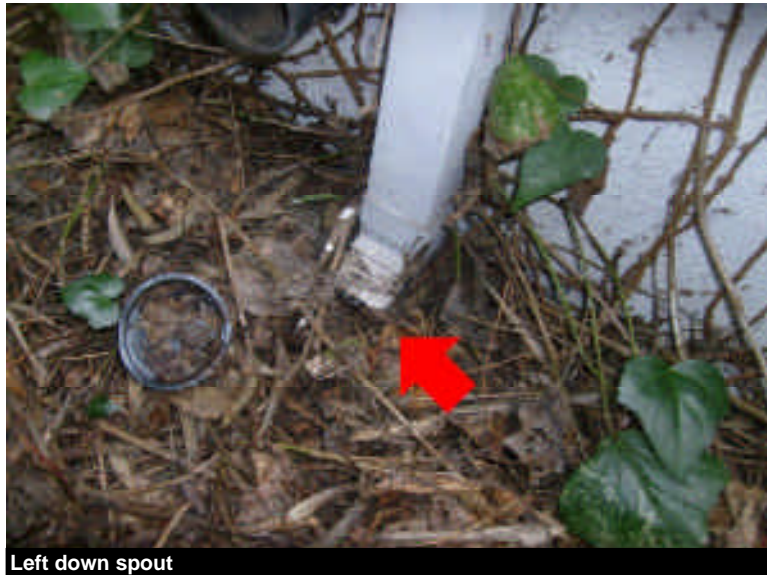
Left down spout

Needs Attention, the left downspout and the front down spout are buried in the dirt and will not drain properly.

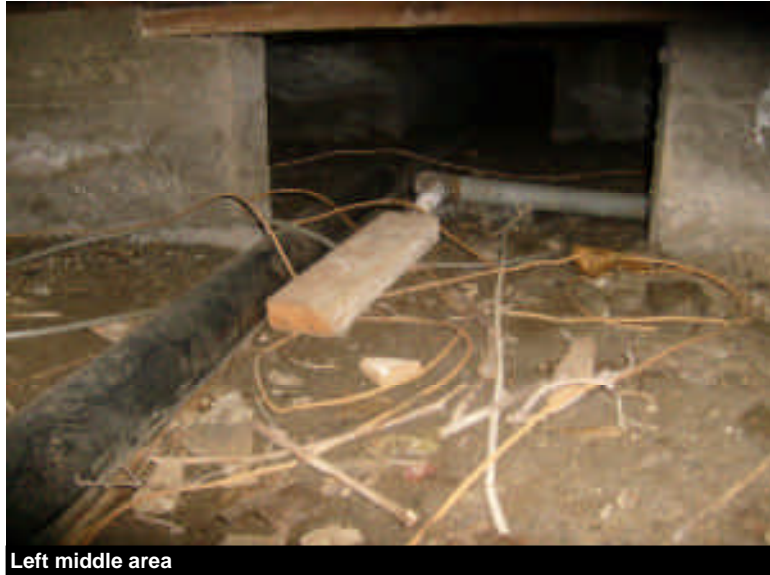
Left middle area

Needs Attention, the crawl space has debris in it, it is advisable to have it removed and the area cleaned up. Wood / cellulose especially should be removed to help prevent future infestations.

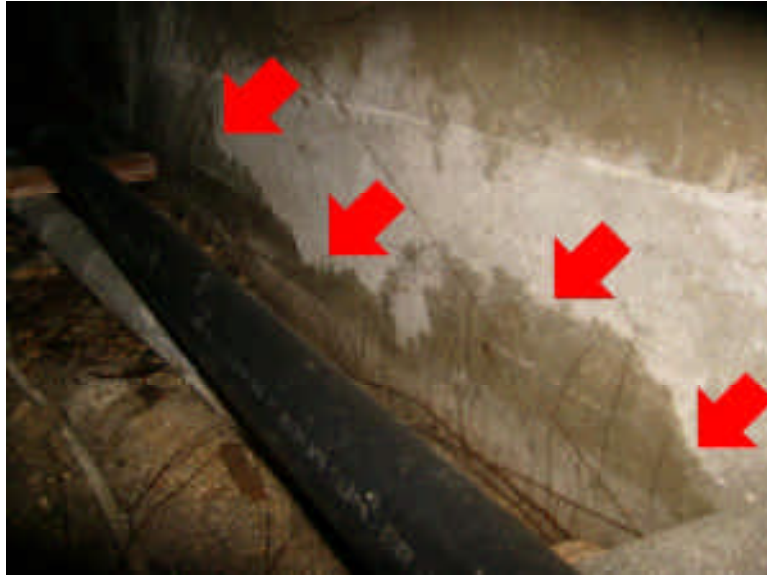
There are areas of excessive dampness in the soil under the building. The soil gets damper and darker closer to the front on the right side. There is no obvious source of this moisture intruding and appears to be percolating up from below and a result of the water table. This property has a large hillside behind. Moisture can be seen wicking up the concrete foundation area (some fine plant roots are also growing up on the concrete). See the ground section of the report for more details and recommendations.

Note: This may cause the building to feel damp and create the growth of mold and/or mildew. It is typically advised to have this examined by specialists to have the source of the moisture detected and any needed corrections performed plus any growth properly abated

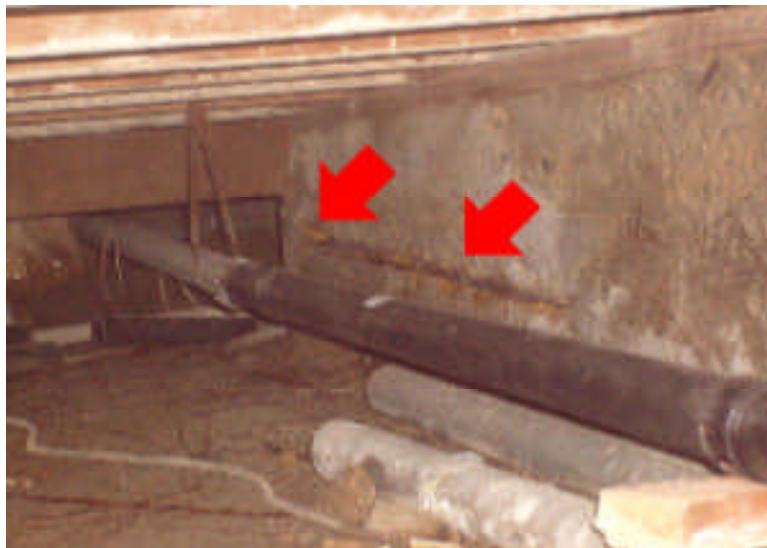
Rusting exposed rebars

Not Acceptable, there is some rusty steel rebar seen in the front middle stem wall. This is the area where moisture is wicking up the

concrete. Moisture penetrating the concrete can rust the steel bars, then they expand as rusting and crack the concrete/foundation. This compromises the integrity of the structure.

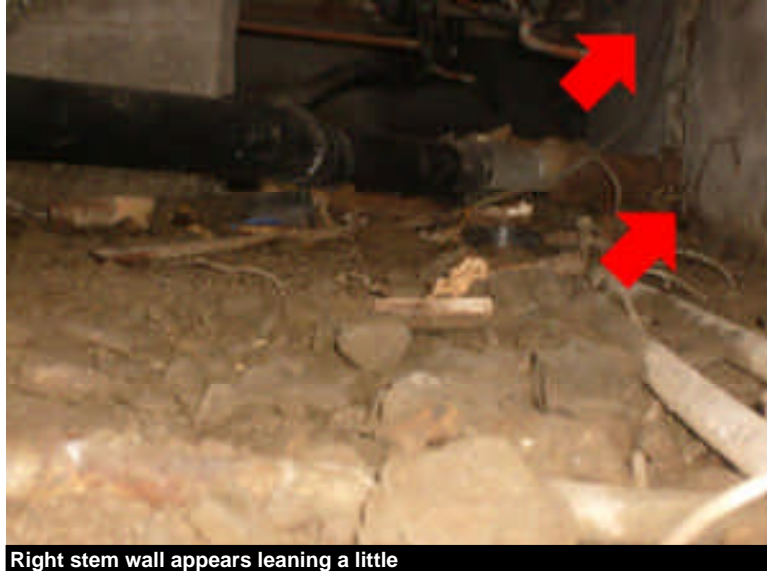
Right stem wall appears leaning a little
This area of damp soil also is showing the stem walls leaning a little and the sloping floors in the front hall indicate some settlement has occurred.

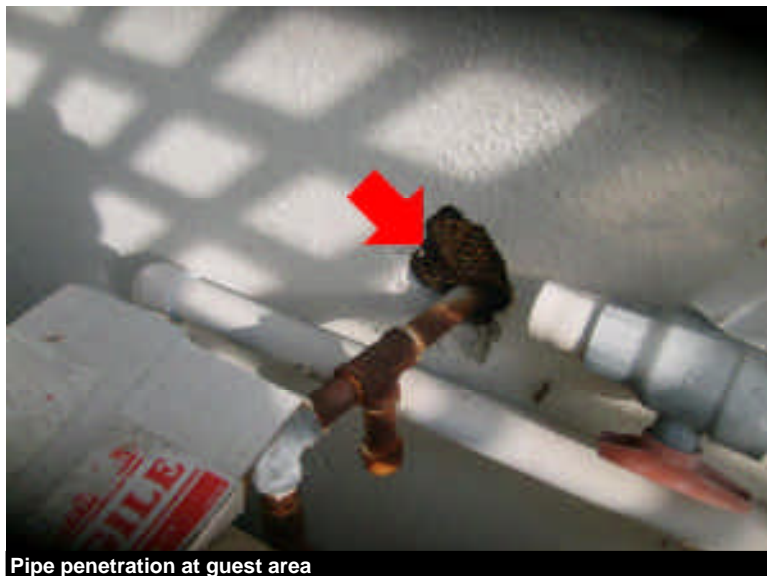
Pipe penetration at guest area

Needs Attention, there are several pipe penetrations which are not properly sealed such as along the left wall and at the back guest house area near the pool equipment.

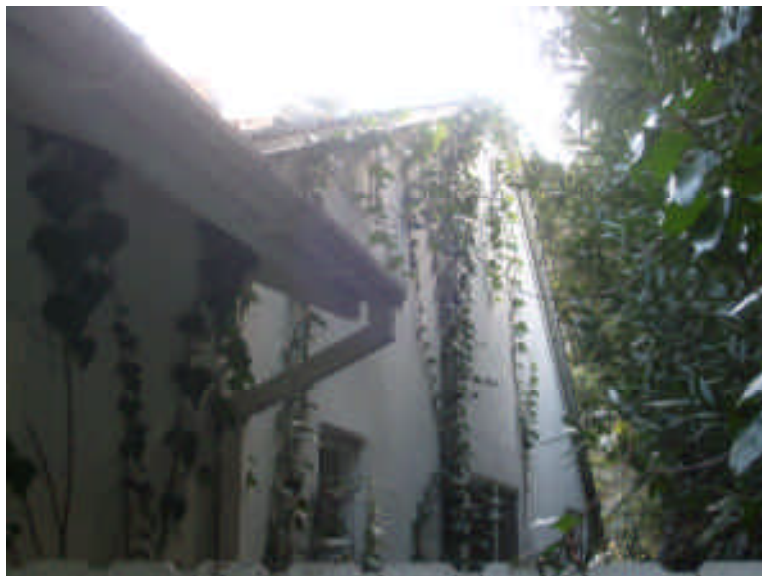
The exterior of the building has vegetation growing on it such as on the left side. While this may be attractive it can deteriorate the covering of the building over time.

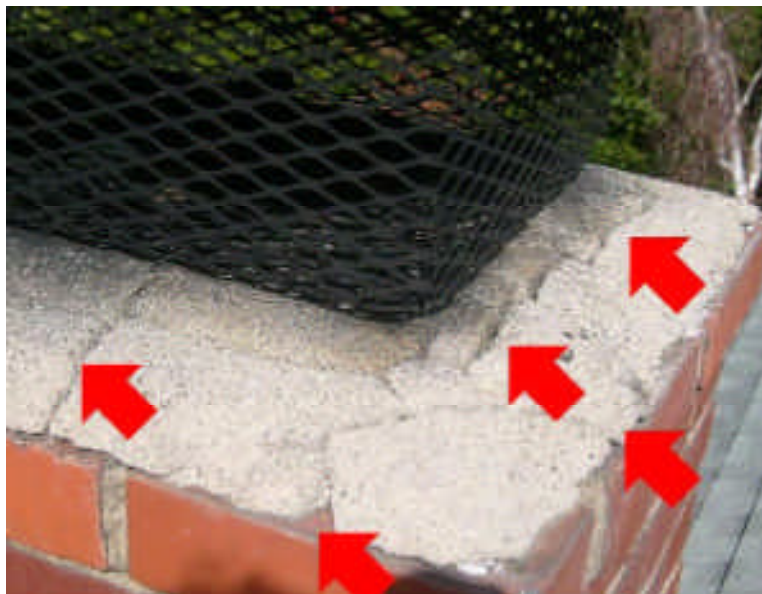
Needs Attention, there are cracks in the mortar chimney cap that need minor repair.

There is some deterioration seen between the flue tiles on the back flue.

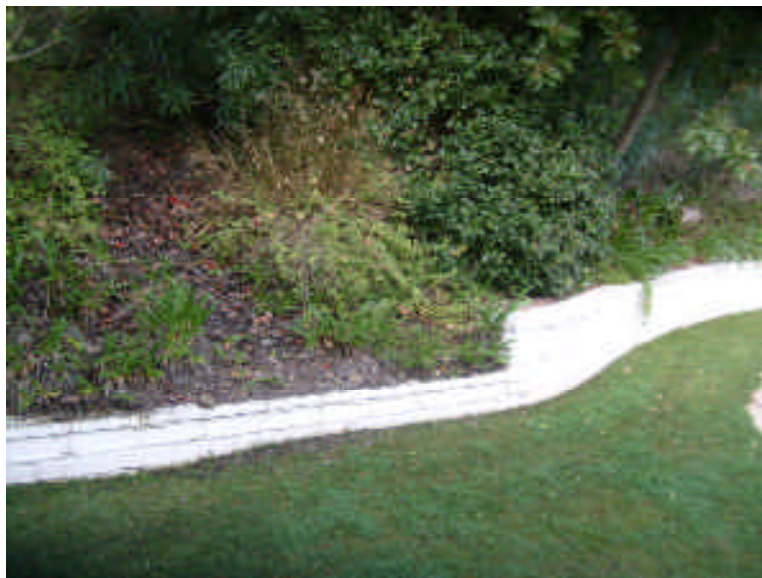
Needs Attention, there is a short retaining wall in the back behind the pool area and there is dirt eroding down the hill and piling up behind the wall. There should be free space behind the wall and this has been filled in and should be cleaned out.

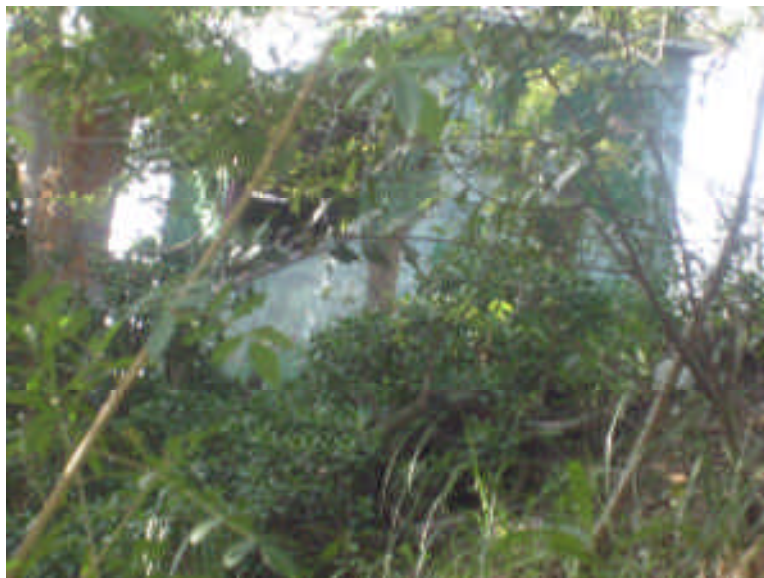
There is an older deteriorated shed in the upper back area. It is beyond the scope of this general inspection to examine this but it appears old and possibly unsafe in its current condition.

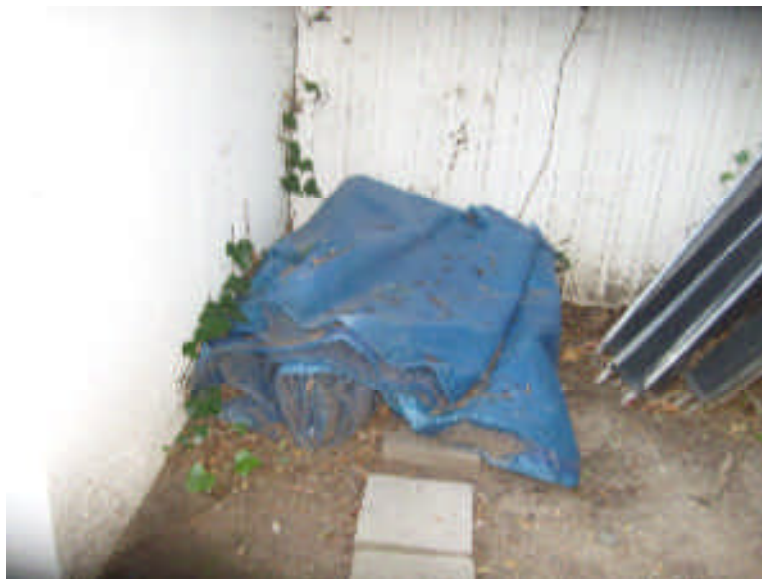
There is a solar blanket in a pile on the back left part of the house. There is some visible wear showing on part of it. Check with the owner for more details.

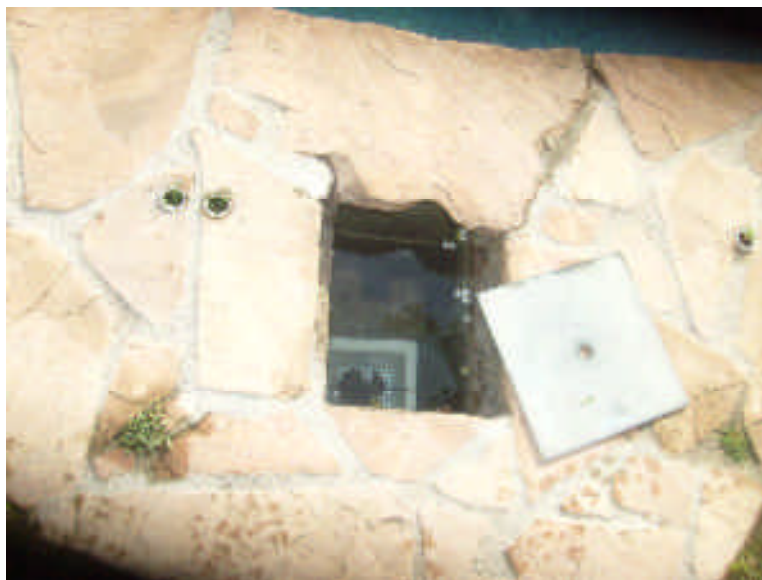
Needs Attention: The weir door is missing from the skimmer basket and no skimming action is taking place because no surface tension is being created.

Also, there was not a normal amount of suction observed and this should be checked and serviced.

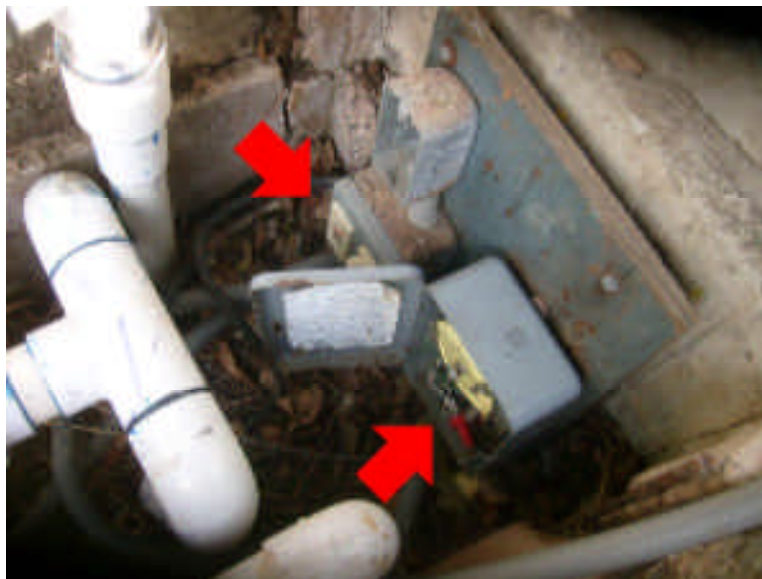
Needs Attention, the timer box has a missing plastic cover guard inside it. The electrical wires are exposed to contact in this condition and it is recommended that this be re-installed.

The switches and the GFCI protective device are exposed to the weather and do not have a proper weather cap/guard.

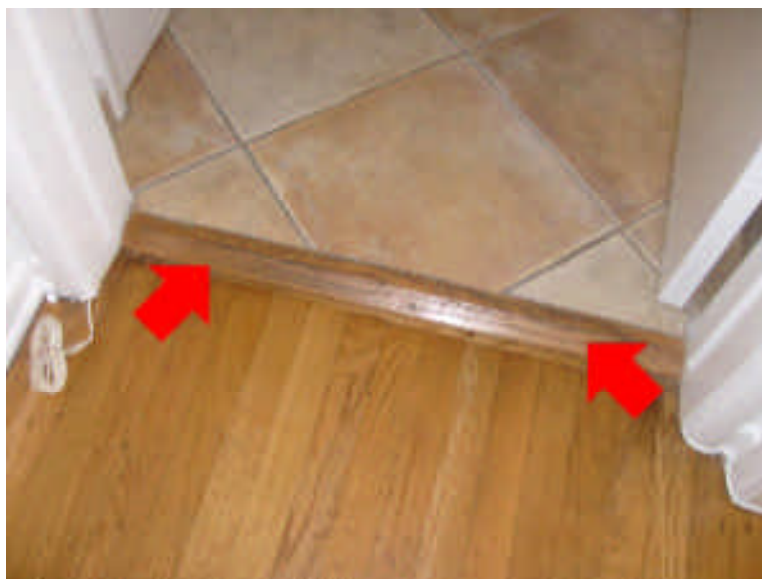
Needs Attention, the threshold at the kitchen tile floor to the hall and dining area is steeper than typically allowed and is a trip hazard.

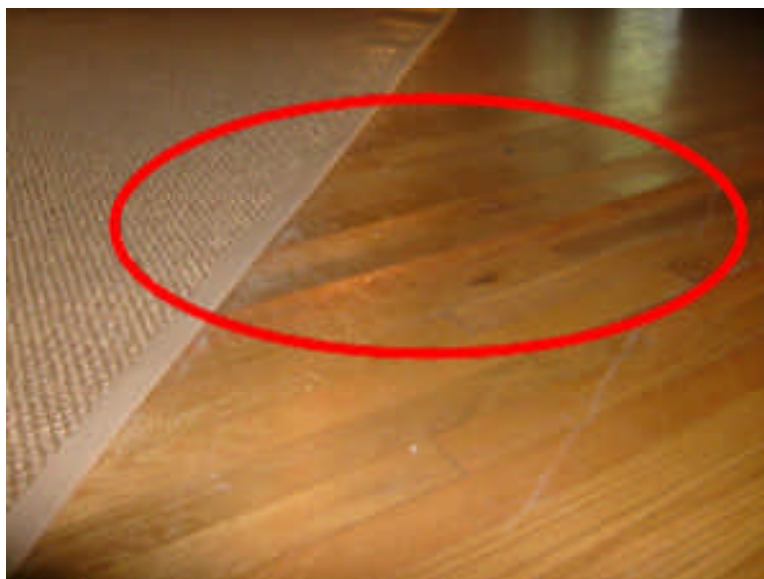
Needs Attention, the hardwood flooring is cupped in areas such as in the middle of the living room, this is usually due to moisture (it was reported by the owner there had been a plumbing leak under the house in this area). It usually will not go back to its original position and be completely flat without refinishing.

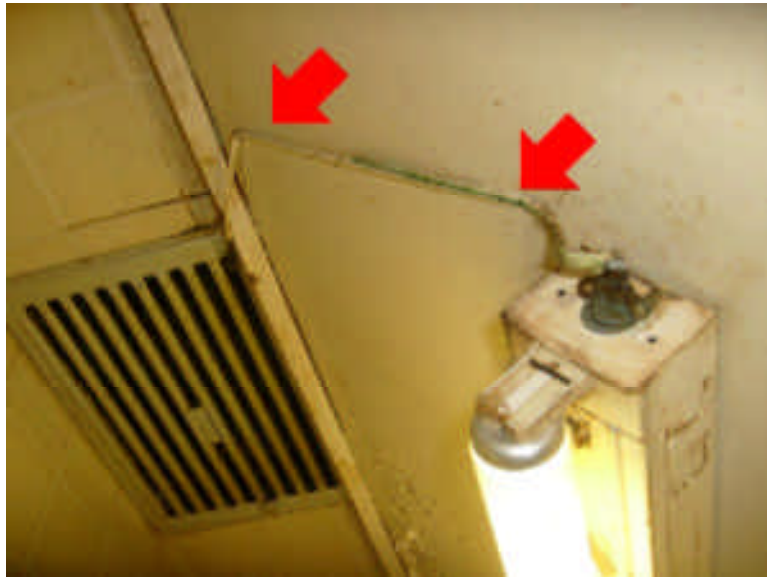
Needs Attention, the light is wired with a light duty extension type cord and not is a proper protective conduit.

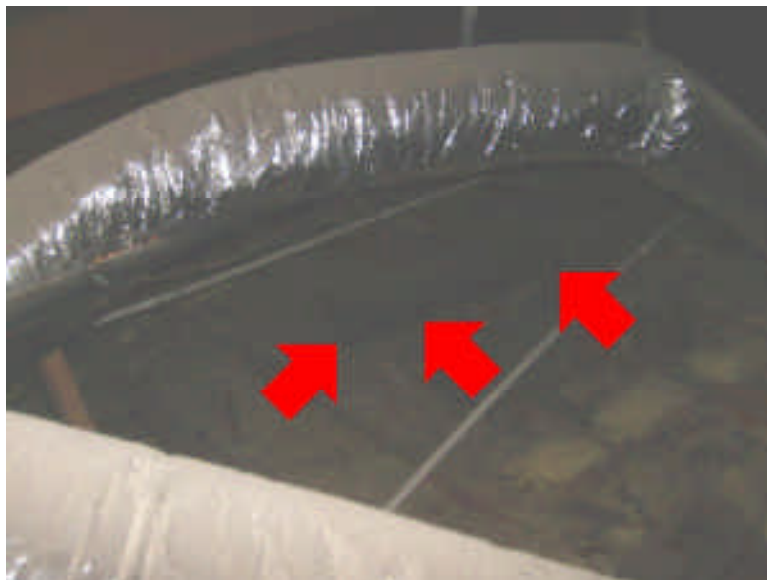
Not Acceptable, the vent duct is laying in the attic and it appears to

have been disconnected and the fan is now just blowing into the attic area

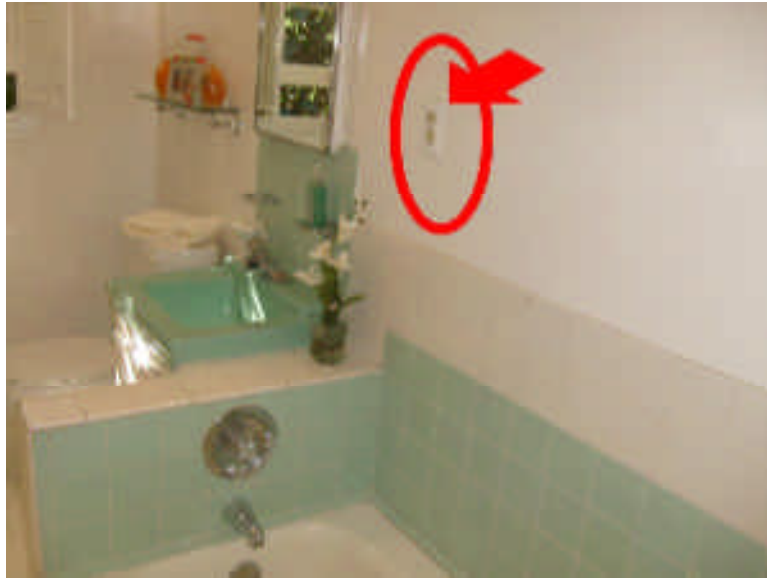
Not Acceptable. the outlet on the wall is close too the tub and is not GFCI protected for safety.

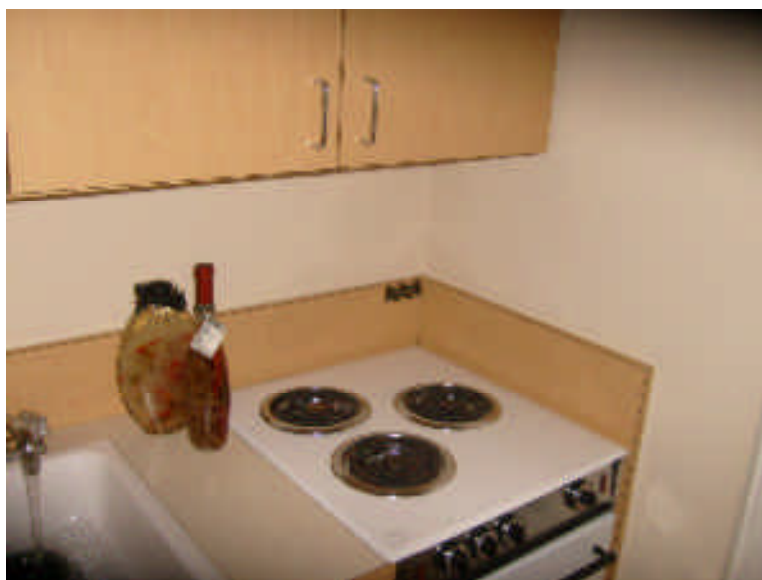
Not Acceptable: The upper cabinets appear to be too close to the cooktop. The cabinets should be 36 inches above it with out a metal hood to reduce the risk of fire.

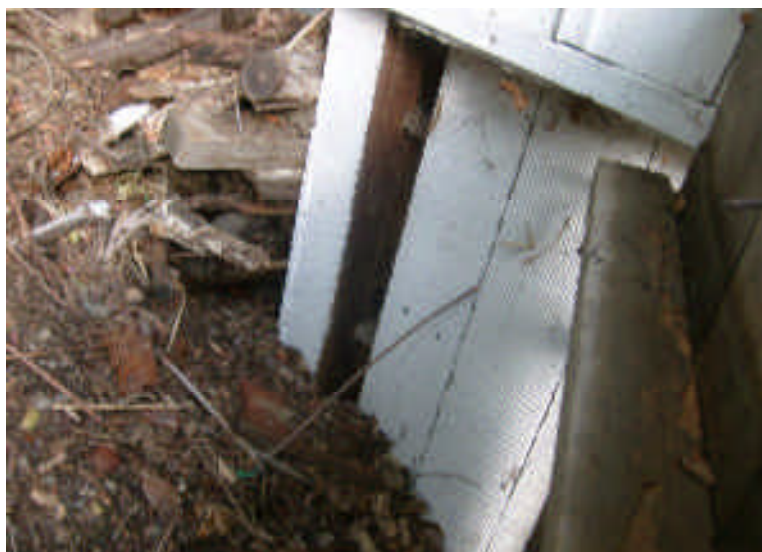
Back of shed

Needs Attention, there is damaged and deteriorated wood at the back of the shed which attaches to the guest house.

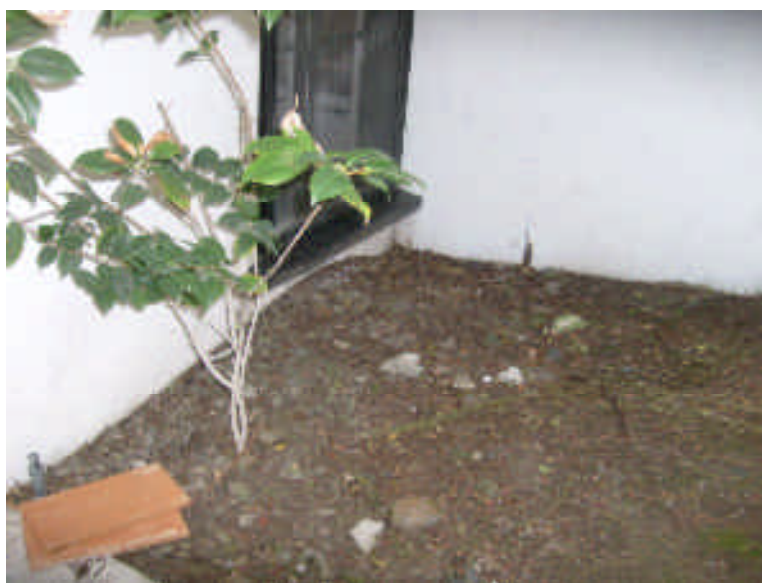
The soil is high against the back side. This appears to be a condition called a "faulty grade" where the ground level on the outside is above the base of the foundation which allows moisture to intrude into the wood framing of the structure, see the pest control report for more information.
