## **Hazards of the Consolidated Industries H-Series Horizontal Furnace**

**By Michael Whedon, Licensed, Certified, Private Fire Investigator**

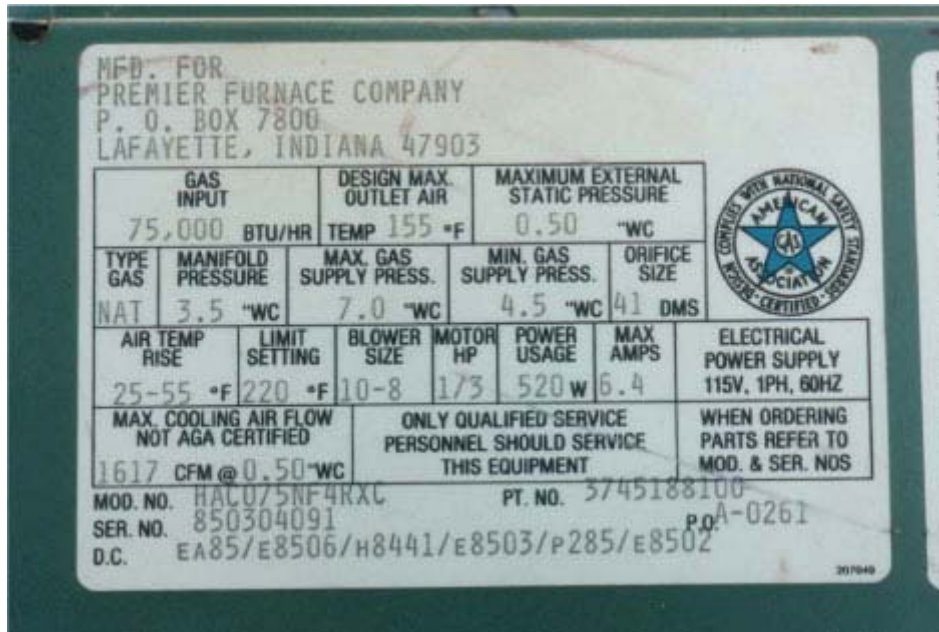
To determine whether a furnace is one of the involved atmospheric H-Series, look on the control side of the furnace for the AGA furnace rating plate. This is a plasticized paper tag which has certain technical information about the furnace as well as the furnace's model number and serial number. (See photo below.) The rating plate may be located on the combustion air intake cover or it may be mounted on the fan door panel. It will always be on the side where the controls are located. The first two or three letters of the model number are used in recognizing the series, modifications, and heat exchanger steel code. The attached list of manufacturers' and model numbers covers furnaces with the Consolidated "Premier" label as well as furnaces sold to other companies and marketed under their labels. If the manufacturer and model number of your furnace appears on the list, you have one of the potentially hazardous models.

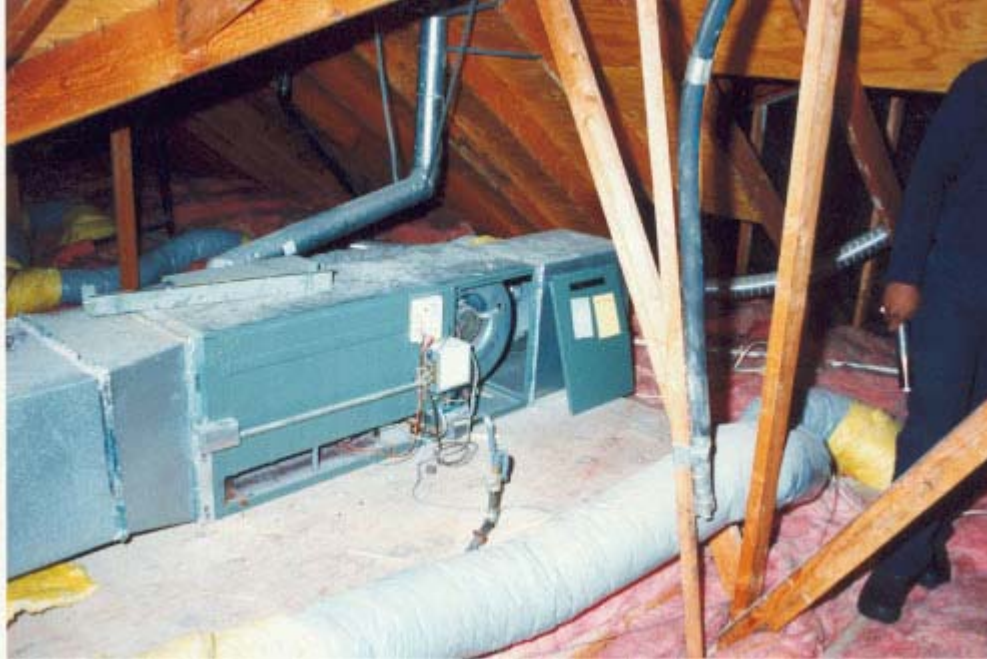
Photo One: Typical installation method for H-Series furnace.

During the same time period, fire investigators began to see an increase in fires occurring in homes equipped with the Consolidated H-Series furnaces. These Consolidated furnaces had been installed in attic spaces on plywood decks or set perpendicular across wooden ceiling joists. The initial theorization was that although the furnaces were rated for installation on

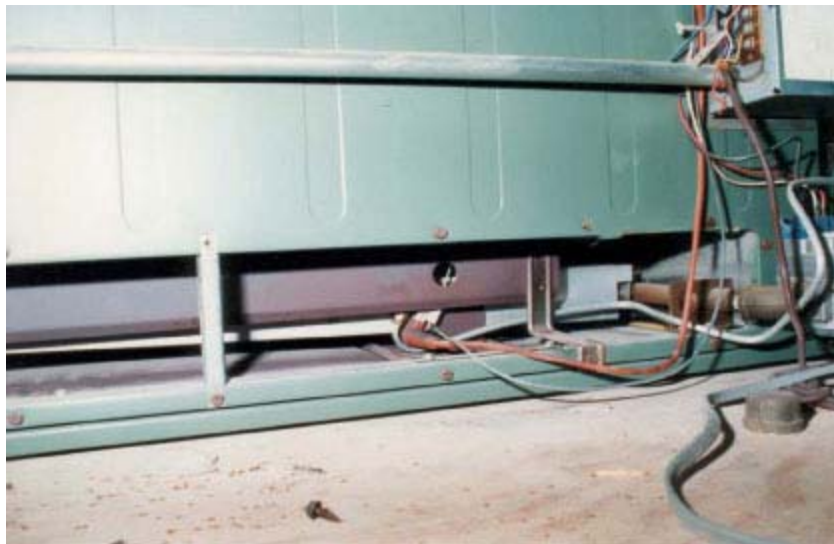
Photo Two: Combustion air intake port at bottom edge of furnace housing.

During the operation of a damaged furnace, if sufficient amounts of circulation air enters the combustion chamber, through holes in the heat exchanger, the burner flames can be pushed down against the bottom panel of the furnace housing as well as out the sides of the furnace through the combustion air intake openings. The combustion air intake openings are located along the sides of the furnace just above the bottom edge. This movement of flames and hot combustion gases out of the furnace is called "flame roll out."

unusual heating of the bottom panel occurs, the heat passes through the metal housing of the furnace into the combustible flooring below. When conditions of flame roll out occur, the flames and hot gases that are venting out through the combustion air intake openings are directed downward by the combustion intake covers and will immediately come into contact with the combustible wood platform. When sufficient heating of the wood occurs, a fire begins. Because most attic spaces are not equipped with heat or smoke detectors, fires in attic spaces can burn for extended periods of time before they are discovered. If the fire occurs during the night time hours, when the occupants of the home are asleep, tragedy can easily occur.

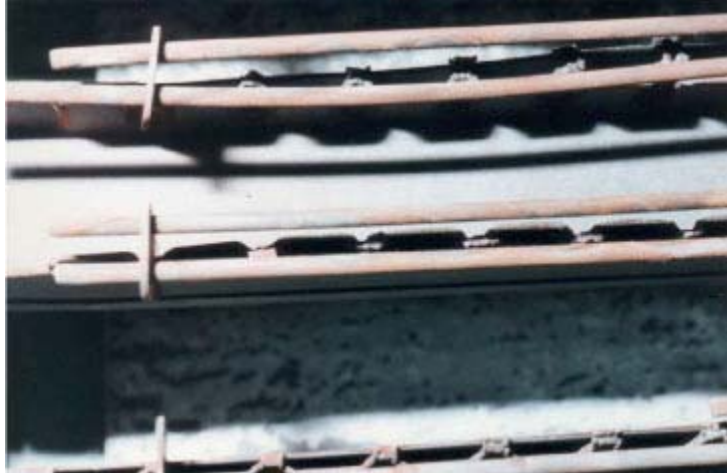
It was determined through observation and testing that small cracks were forming in the metal webs between the gas port openings in the individual burner tubes. After the cracks formed, continued use of the furnace caused the cracks to grow. This resulted in the eventual splitting of the metal between the individual ports which enlarged the port openings to many times their original size. In some burner assemblies examined, holes measuring three to four inches in length and 3/4-inch in width were found. It follows that the larger the hole, the more gas/air can pass through the opening and burn above the burner tube. The normally small, controlled gas flames are replaced by large, irregular shaped flames. Depending on the degree of the failure in the burner assembly, the resulting flames can reach nine or more inches in height. These irregular flames impinge directly on the bottom of the heat exchanger cells which are normally offset and two to 2-1/2 inches above the burner assembly.

Photo Three: Close up view of cracks in the web between burner port openings resulting in the enlargement of the port openings.

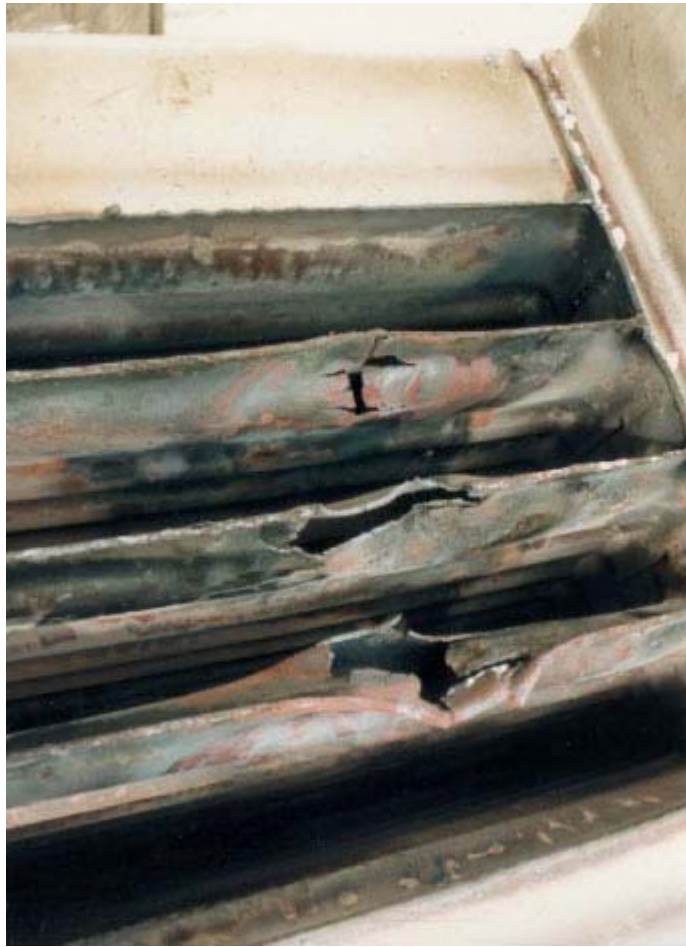
The heat exchangers are made of 18 gauge steel machine welded together to form cells or tubes. The purpose of the heat exchanger is to warm the air passing through the furnace before it is discharged into the duct system for distribution into the living space of the house. The metal from which the heat exchanger is formed did not have the ability to withstand the direct impingement of the burner flames. Additionally, weld seams at the bottom of the heat exchanger tubes were also being subjected to the direct flame impingement. The welds were of relatively poor quality and would fail quickly when exposed to the direct flame contact. Lateral cracks would begin to form in the weld seams and horizontal cracks would also begin to appear in the walls of the heat exchanger cells. Under continued use, these cracks widen and eventually the metal fails causing holes to form in the bottom of the heat exchanger cells. The holes continue to grow larger in size each time the furnace is used.

Photo Six: Failed heat exchanger.

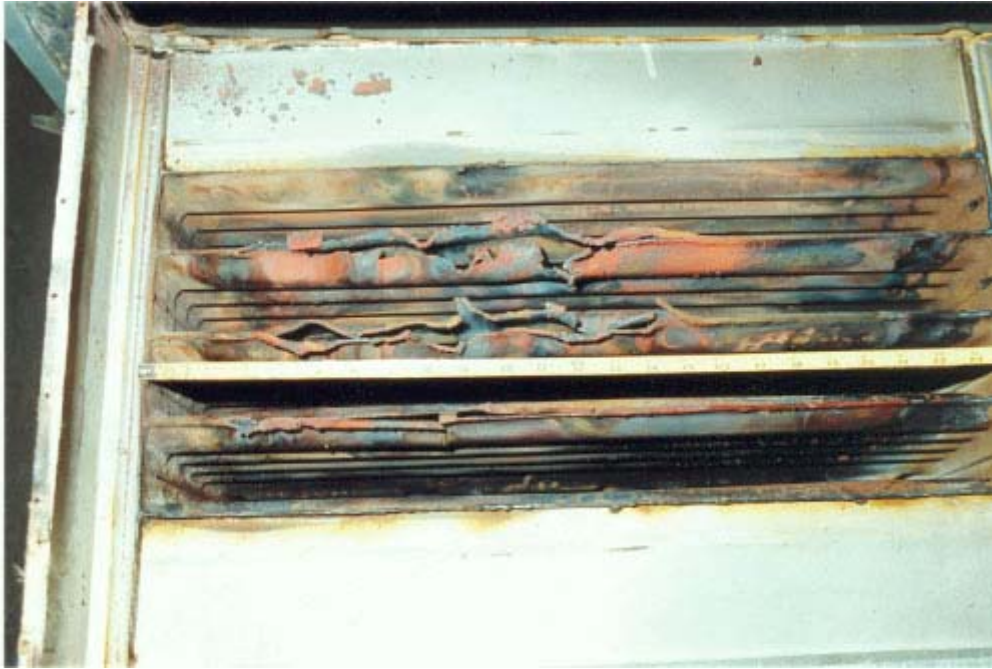
Photo Seven: Major failure of heat exchanger.
