Real Estate Inspection Report

Sample Short Sale Condo

Northridge, CA.

Inspector - Bud Hayes
Confidential and Proprietary

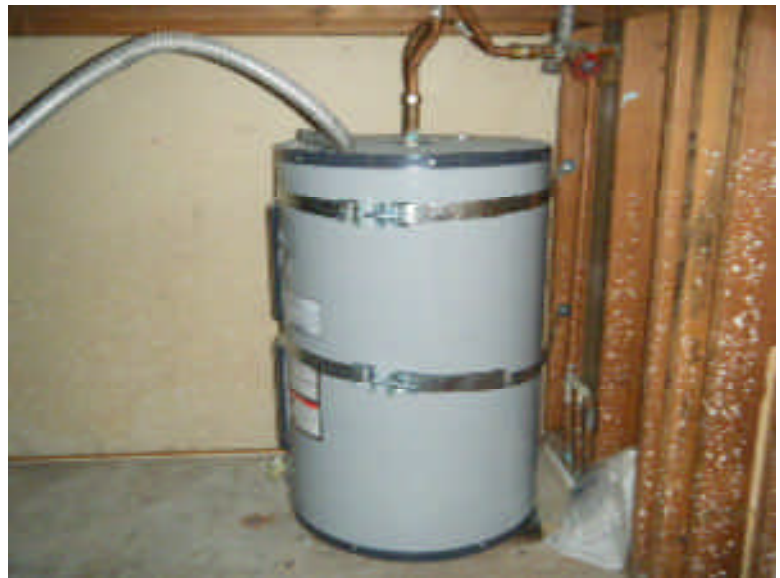
The water heater is located in the closet under the stairs.

Needs Attention: There is no drain pan below the water heater, this is advised in case the water heater leaks so that the water can be carried away from the living space

Note: the building has not been designed to allow a drain for this pan or the emergency release valve. Check with the HOA for more information and to coordinate repair/modification.

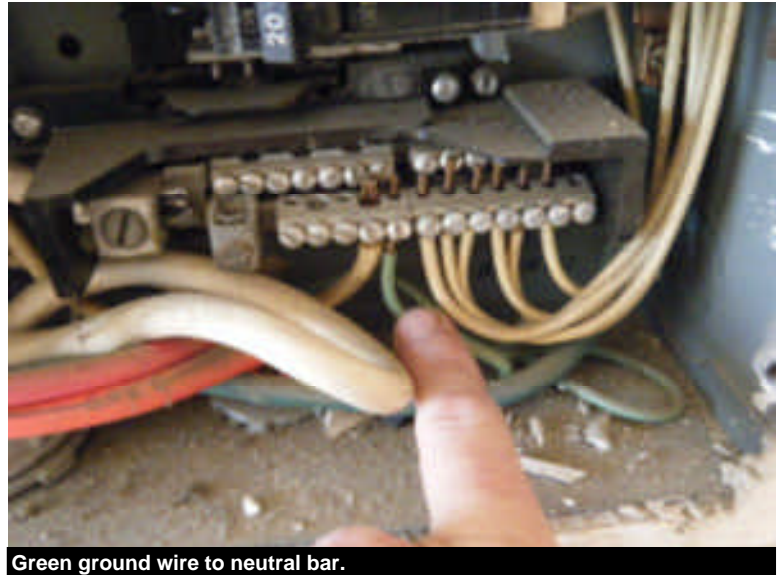
Green ground wire to neutral bar.

Needs Attention:, The neutral and grounding wires appear to be interconnected within the sub panel. This was allowed at one time and may have been approved at the time this panel was installed. It should be noted that this is no longer an approved installation and upgrade should be considered by a license electrician to improve the overall safety of the electrical system.

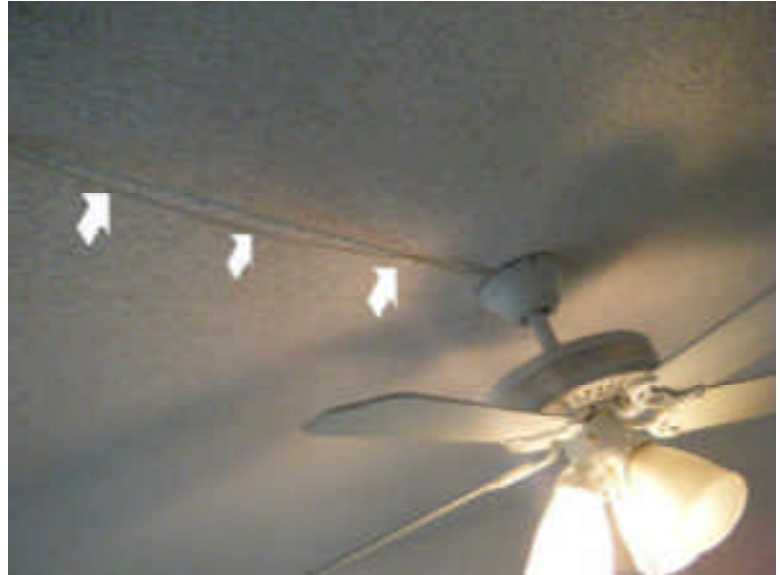
Not Acceptable: Extension cord type light duty wiring is being used to provide power in areas. It needs to have proper wiring installed as this cord wiring is not rated to supply permanent power. This is found at the master bedroom ceiling light connected to an outlet.

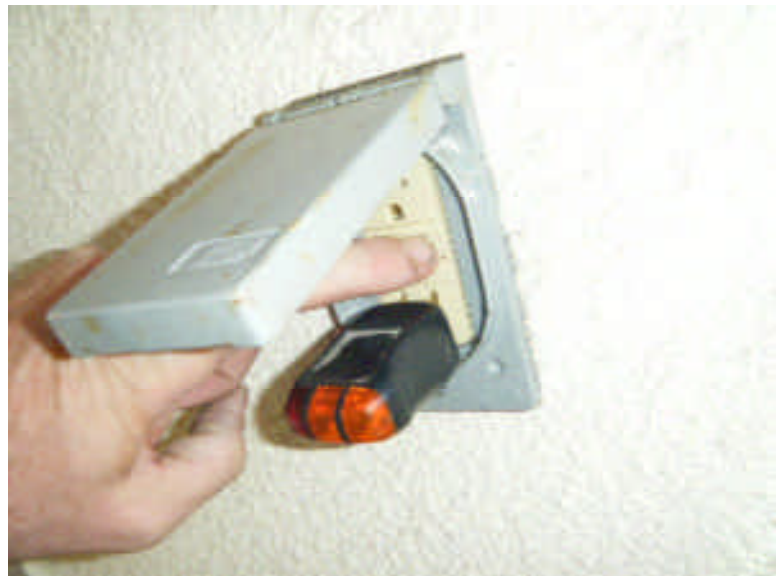
Not Acceptable: The Ground Fault Circuit Interrupter (GFCI) outlet did not turn off (trip) when tested. It should be replaced, outside the building in the patio area.

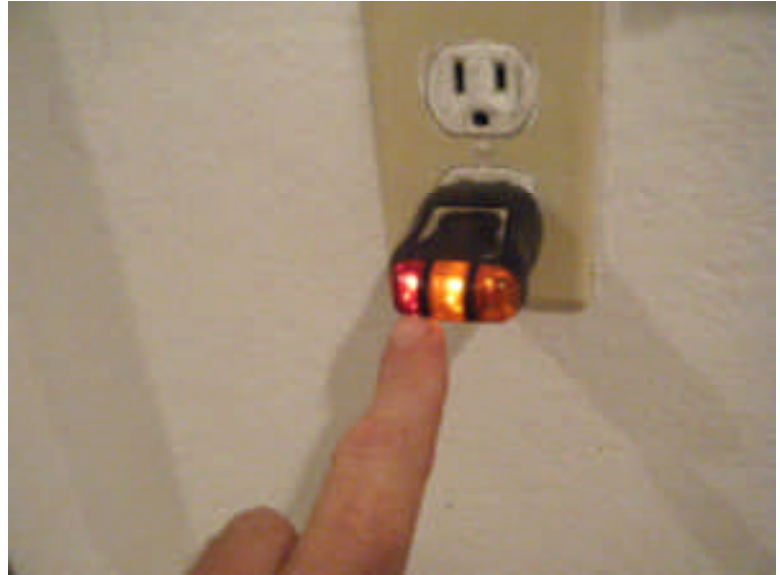
There are outlets that had the wires reversed in them (this is called reversed polarity) such as in the upstairs hall bath. These outlets are still live and will work but could potentially harm anything that is plugged into them

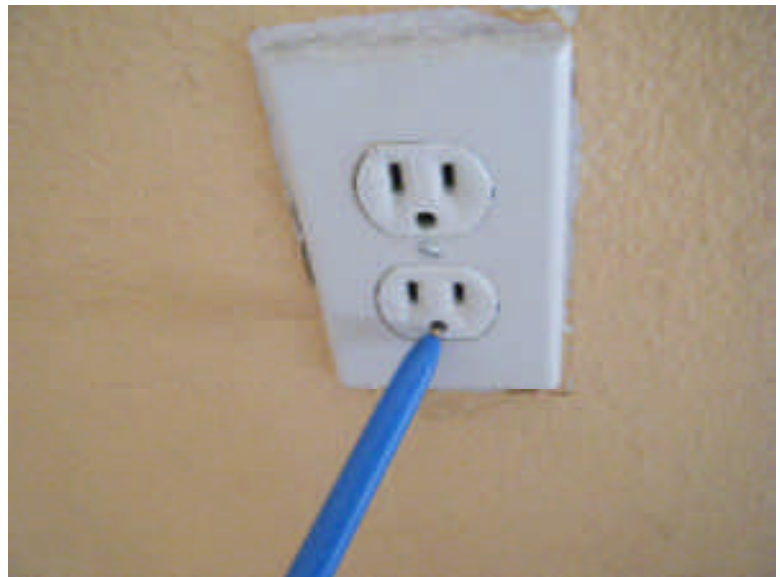
The outlet near the front door has a broken piece jammed into the bottom ground plug hole.

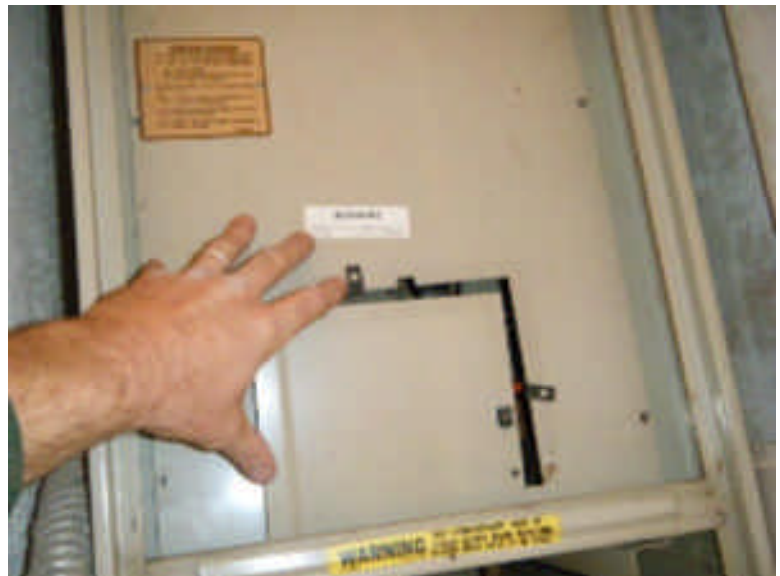
Needs Attention:, the inner cover panels are loose and not screwed and secured.

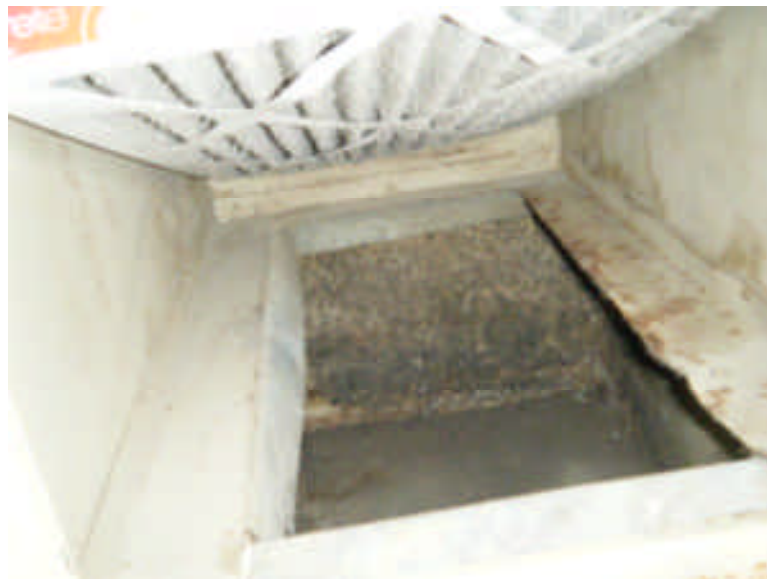
Needs Attention: The filter is not properly secured in place within the furnace and will float out of position and not filter the air when the fan is in operation. NOTE, a missing filter or loose can allow dust to cover and block the A/C evaporative coils that are concealed inside the furnace. This should be checked by a heating specialist and cleaned/repared as needed.

The area under the filter is very dirty and needs servicing and cleaning.

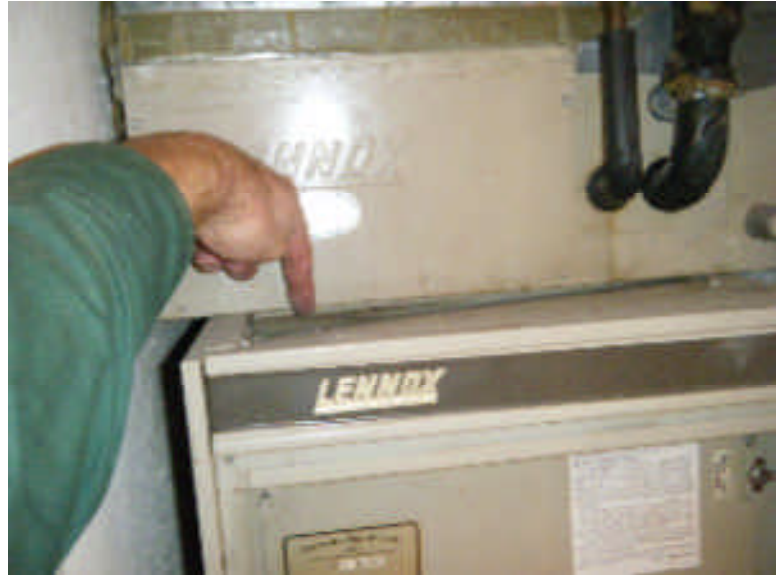
There is a leak at the duct connection inside of the closet. This should be further examined by a Heating and Cooling Specialist.

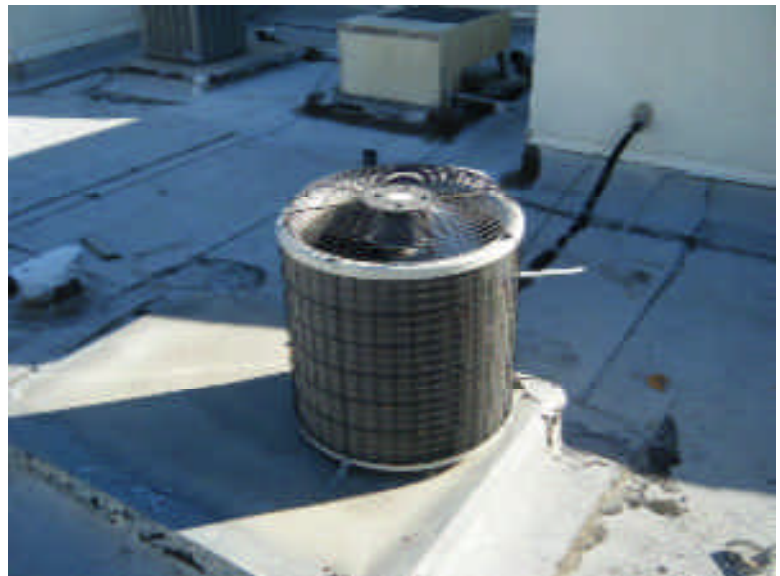
The condenser for the air conditioning is located on the roof.

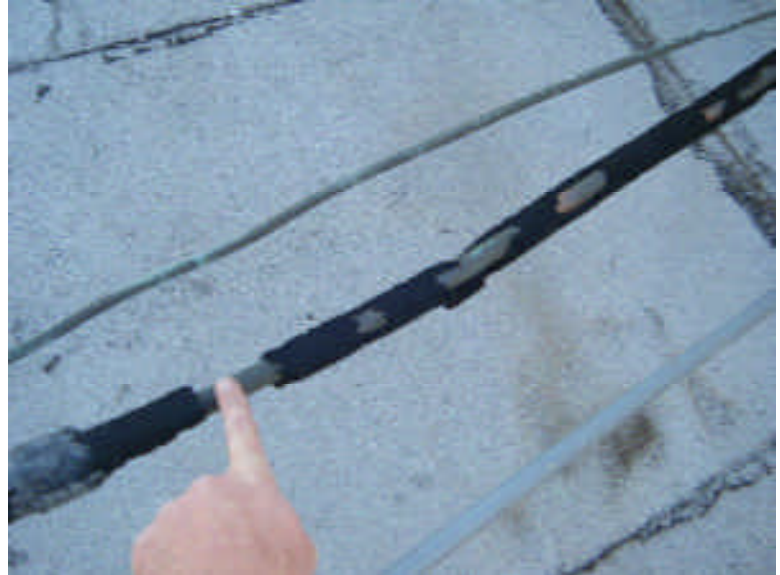
Needs Attention: The refrigerant lines have damaged insulation on them. This will cause them to be inefficient and they should have the insulation repaired. This is usually not an expensive item.

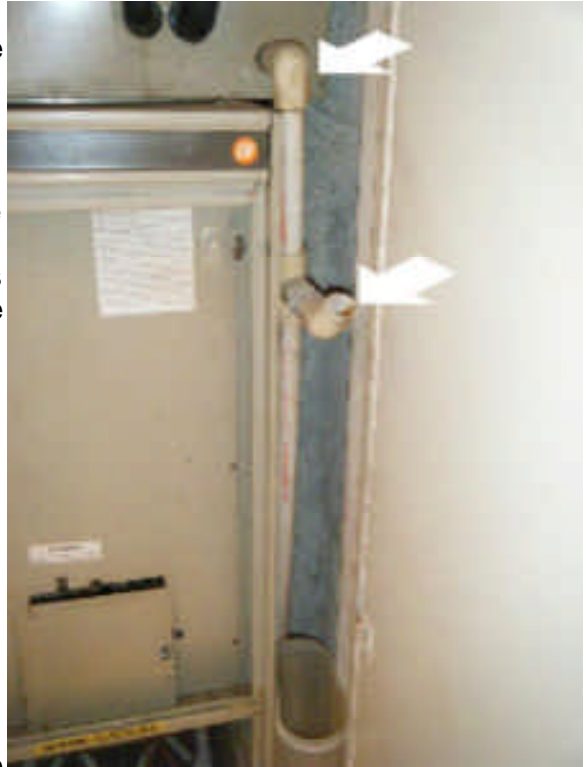
Needs Attention: There is no secondary condensate line installed. All air conditioning pulls moisture from the air and this moisture has to be taken somewhere. There is supposed to be a main condensate line to do this and a back up in case the primary line fails. The secondary backup line is missing.

Note: this is an older type with out an overflow or secondary drain connection. There are plastic pans and containers under the drain and some rust seen on the metal covers indicating this has clogged and leaked in the past.

On older models the design does not allow for a secondary drain line. There are ways that the main primary drain line can be set up to allow proper drainage such as adding a trap formation to the line with a short vent section, so it can be easily inspected, drains better and easy access to clean out when they become clogged.

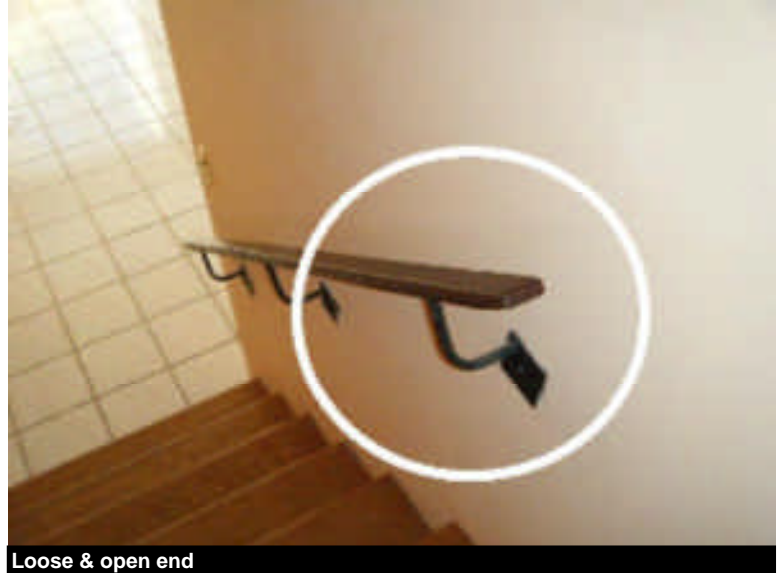
Needs Attention, the railing does not return to the wall but stops with the end of it exposed. This is considered a safety hazard as the end of it could catch a garment or handbag and cause someone to trip or fall

The lower railing is a little loose

The space between the rails is greater than is currently recommended for child safety. The railings should not have any space greater than four inches in any portion of them.

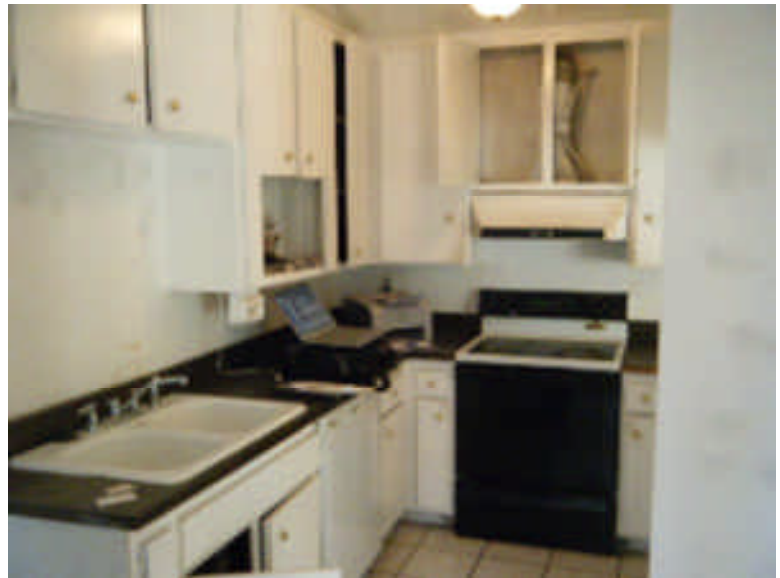
Note: the kitchen is dirty and has some damage and odd odors and will need professional deep cleaning besides repairs recommended.

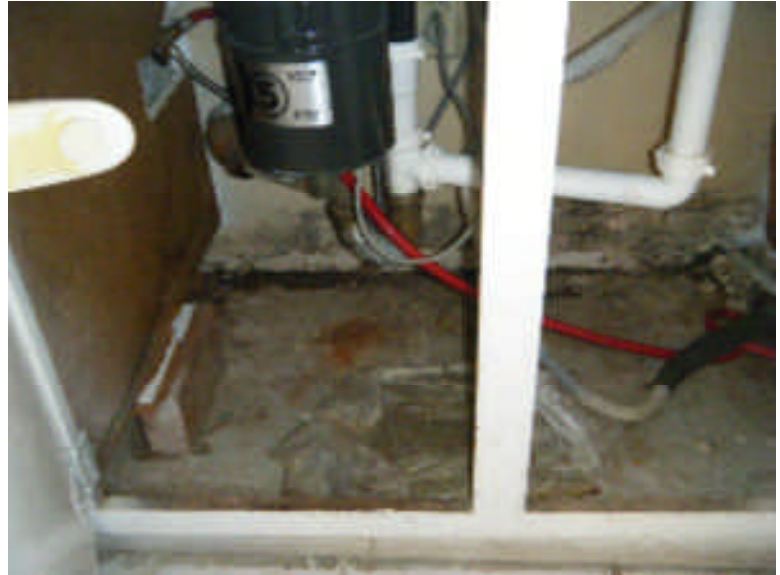
Not Acceptable, the cabinet area below the sink has damage/deterioration which appears to have been caused by moisture. The bottom shelf is missing. There is a black growth which appears to be a mold like substance. This needs to be properly examined and abated by a mold specialist.

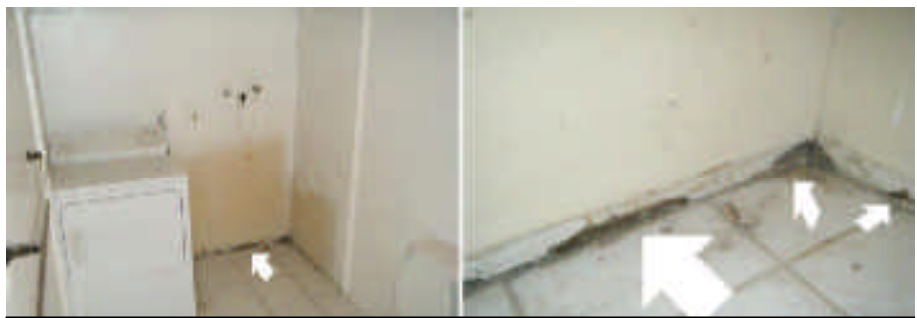
Laundry area & close up

Not Acceptable, there are areas of moisture damage on the lower wall at the washer area and some rotted wood is seen, see the pest control report for more information.

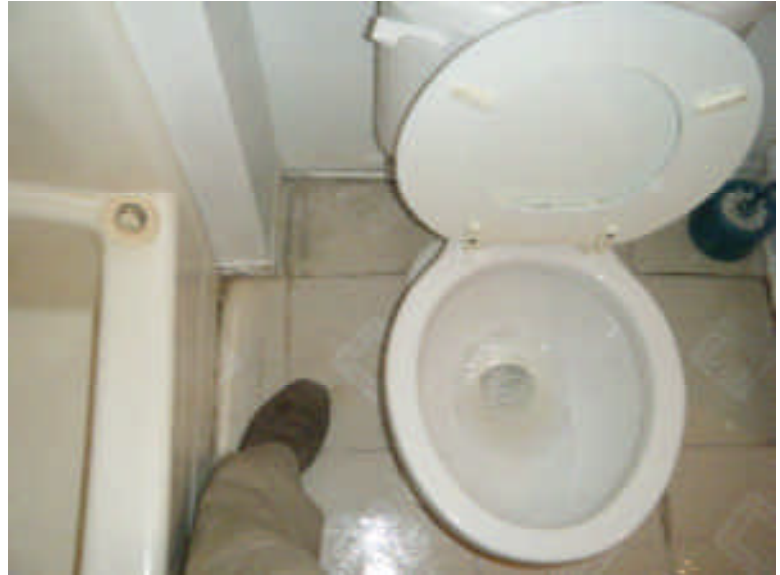
Not Acceptable:, the floor is a little soft around the loose toilet. This appears to be rotted, see the pest control report for more information.

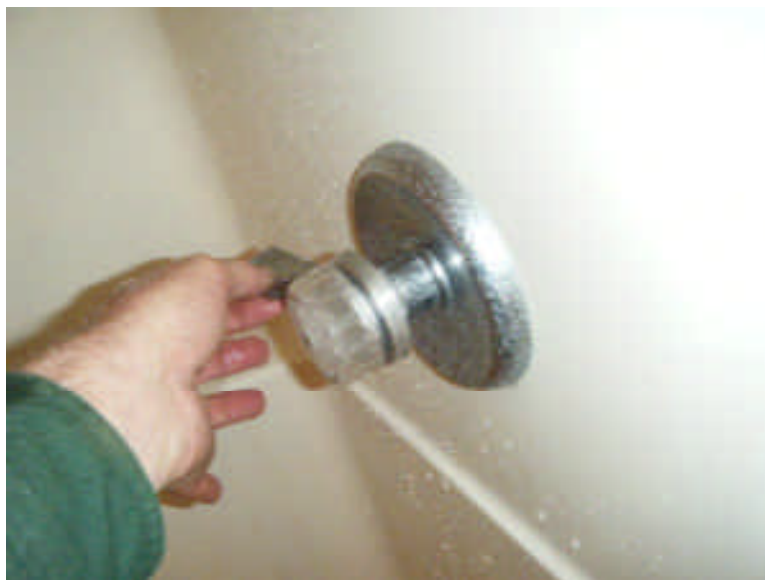
Not Acceptable; the valve is loose and stuck on the hot mode and does not change. It is advised to have a licensed Plumber further examine this and make any needed repairs.

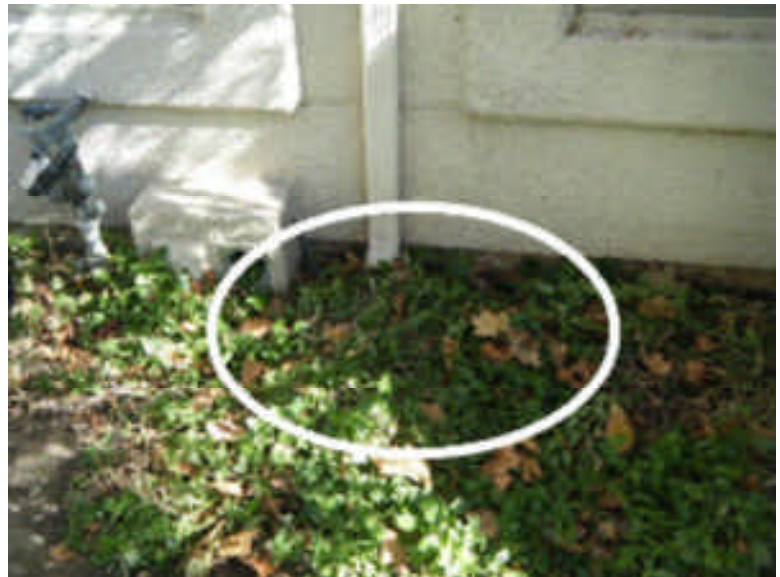
Needs Attention, the roof downspout empties close to the building and does not appear that the water will drain properly. An extension diverter piece could be added and some landscaping modifications should be done to allow the water to drain to the area drains. Check with the HOA for more information and to coordinate repair.
