Real Estate Inspection Report

Sample Report

**604 S. Any Street
Los Angeles, CA 90689**

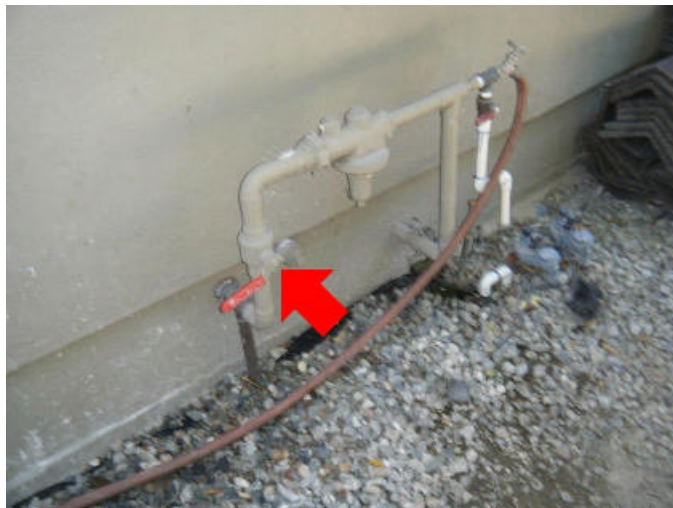
MAIN WATER SHUT OFF LOCATION:

On the left side of the building.

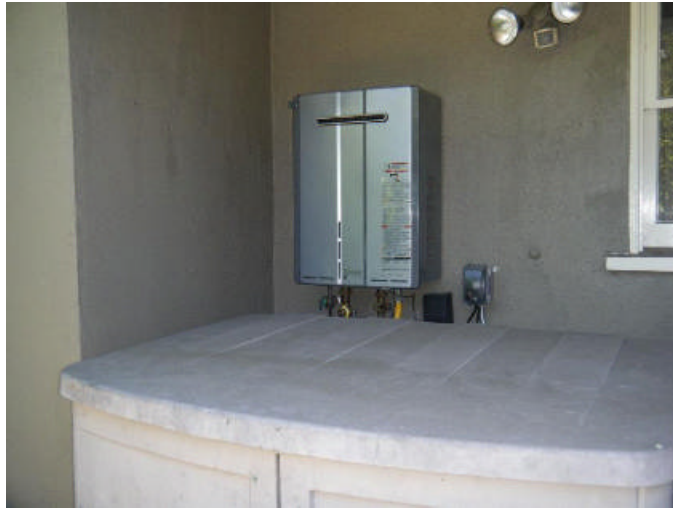
WATER HEATER:
LOCATION:

The water heater is located on the exterior of the building at the left.

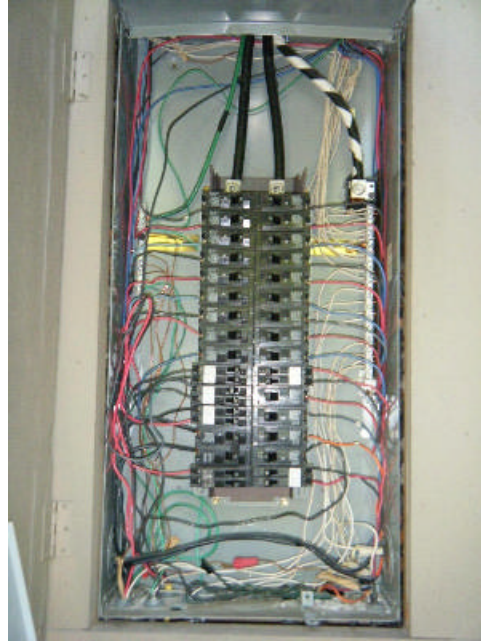
SUBPANEL LOCATION:

There is an electrical subpanel on the exterior of the building at the left side where the original main service panel was located.

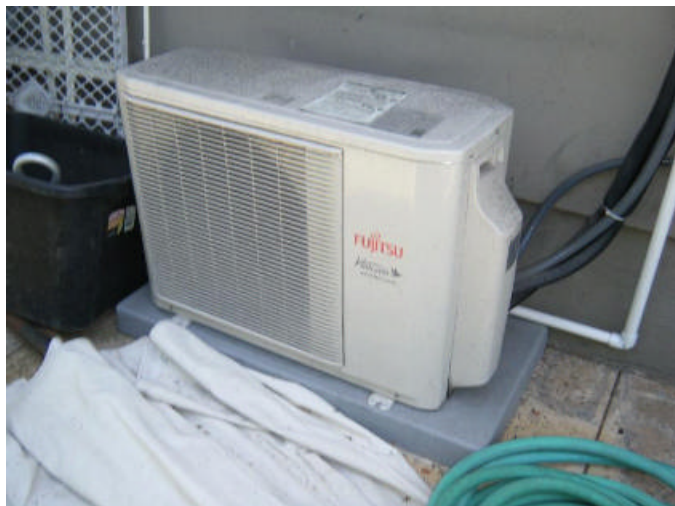
HEATING AND COOLING SYSTEM:

There is a third heat pump style wall unit and condenser for the garage office area. This is a newer unit and appears to be operating normally. Our evaluation of this type of unit is limited to general operation.
