Real Estate Inspection Report

Sample HOA Common Areas Report

Los Angeles, CA

Inspector - Bud Hayes
Confidential and Proprietary

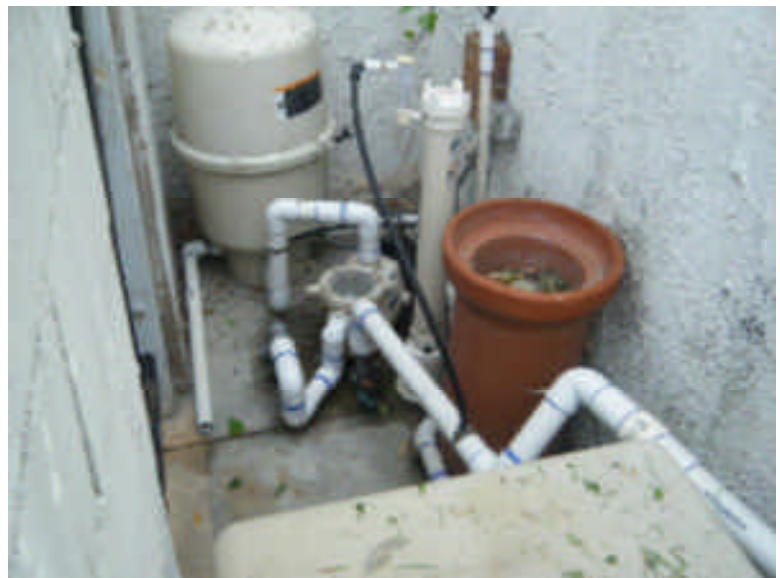
EQUIPMENT AREA:

Serviceable.

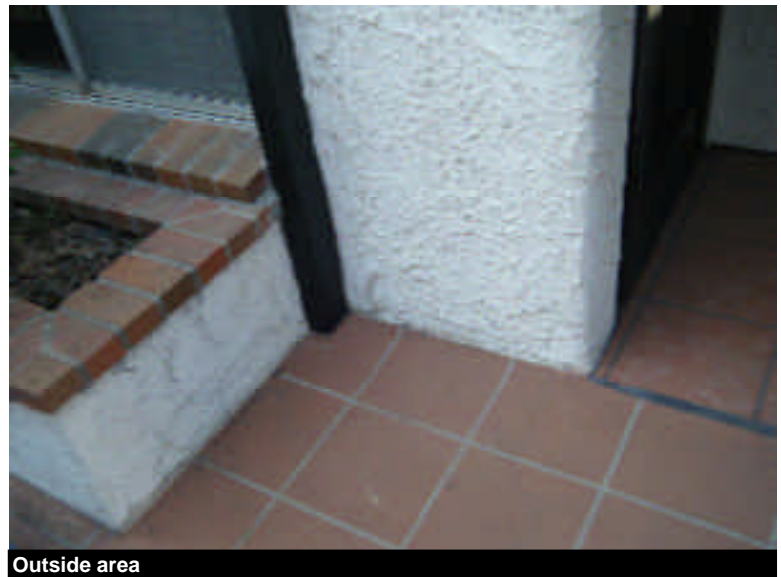
Unit #21.

Not Acceptable. water stains and intrusion is found near the edge of the exterior planter and in the middle area.

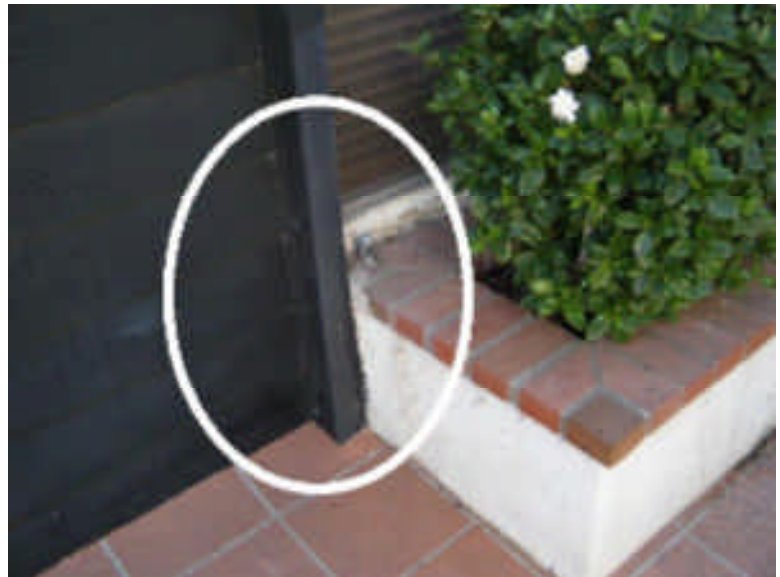
Unit #22.

Not Acceptable, there are areas cupping and bowing pergo type flooring along the planter area especially near the front door.
