Real Estate Inspection Report

September 2009.

Sample Apartment Report

Huntington Park, CA 90255

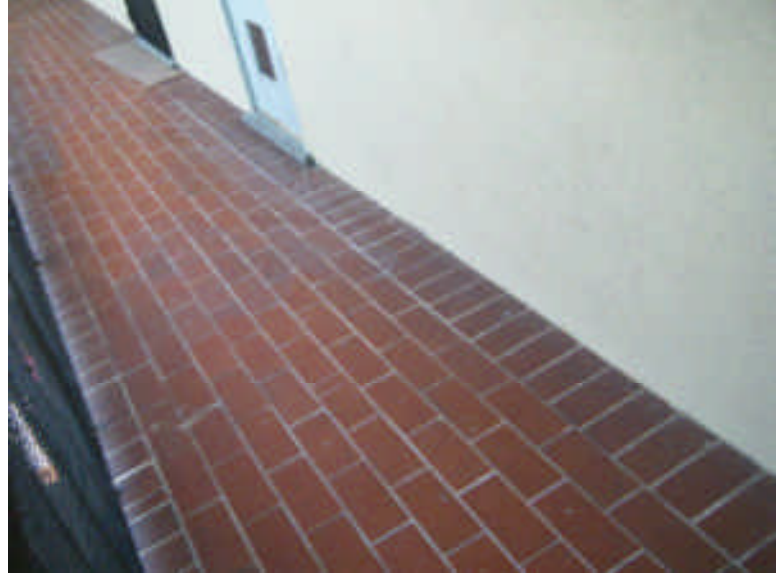
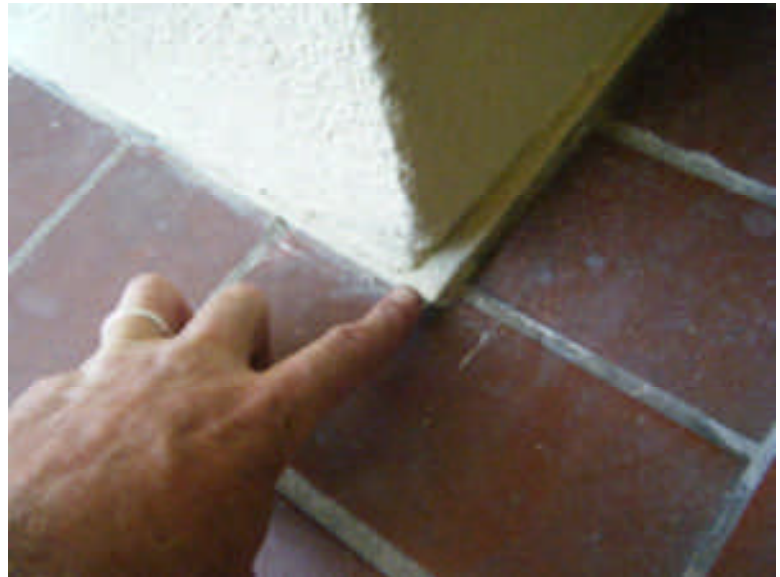
Serviceable.

Note: the water proof seals inside of the walls can not be seen. There is a small metal piece on the stucco wall at the connection to the tiles indicating some metal flashing trim is present.

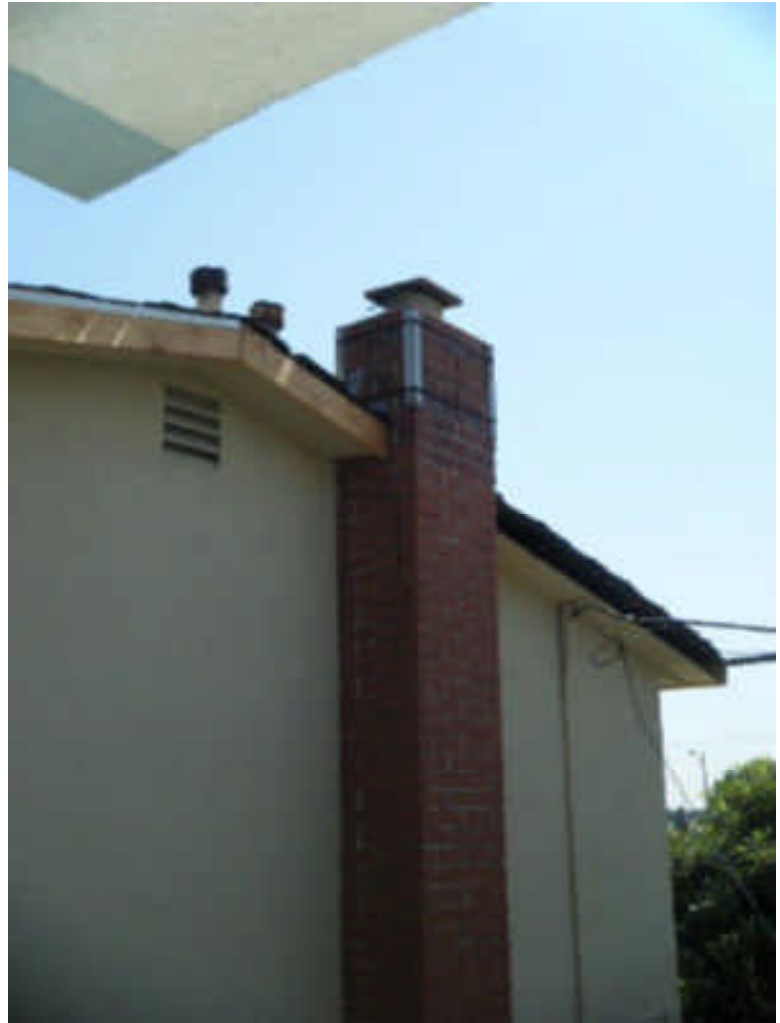
This chimney is located at the back side of the front building on the left.

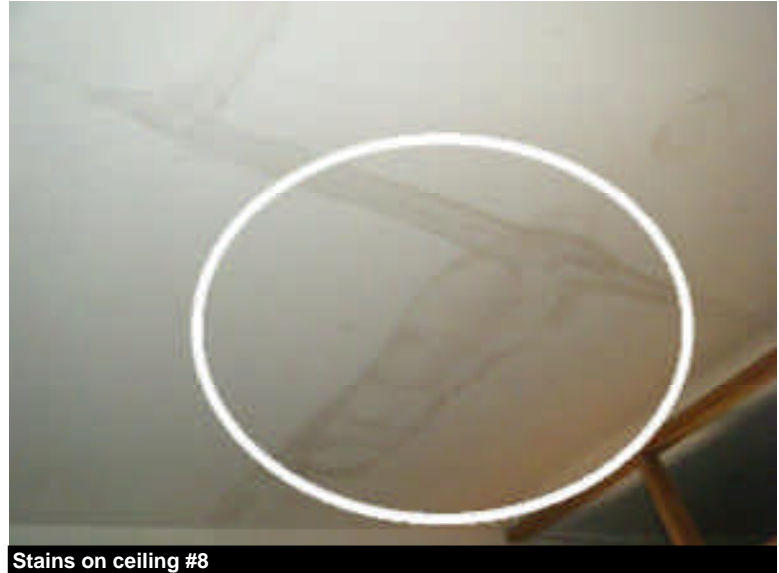
Not Acceptable: The garage interior has areas of moisture stains in #6 & #8. It #6 there is also a black mold like growth and the plumbing access door is missing some the firewall separation to the above unit has been compromised.

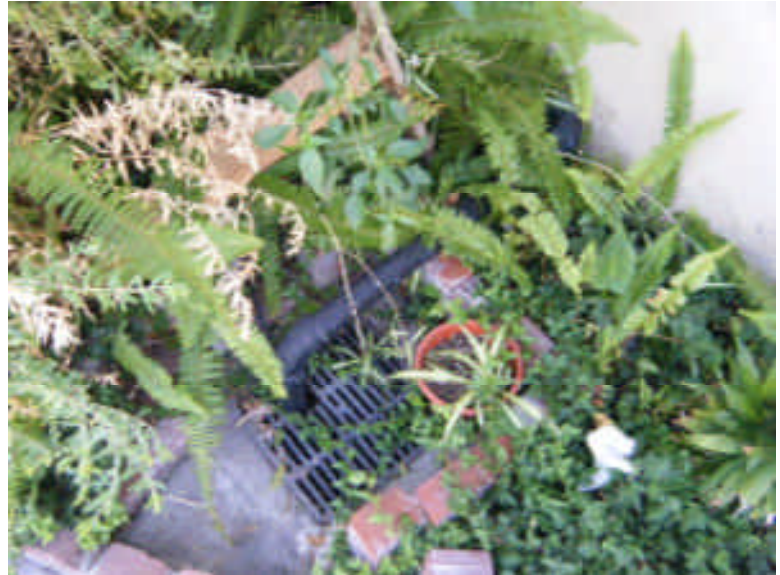
DRAINAGE
CONDITION: Needs Attention: There are areas where the water may pond instead of flowing off the site during heavy rains, such as at the left side of the building.

The back right downspout does not extend away properly and the sidewalk appears to be a low spot (a green plant is growing under the structure at this area)
